REVISED FINAL REPORT

New York State Office of General Services

Engineering Report for WA.01 Port Bay

March 18, 2020

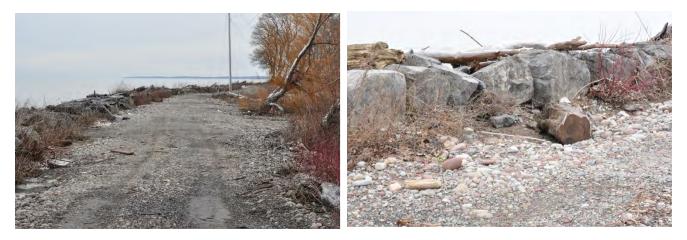
We recommend maintaining the existing west barrier bar revetment, as there were no breaches during the recent flooding/breaching of the eastern barrier. Site observations (**Figure 4-4**) suggest that repairs and supplemental erosion control measures may be needed to avoid loss of sediment from the inboard side of the revetment. These erosion control measures could dovetail with needed repairs to approximately 750 linear feet of public access roadway to the DEC boat launch and public beach (**Figure 4-5**). Based on data collected from the UAV flyover, typical low elevations of the road are at approximately 250 ft and raising the road to 251 ft may be warranted to achieve two feet of freeboard above the base flood elevation for this area (Section 2). A typical cross-section is provided in **Figure 4-6**. Additional work recommended for consideration during design is the installation of living timber cribbing on the bay side of the road, for an approximately length of 100 ft. where the road descends from the mainland to the western barrier bar.

Figure 4-4 (Left) Low areas of the west barrier bar access road subject to flooding and erosion. (Right) Typical erosion occurring immediately inboard of the stone armoring the lake side of the west barrier bar.

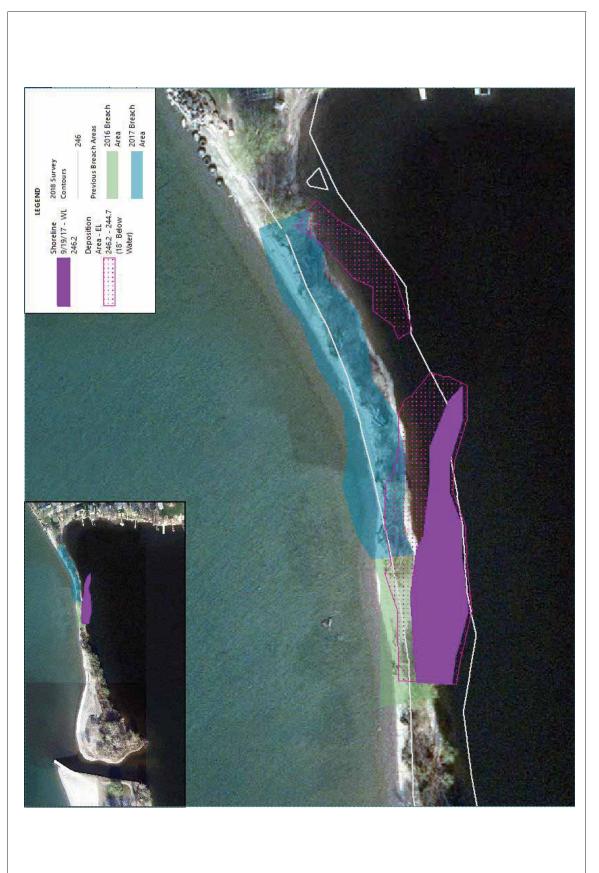
Figure 2.1-15 East Barrier Bar Breach of 2017 and Its Natural Repair (viewed Feb. – Apr. 2018)

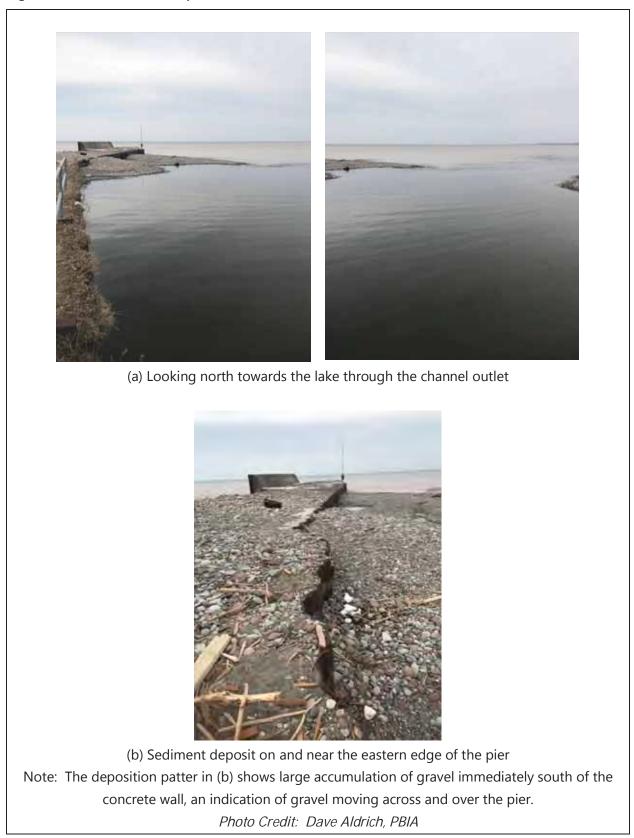
Figure 2.1-19 Sediment Deposition at the Channel Outlet as Viewed on March 24, 2019
