REVISED FINAL REPORT

New York State Office of General Services

# Engineering Report for WA.01 Port Bay

March 18, 2020

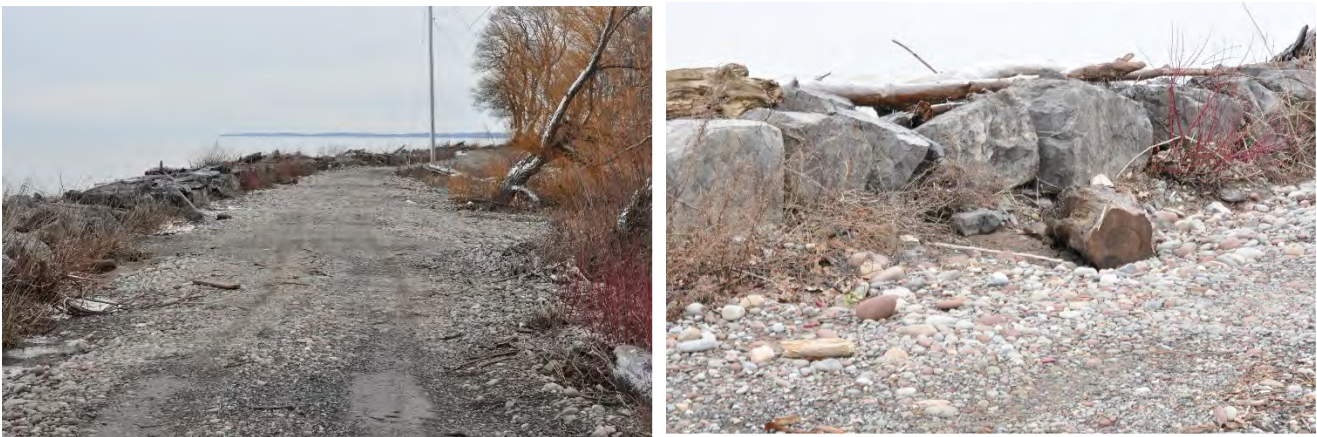
We recommend maintaining the existing west barrier bar revetment, as there were no breaches during the recent flooding/breaching of the eastern barrier. Site observations (**Figure 4-4**) suggest that repairs and supplemental erosion control measures may be needed to avoid loss of sediment from the inboard side of the revetment. These erosion control measures could dovetail with needed repairs to approximately 750 linear feet of public access roadway to the DEC boat launch and public beach (**Figure 4-5**). Based on data collected from the UAV flyover, typical low elevations of the road are at approximately 250 ft and raising the road to 251 ft may be warranted to achieve two feet of freeboard above the base flood elevation for this area (Section 2). A typical cross-section is provided in **Figure 4-6**. Additional work recommended for consideration during design is the installation of living timber cribbing on the bay side of the road, for an approximately length of 100 ft. where the road descends from the mainland to the western barrier bar.

**Figure 4-4** (Left) Low areas of the west barrier bar access road subject to flooding and erosion. (Right) Typical erosion occurring immediately inboard of the stone armoring the lake side of the west barrier bar.

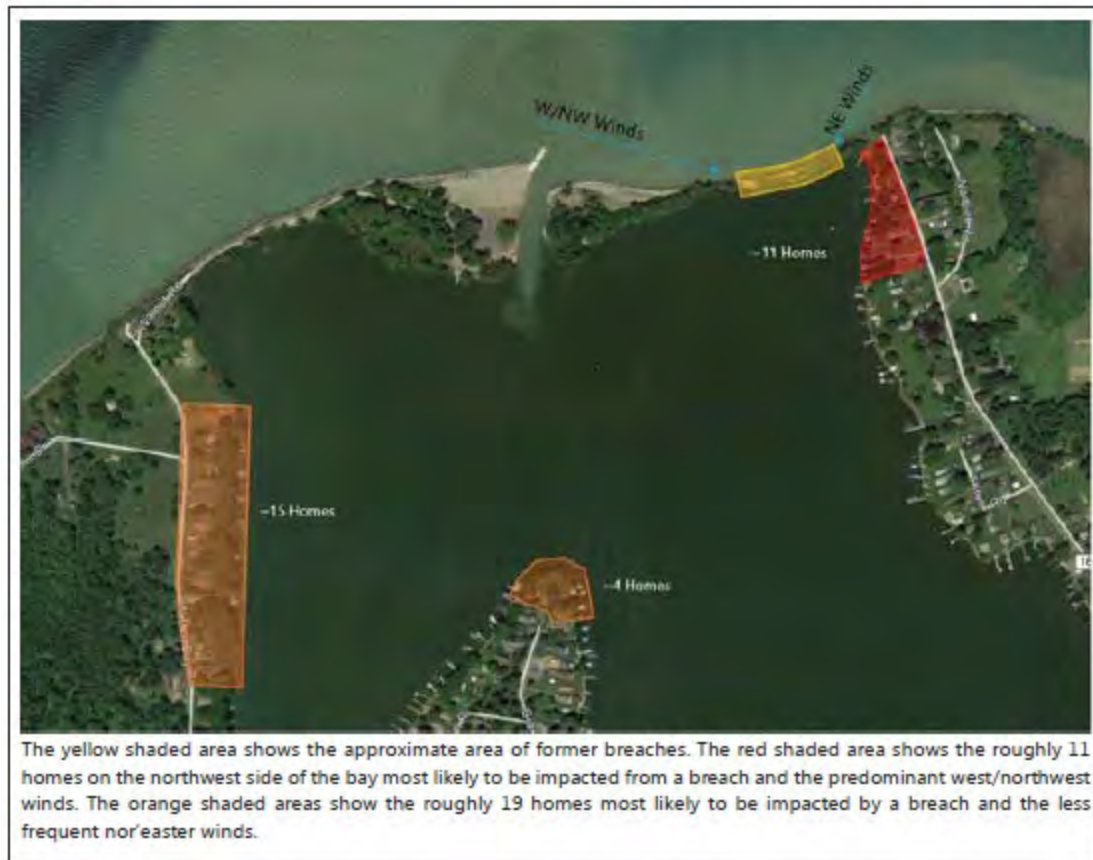
Figure 4-6 Homes Likely to be Damaged During a Breach Event (Bergmann 2019)

During the 2017 high water and breach, extensive damage occurred to Port Bay and its 8-miles of shoreline. Damages include but is not limited to repair, failing break walls, erosion behind break walls, structural flooding, damaged to homes, sheds, and garages (Bergmann 2019). During breach events, the homes along the northeastern and northwestern sides of the bay are most likely to be impacted from a breach (**Figure 4-6**). Strengthening the barrier bar will help to reduce risks to Port Bay and its residents along the shoreline from future damage. It is important to note that high water alone may cause future damage regardless of the wave attenuation value of the barrier bar.

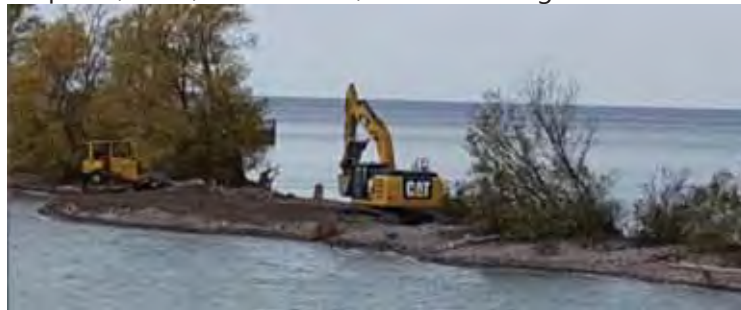
Repair completed in Nov. 2016 (~WL 244.4 IGLD85)

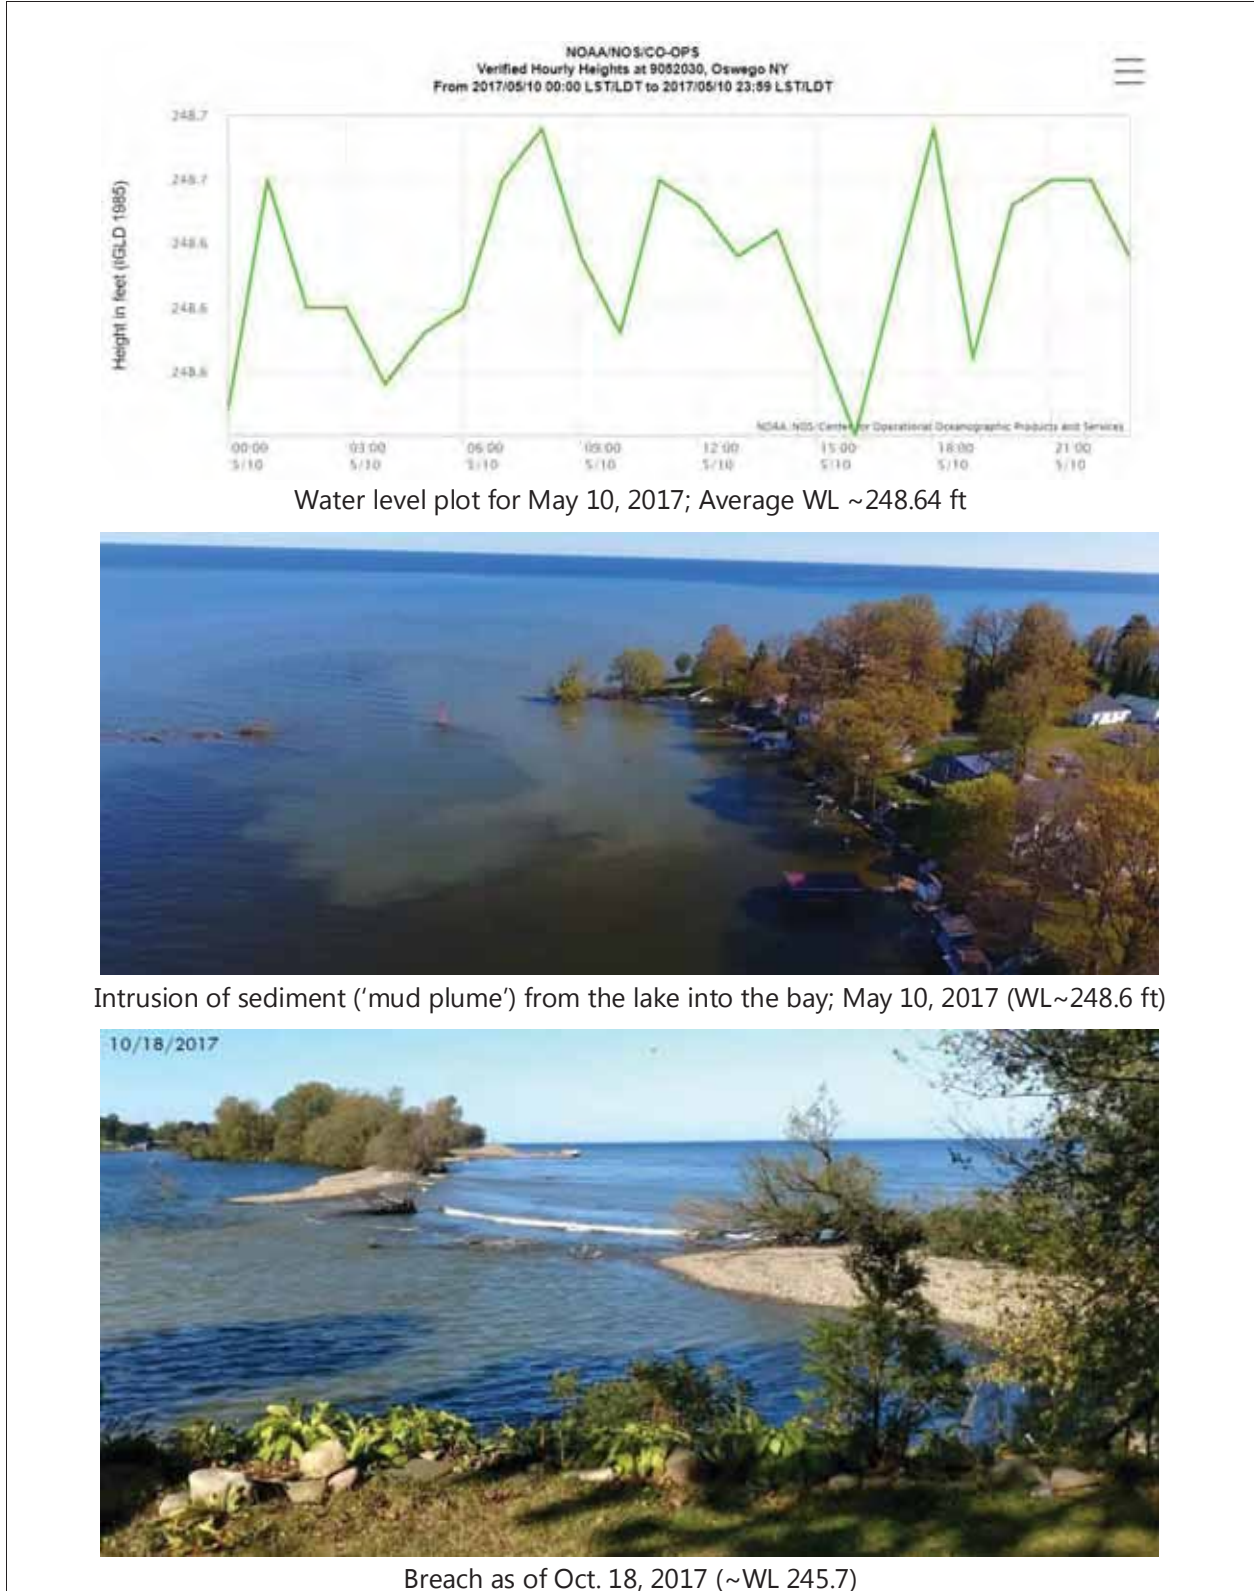
Figure 2.1-9 East Barrier Bar Breach under High Water Level (~248.6 ft), May 10, 2017 (drone view)

East barrier bar breach wide open because of high water level

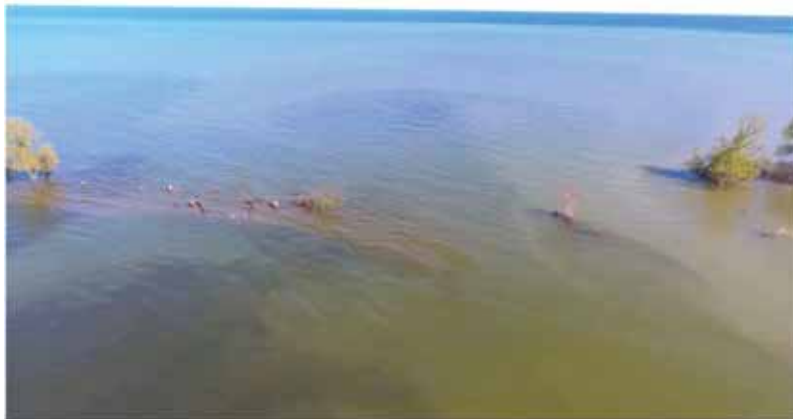
Part of the east barrier bar (repair of 2016, west of the breach) inundated because of high water level

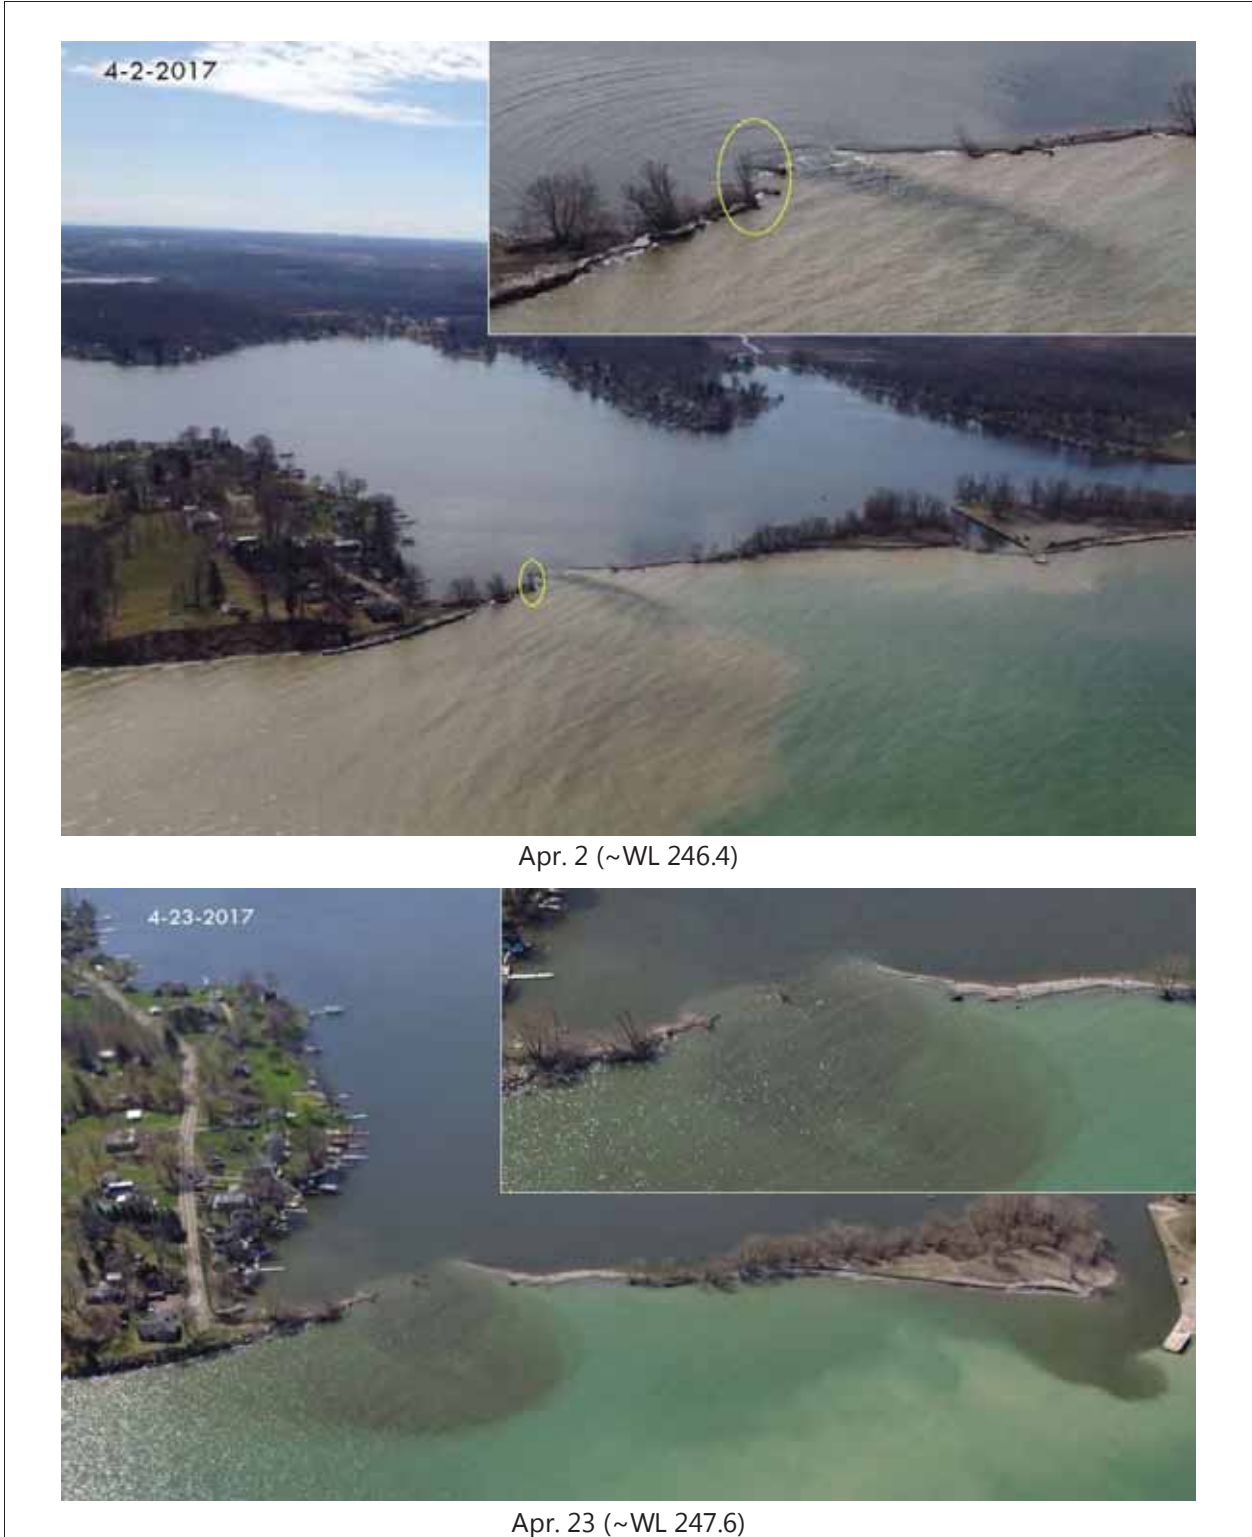
Figure 2.1-13 Damage During Breach of March 2017

May 3, 2017; WL=248.69 ft (normal average WL=246.10 ft)

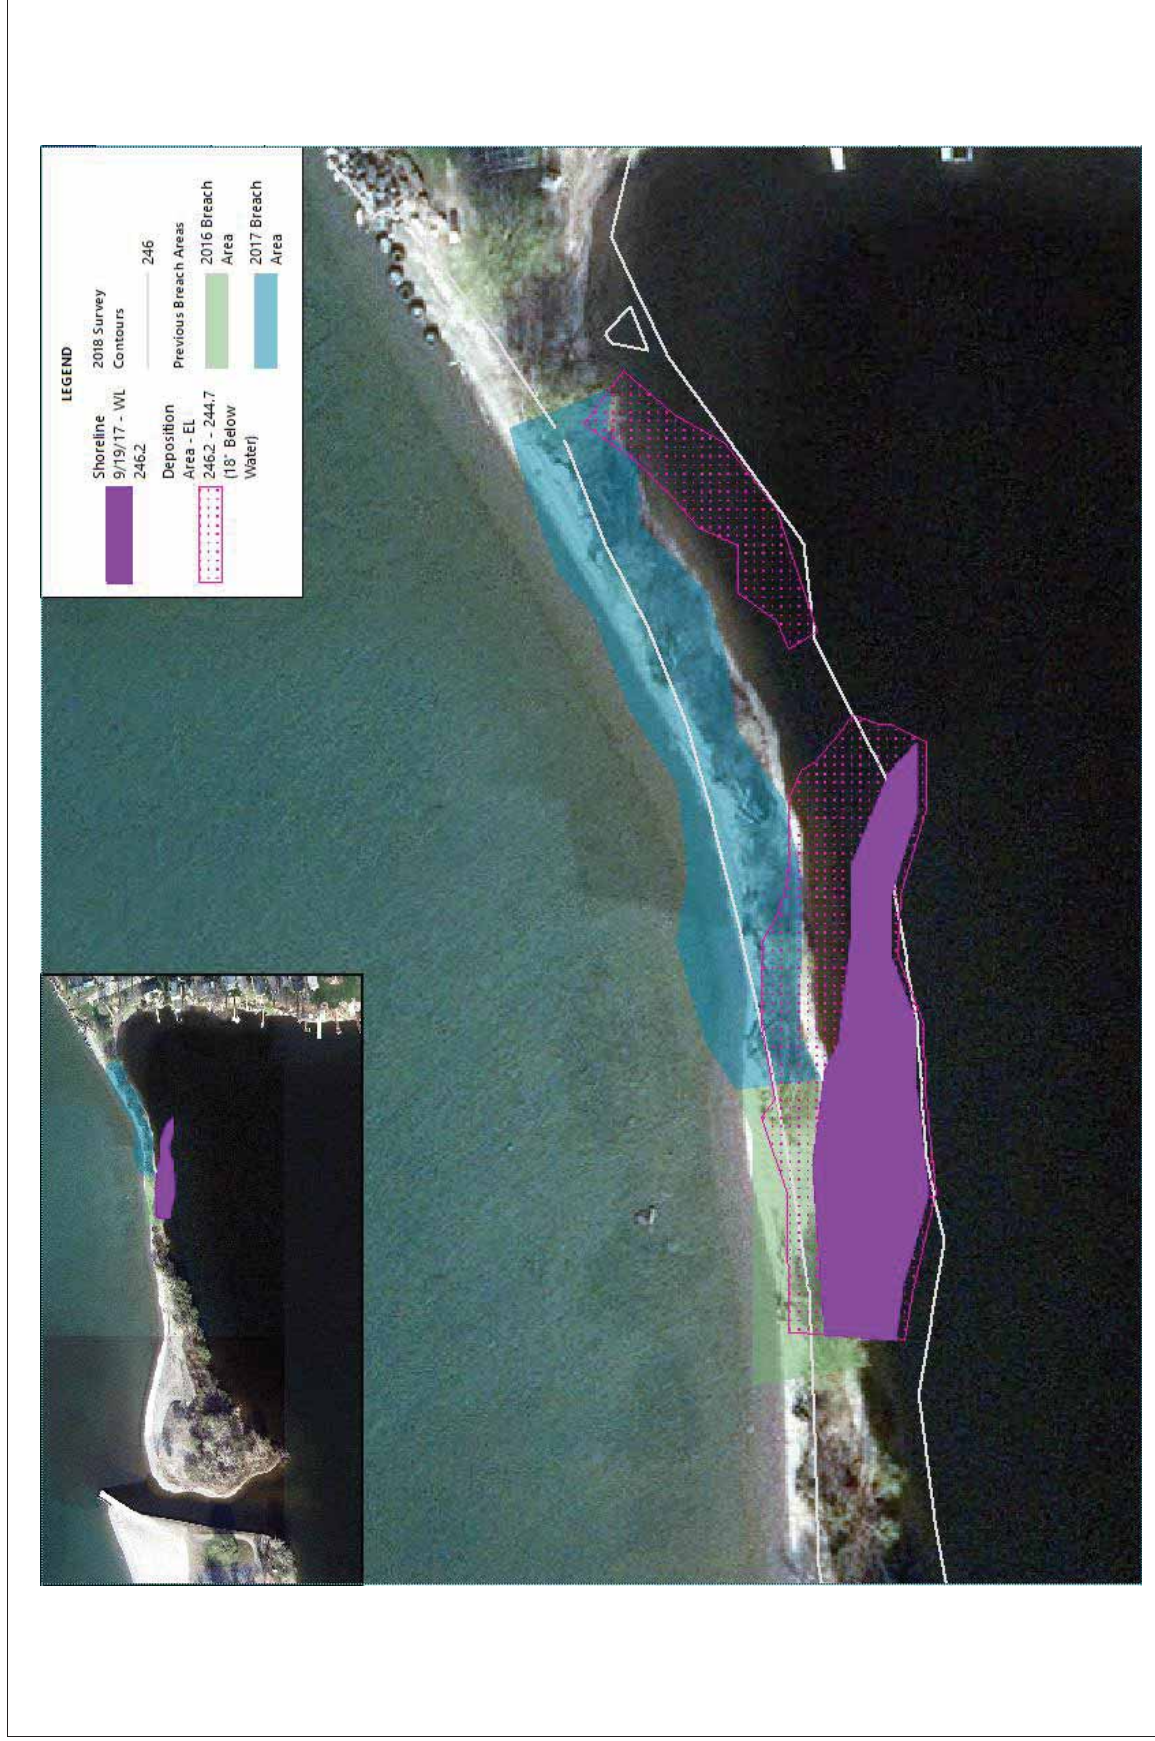
Figure 2.1-15 East Barrier Bar Breach of 2017 and Its Natural Repair (viewed Feb. – Apr. 2018)

Looking east (some flow from the bay to the lake; left to right)

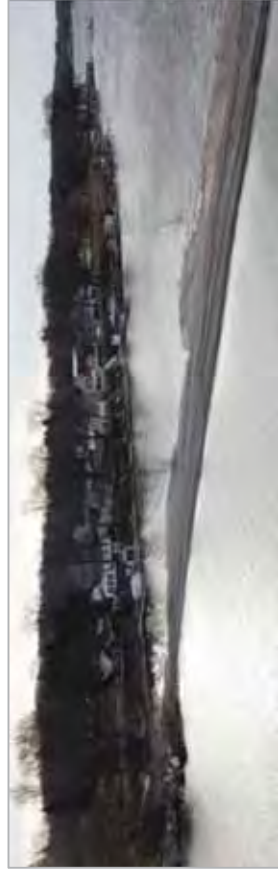
Drone view of the east barrier bar on Mar. 27, 2018; Natural repair of the breach; photo credit: David Aldrich, PBIA (~WL 245.5)

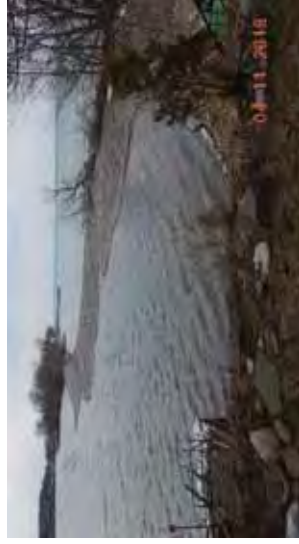
Looking west to the east barrier bar on Apr. 11, 2018 (site visit); Breach is naturally closed (~WL 245.8)

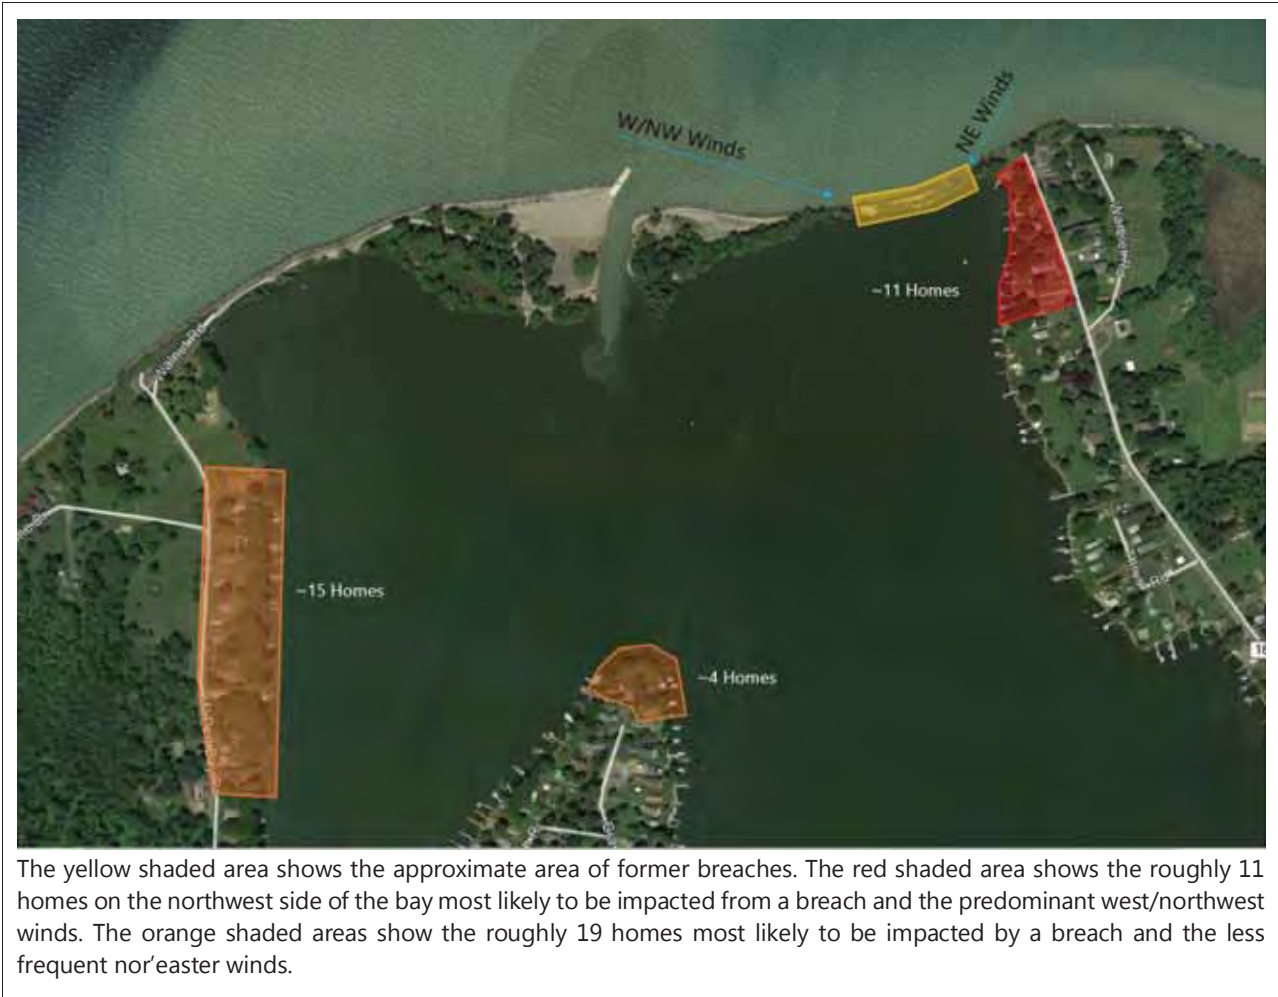
**Figure 2.2-7 Estimate of Homes With Highest Likelihood of Damage During Breach Event**

Looking at the damage reported in these areas, the 2017 damage costs ranged from \$50,000 reported for a new retaining wall and dock to \$1,000 for backfill of an existing wall. The shoreline management technique in this select 30 home area includes unprotected shores, sheet pile walls, timber walls, concrete walls, and rock revetments. The most northern areas are bluffs where the homes are situated well above the normal water levels. The bluff lowers towards the southern limits. The west side properties are predominantly protected with rock revetments at the water level, transitioning into low walls at the southern limits. The east side has more vertical walls (sheet pile or concrete) with low lying boat houses and patios built into the water's edge. The point is a low bluff with low vertical walls at most homes. A number of breakwalls were replaced in these areas, particularly the red area, following the damage of 2017.
