FINAL REPORT

New York State Office of General Services

Engineering Report for WA.37 Blind Sodus Bay

February 14, 2020

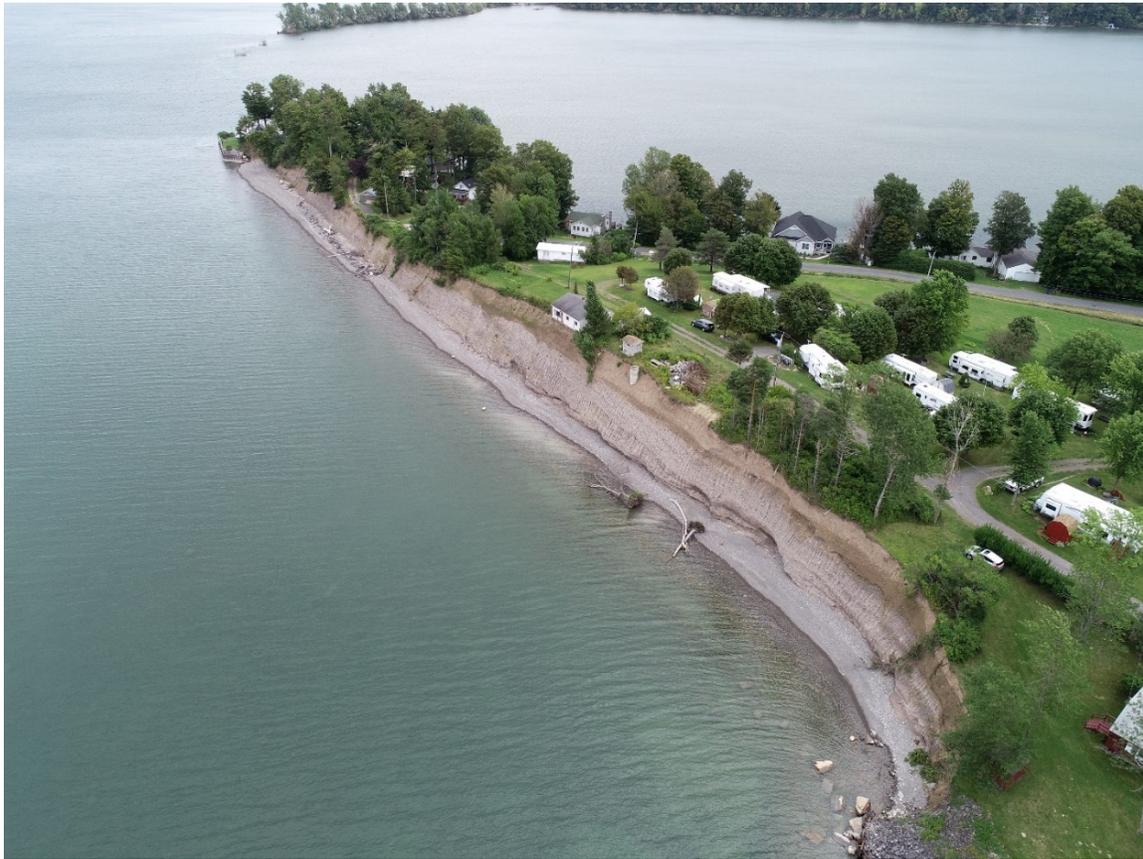
The Bluff Area is located south of the barrier bar and extends for approximately 1,100 linear feet of shoreline. A private homeowner installed approximately 175 linear feet of shoreline protection at the northern terminus of the Bluff Area. Shoreline protection consists of a concrete cap, drilled steel pipe piles filled with concrete extending up 8 to 10 feet above the concrete cap, timber cribbing behind the steel pipe piles, and gabion baskets behind the cribbing. Wave and freeze action have continually eroded the toe of the bluff causing sloughing and encroachment onto properties and structures; several properties have structures that are undermined from erosion. **Figure 2-2** shows an overview of the Bluff Area. The sloughed material is at the base of the bluff and is referred to herein as the slope. The bluff has a near vertical face at the top of the bluff in most areas and at the toe in several areas.

Figure 2-2 *Bluff Area*

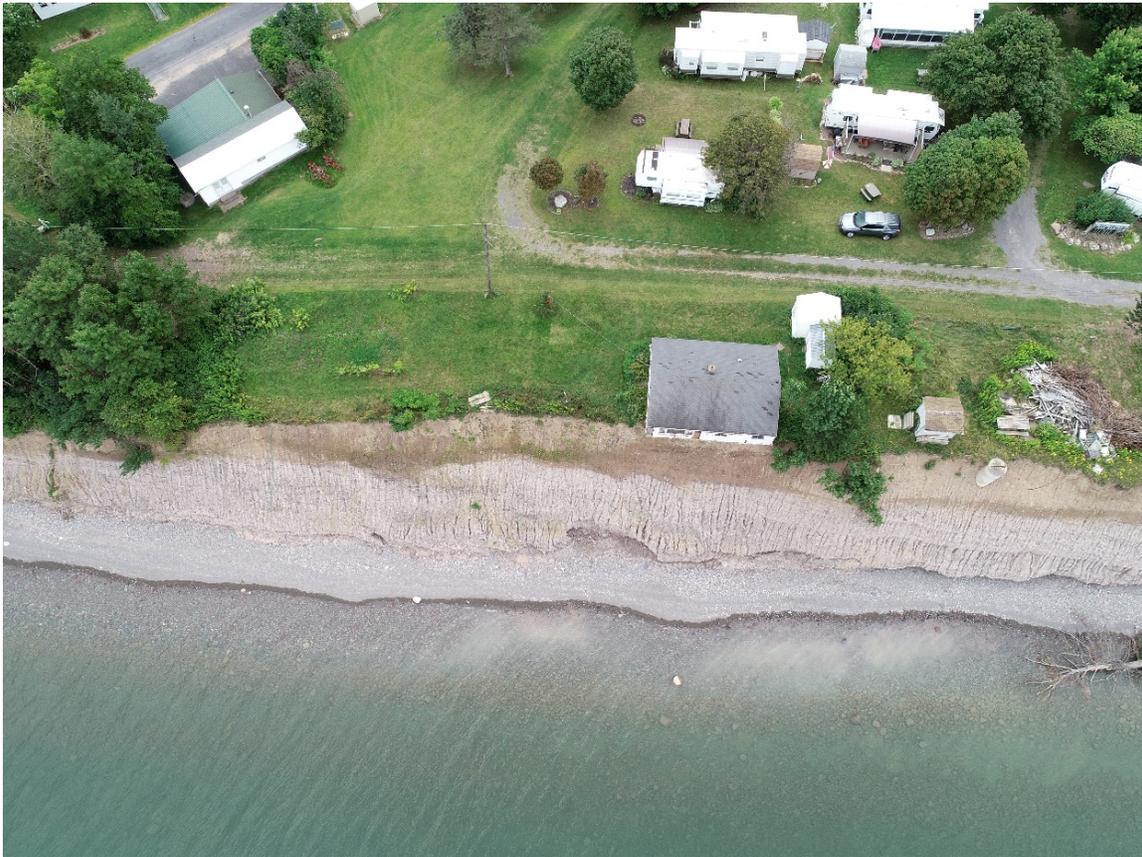
Existing structures from STA 2+25 to 3+10 are currently undermined and unsafe. The structures include a single-story residential home, shed, and manhole (see **Figure 2-3** below).

Figure 2-3 *Undermined Structures*

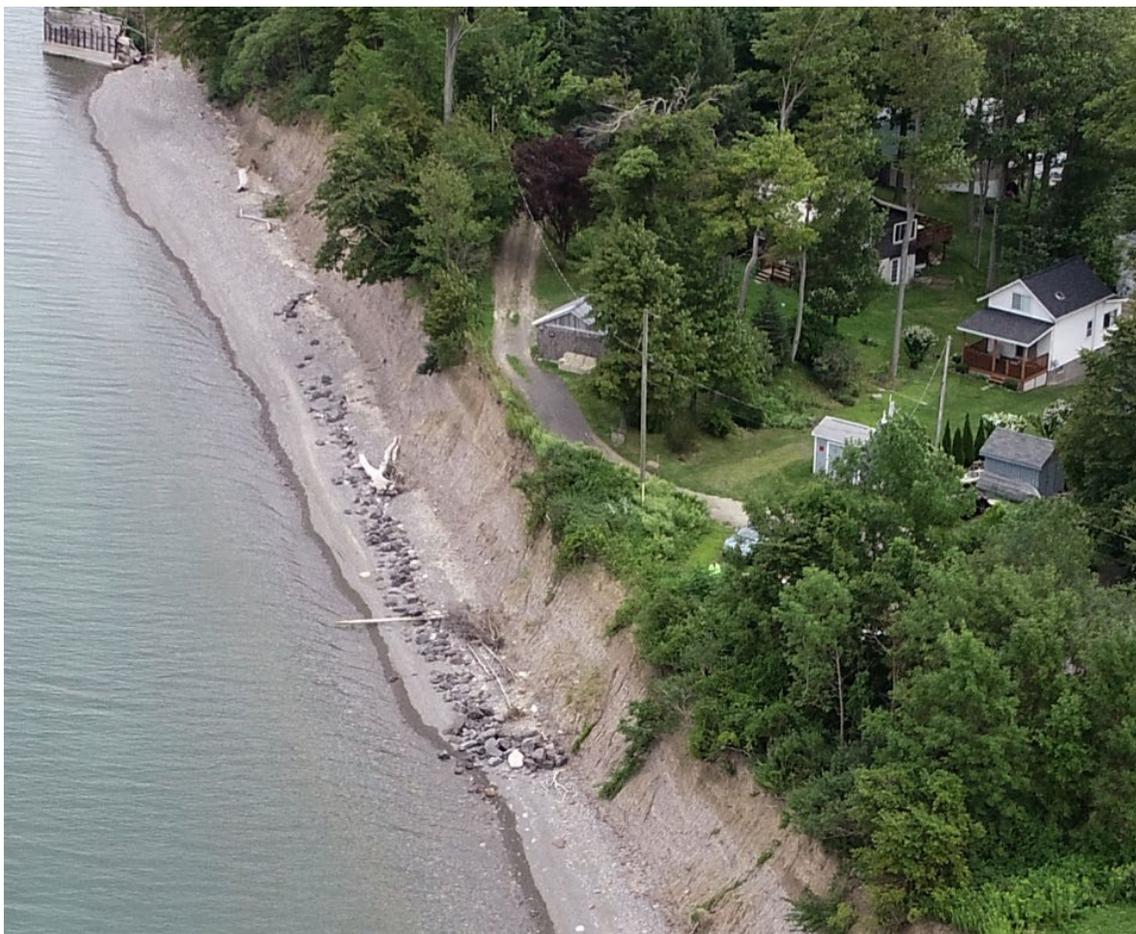
The bluff is encroaching on an unpaved road which provides access to several properties to the north and has public wastewater infrastructure that serves those properties. Approximate stationing from STA 5+50 to STA 8+10 (see **Figure 2-4** below). A slope stabilization design was completed for this portion of the bluff by MRB Group (**Appendix A**).

Figure 2-4 Bluff STA 5+50 to STA 8+10

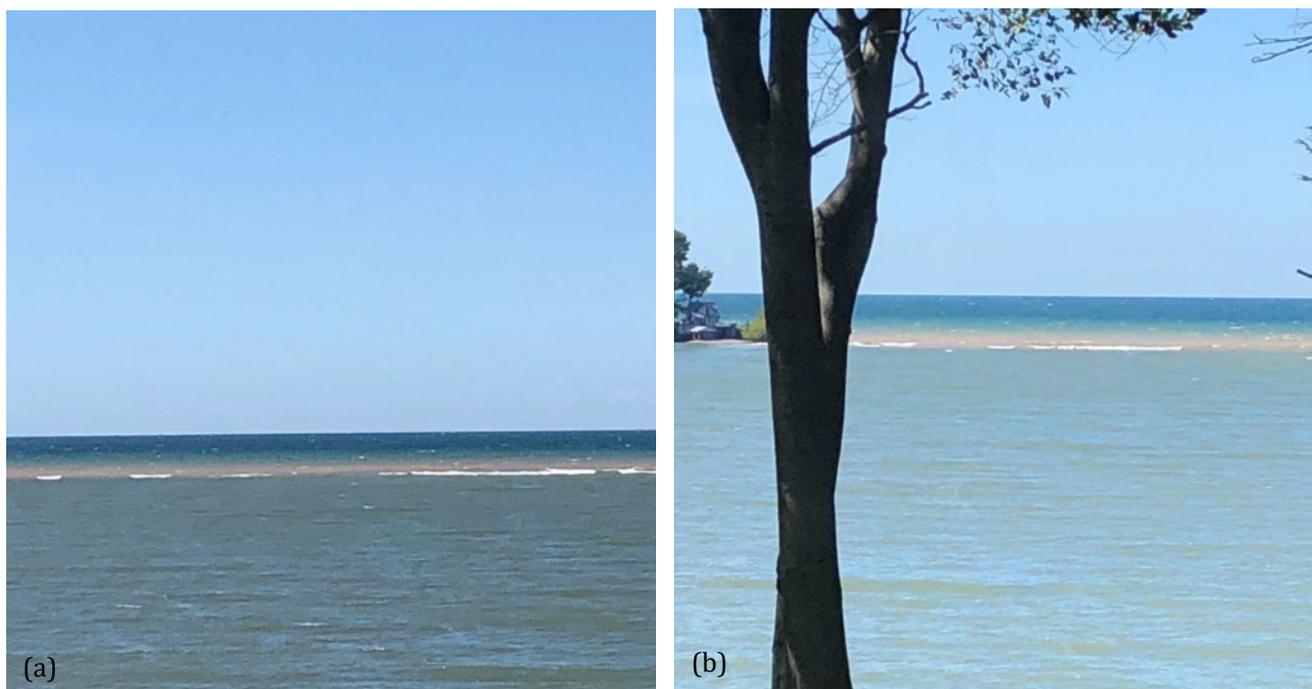
The storm water and wave action combine to undermine the face of the bluffs, causing large sections to seasonally collapse into Lake Ontario. Bluff degradation is also subject to ground and surface water discharge over and through the natural channels in the bluff. The seasonal shift, freeze/thaw action causes loss each season and wave/wind capturing the eroded material. As the natural barrier has eroded, wave action has produced visibly uprooted trees along the Lake.

Figure 2-11 (a,b) Wave Action and Eroded Barrier Bar in 2019.

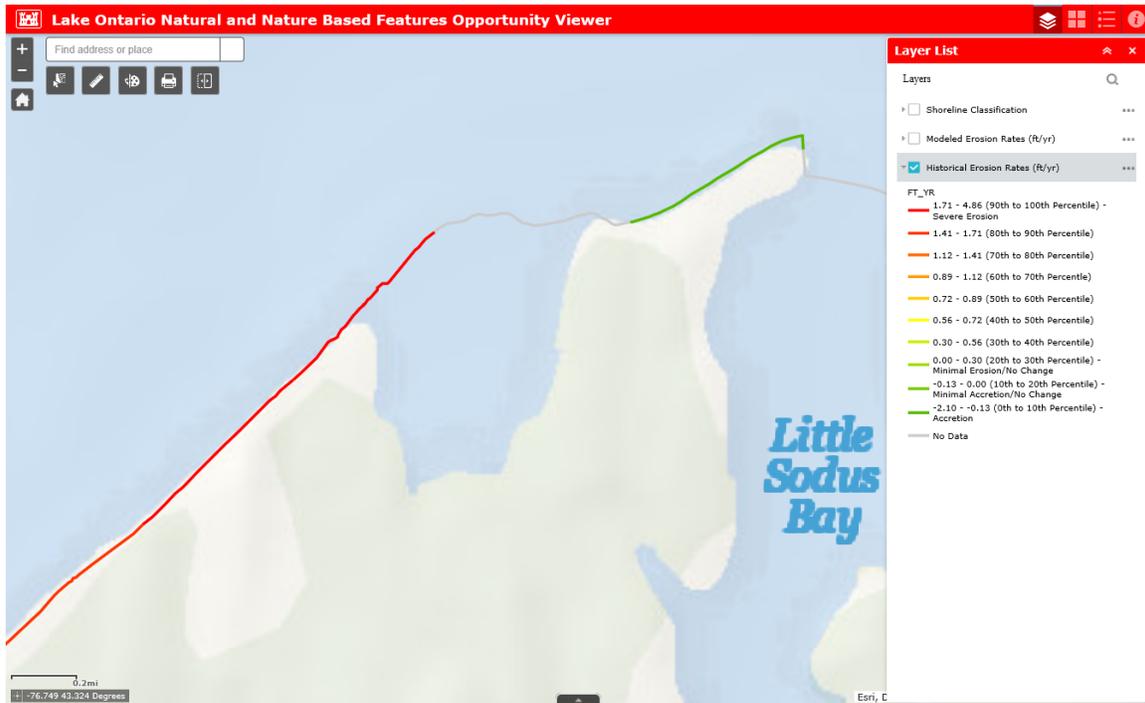
Figure 2-12, obtained from Lake Ontario Natural and Nature Based Features (NNBF) opportunity viewer, indicated significant historical erosion on the bluff side as well as on the bar. The rates are as high as 1.7 ft/year and above for the western half of the project area. Modeled erosion rates, shown in **Figure 2-13**, indicated a loss of less than 1 ft/year, which suggests one portion of this reach has stabilized. A more detailed analysis of shoreline evolution and sediment transport is recommended for the next stage of the design process.

Figure 2-12 Historical Erosion Rates

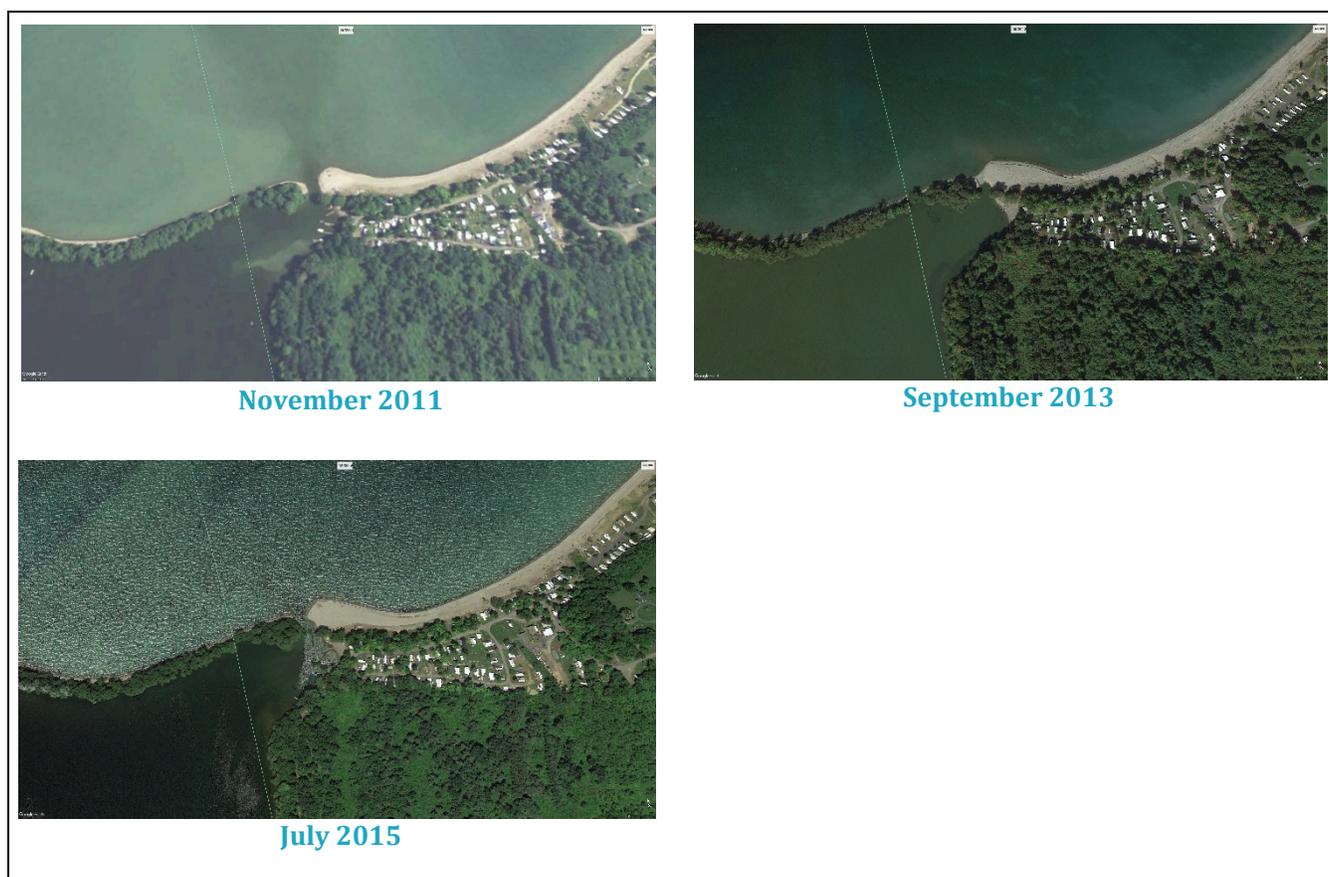
Figure 2-15 shows the change in the Blind Sodus Bay barrier bar between April 1994 to July 2015. Aerial photos illustrate that the barrier bar was intact with some variation in width, and one inlet opening at the east end of the bar for navigation. The 1988 Coastal Erosion Hazard Area map for the area shows that at that time the opening was approximately in the middle of the barrier.

Figure 2-15 Evolution of Blind Sodus Bay Barrier Bar and Channel

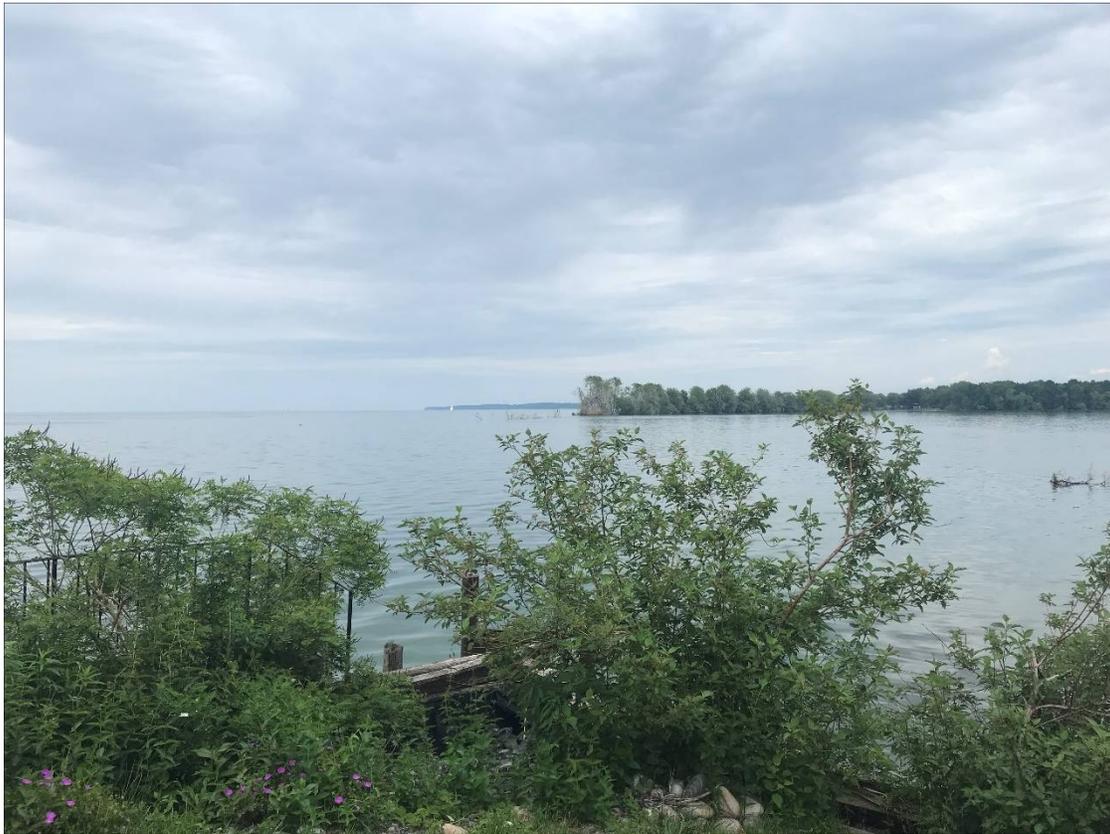
Figure 2-16 Photos of 2019 breach on the west side of the barrier bar. Trees that were present on this side of the barrier are no longer present. On site observations suggest significant redistribution of sediment

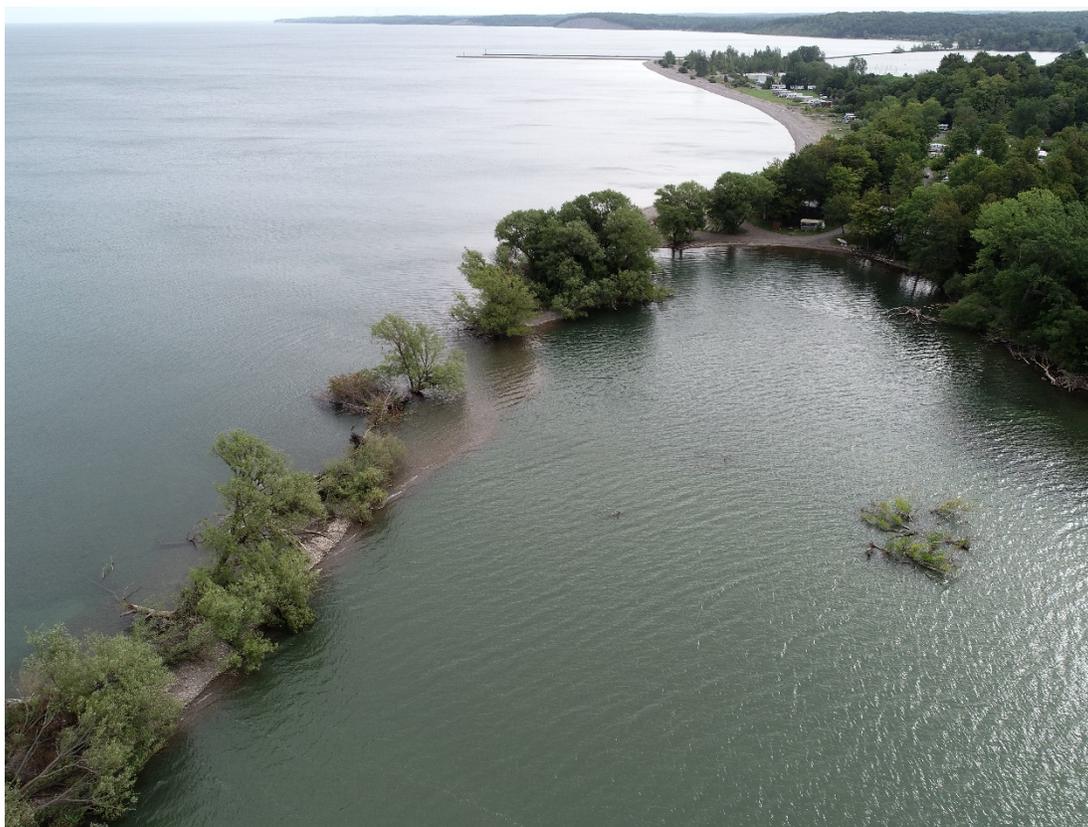
Figure 2-17 Photos of 2019 inundation of the eastern end of the barrier bar. Sediment is still largely in place.

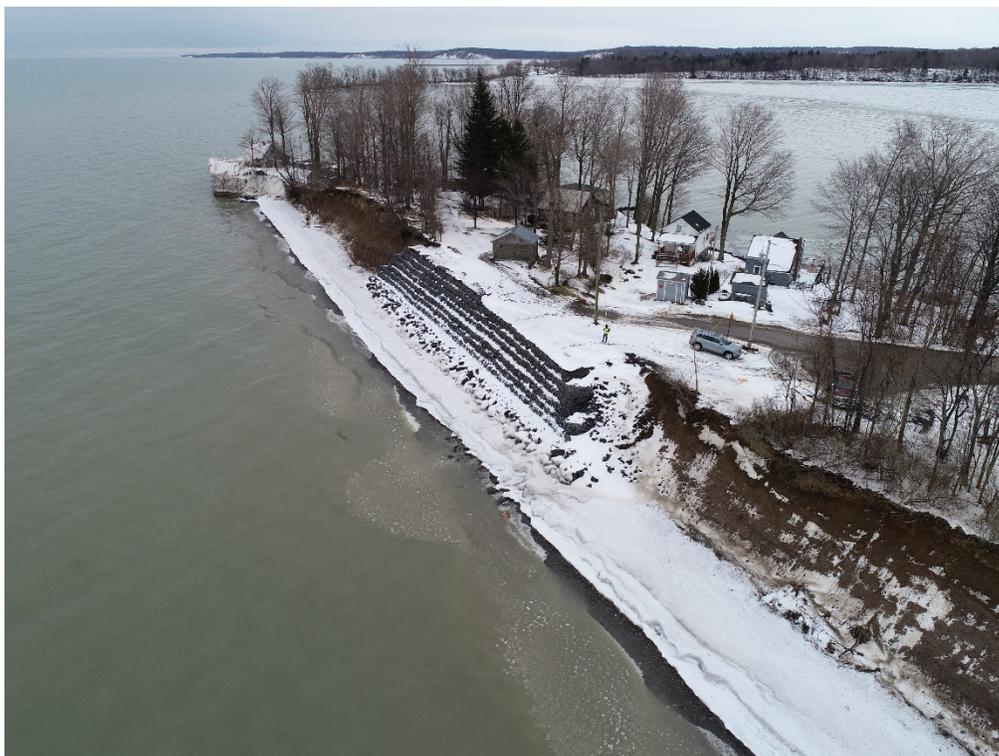
Figure 4-2 Recently constructed gabion wall

Qualitative evaluation of the gabion wall (**Figure 4-2**) suggests that wave flanking and erosion around the sides of the gabion wall are an important concern. Forthcoming design efforts for the remainder of the bluff will need to carefully consider how to best tie into this structure and to mitigate for potential erosion around the sides of hardened features.
