REVISED FINAL REPORT

New York State Office of General Services

# Engineering Report for WA.37 Blind Sodus Bay

March 26, 2020

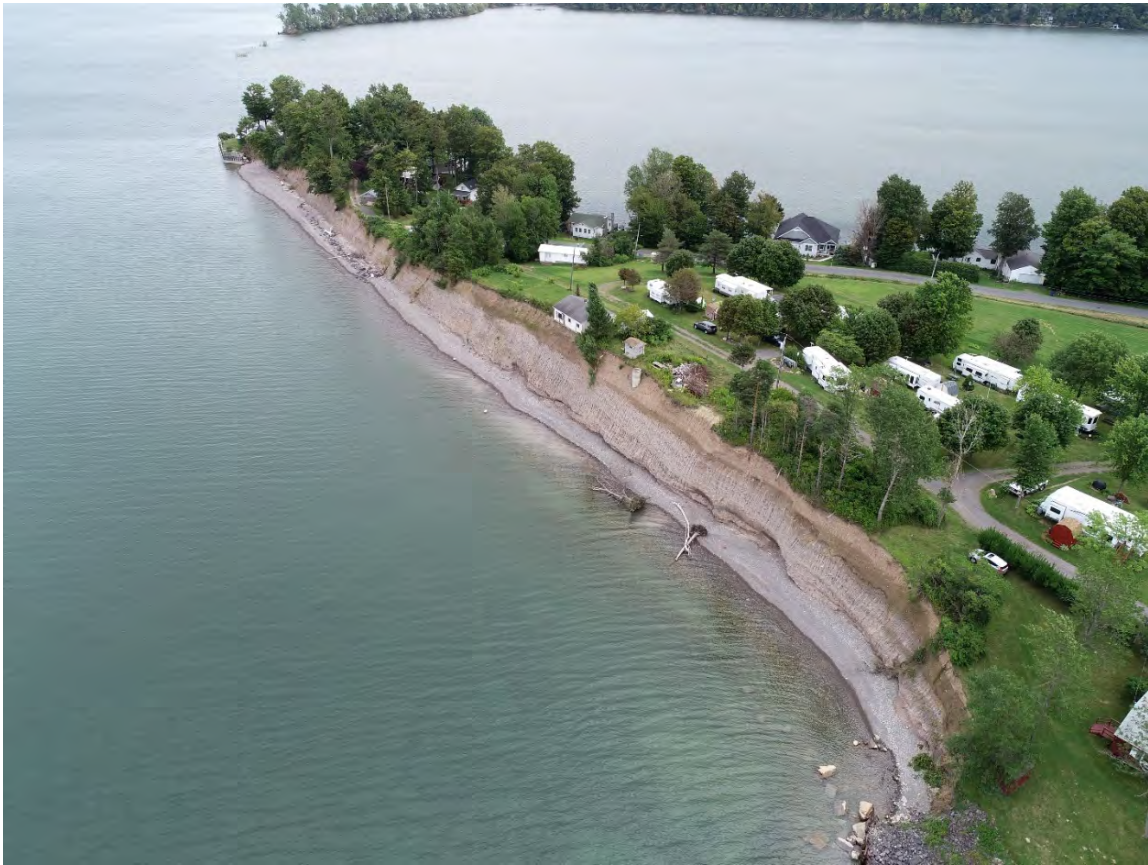
**Figure 2-2** *Bluff Area*

The Bluff Area is located south of the barrier bar and extends for approximately 1,100 linear feet of shoreline. A private homeowner installed approximately 175 linear feet of shoreline protection at the northern terminus of the Bluff Area. Shoreline protection consists of a concrete cap, drilled steel pipe piles filled with concrete extending up 8 to 10 feet above the concrete cap, timber cribbing behind the steel pipe piles, and gabion baskets behind the cribbing. Wave and freeze action have continually eroded the toe of the bluff causing sloughing and encroachment onto properties and structures; several properties have structures that are undermined from erosion. **Figure 2-2** shows an overview of the Bluff Area. The sloughed material is at the base of the bluff and is referred to herein as the slope. The bluff has a near vertical face at the top of the bluff in most areas and at the toe in several areas.

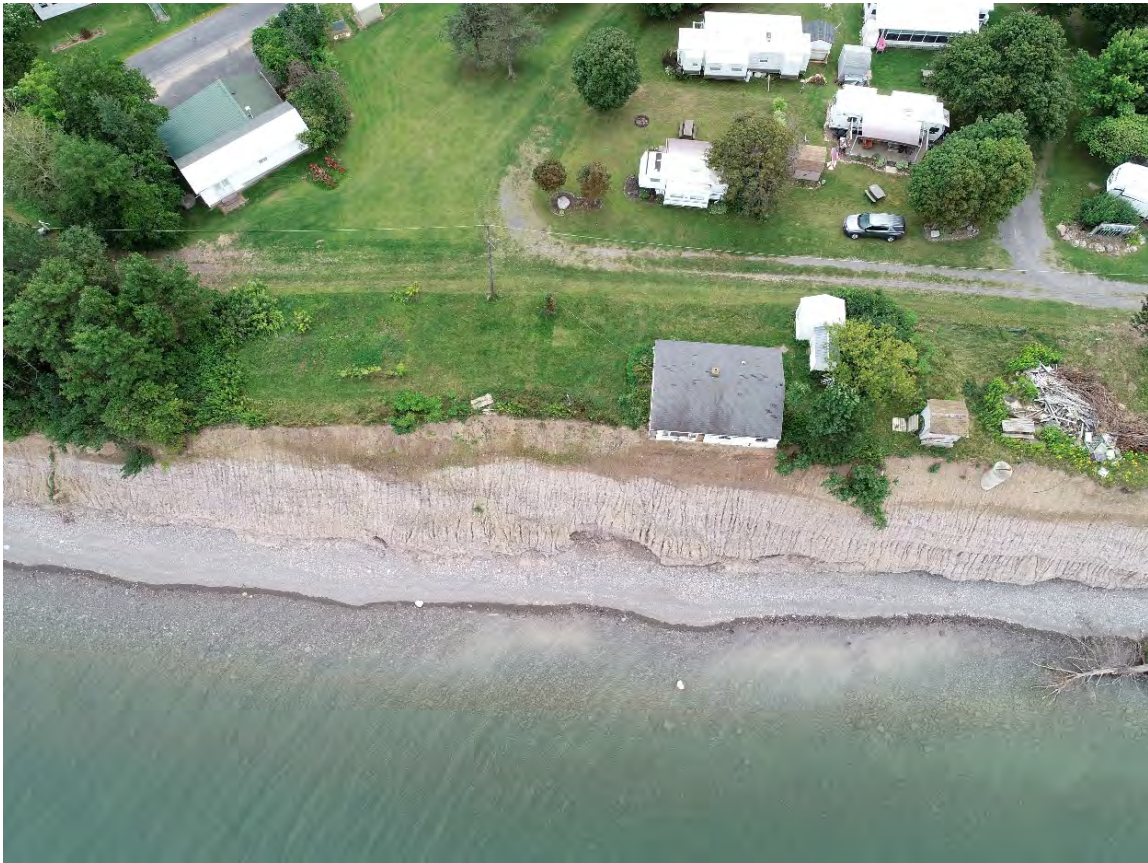
**Figure 2-3** *Undermined Structures*

Existing structures from STA 2+25 to 3+10 are currently undermined and unsafe. The structures include a single-story residential home, shed, and manhole (see **Figure 2-3** below).

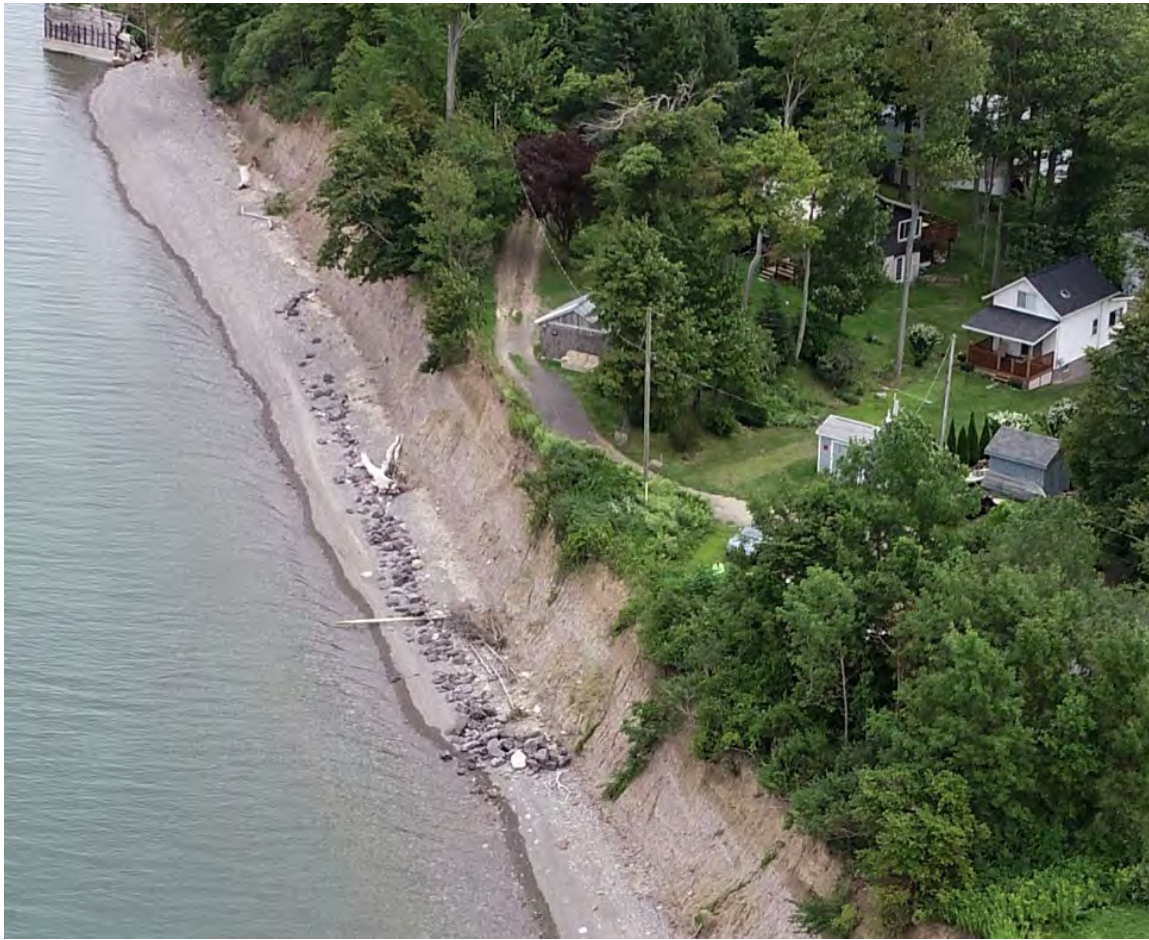
**Figure 2-4** Bluff STA 5+50 to STA 8+10

The bluff is encroaching on an unpaved road which provides access to several properties to the north and has public wastewater infrastructure that serves those properties. Approximate stationing from STA 5+50 to STA 8+10 (see **Figure 2-4** below). A slope stabilization design was completed for this portion of the bluff by MRB Group (**Appendix A**).

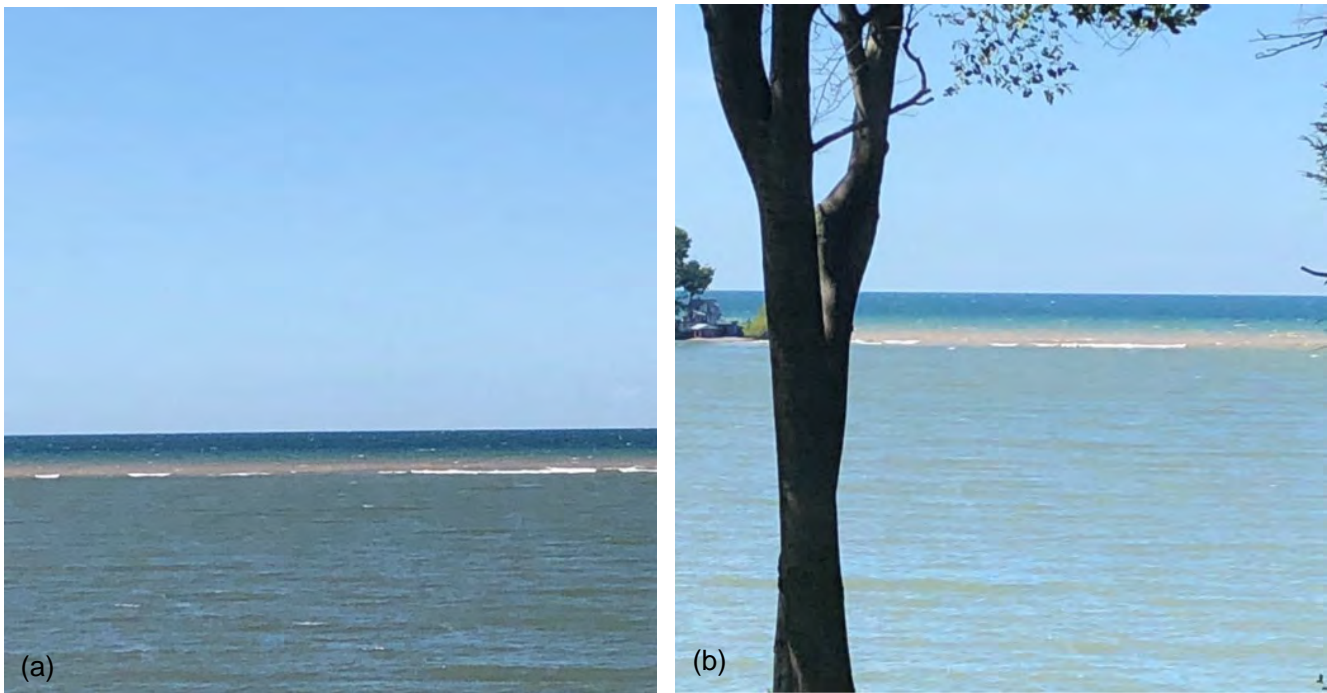
The storm water and wave action combine to undermine the face of the bluffs, causing large sections to seasonally collapse into Lake Ontario. Bluff degradation is also subject to ground and surface water discharge over and through the natural channels in the bluff. The seasonal shift, freeze/thaw action causes loss each season and wave/wind capturing the eroded material. As the natural barrier has eroded, wave action has produced visibly uprooted trees along the Lake.

**Figure 2-11** (a,b) Wave Action and Eroded Barrier Bar in 2019.

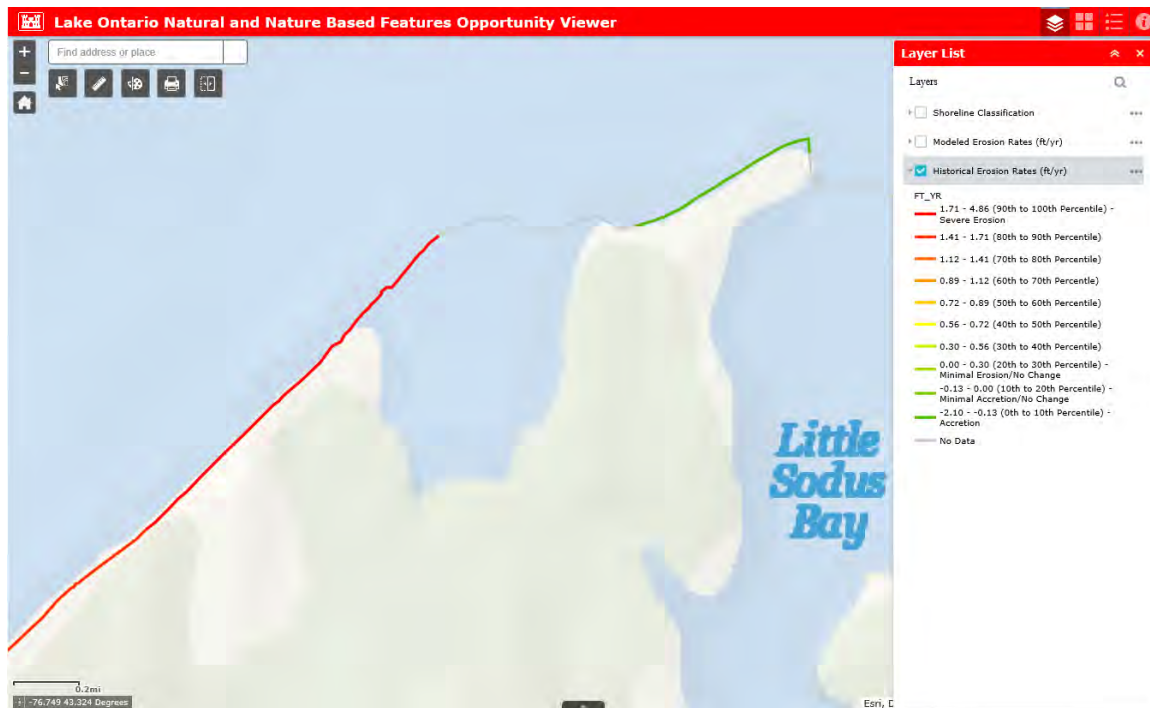
Figure 2-12 Historical Erosion Rates

**Figure 2-12**, obtained from Lake Ontario Natural and Nature Based Features (NNBF) opportunity viewer, indicated significant historical erosion on the bluff side as well as on the bar. The rates are as high as 1.7 ft/year and above for the western half of the project area. Modeled erosion rates, shown in **Figure 2-13**, indicated a loss of less than 1 ft/year, which suggests one portion of this reach has stabilized. A more detailed analysis of shoreline evolution and sediment transport is recommended for the next stage of the design process.

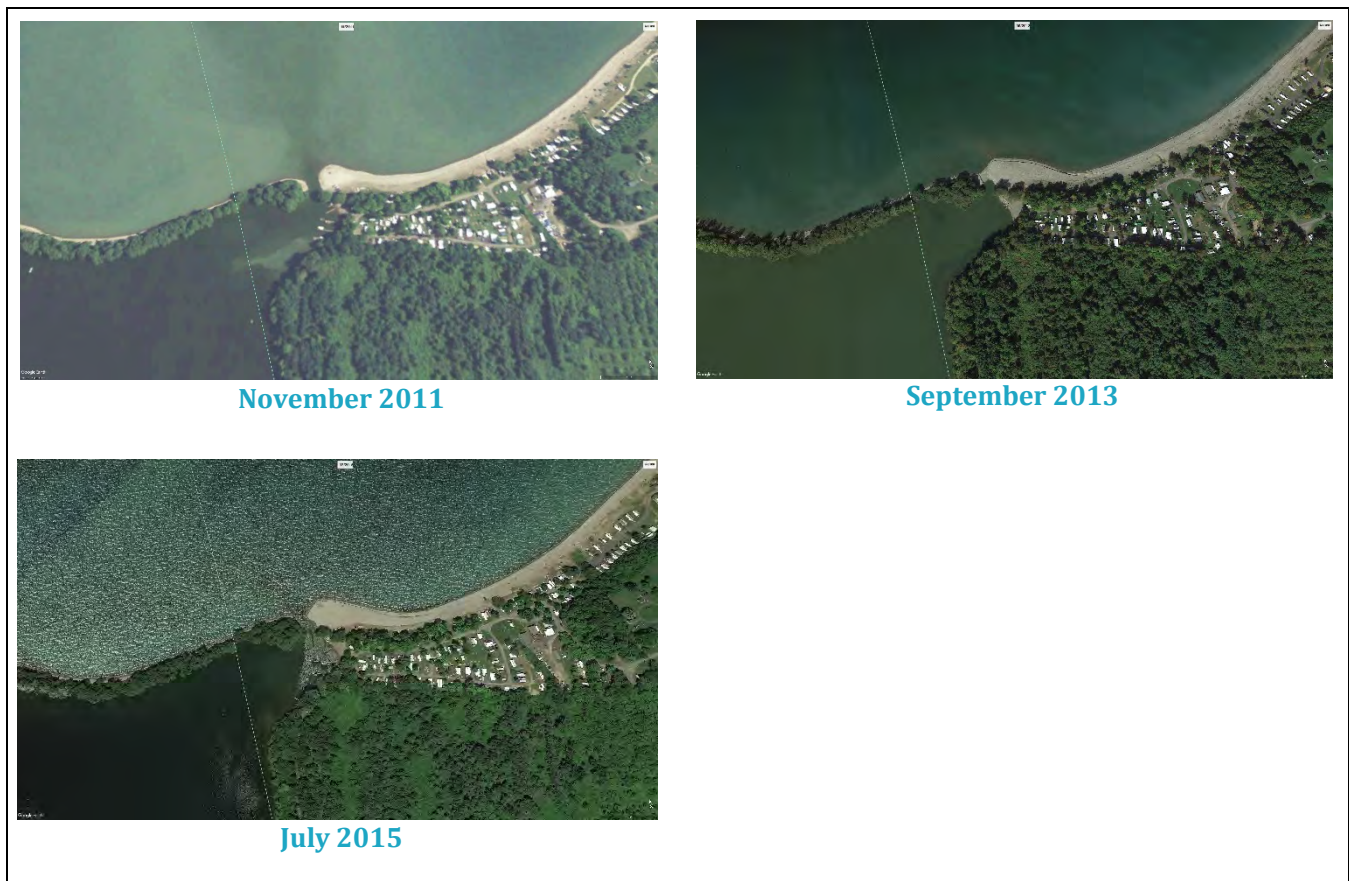
**Figure 2-15** shows the change in the Blind Sodus Bay barrier bar between April 1994 to July 2015. Aerial photos illustrate that the barrier bar was intact with some variation in width, and one inlet opening at the east end of the bar for navigation. The 1988 Coastal Erosion Hazard Area map for the area shows at that time the opening was approximately in the middle of the barrier.

**Figure 2-15** Evolution of Blind Sodus Bay Barrier Bar and Channel

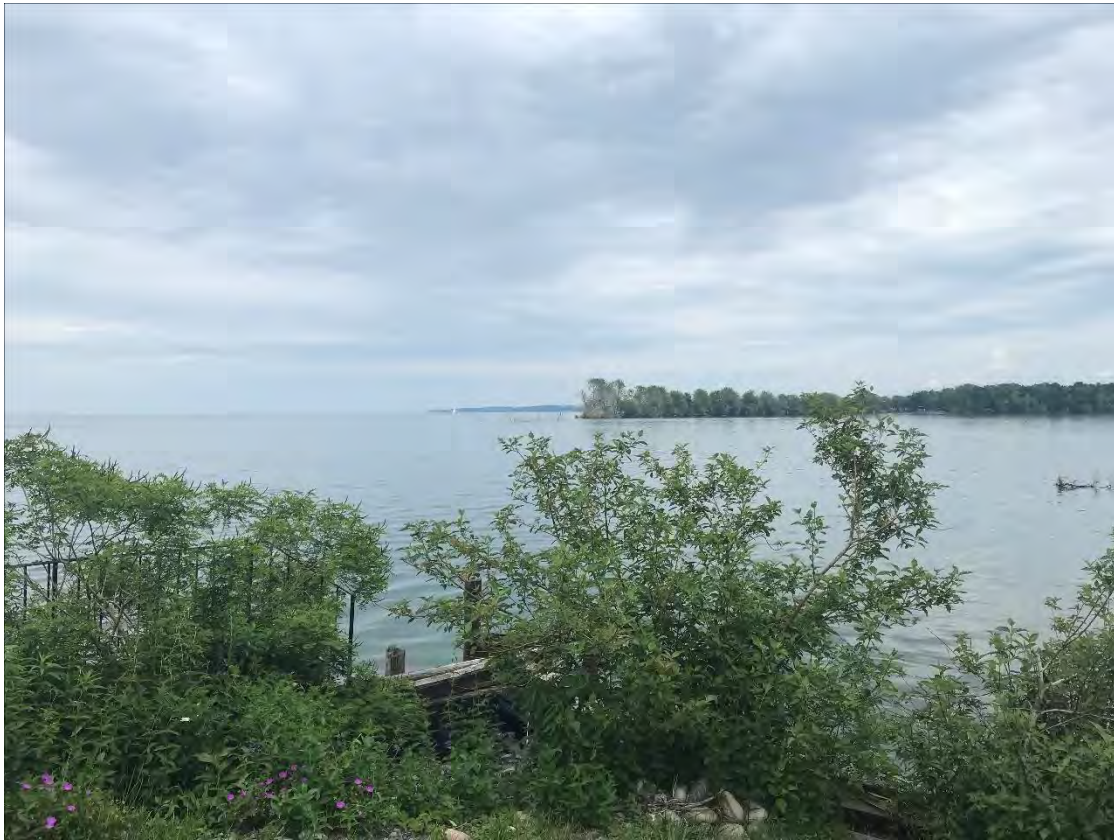
**Figure 2-16** Photos of 2019 breach on the west side of the barrier bar. Trees that were present on this side of the barrier are no longer present. On site observations suggest significant redistribution of sediment

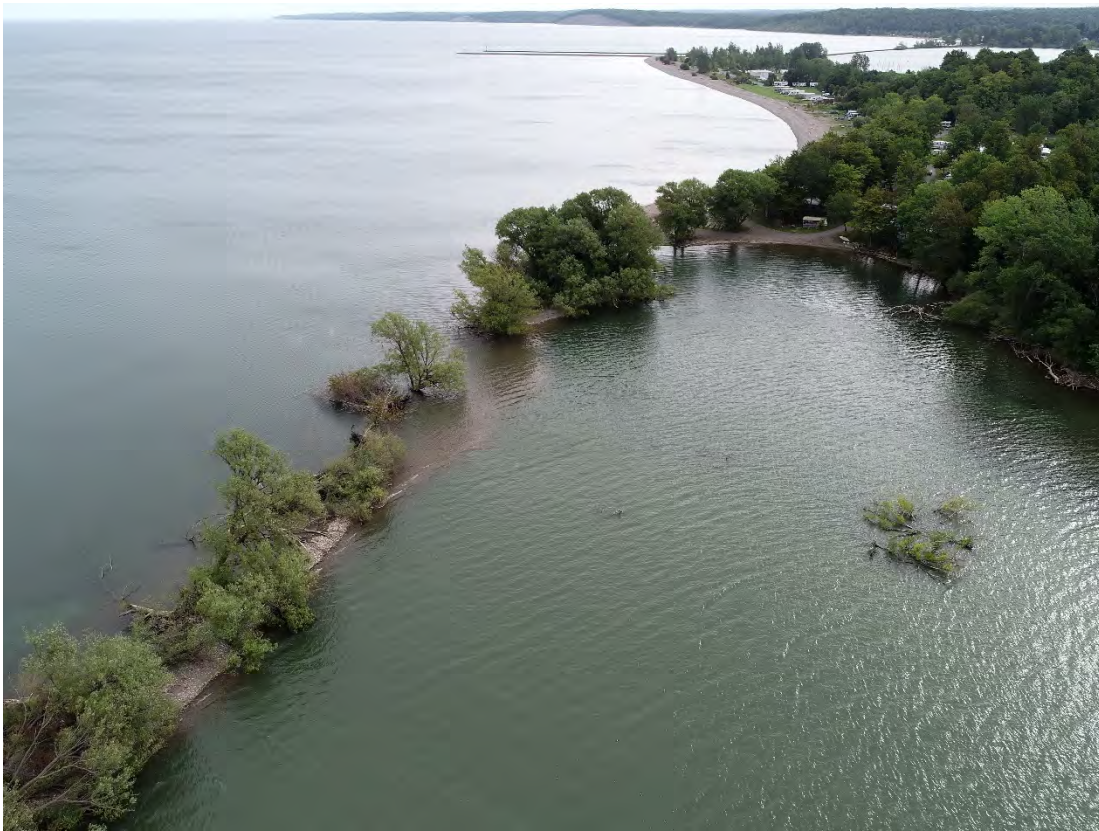
**Figure 2-17** Photos of 2019 inundation of the eastern end of the barrier bar. Sediment is still largely in place.

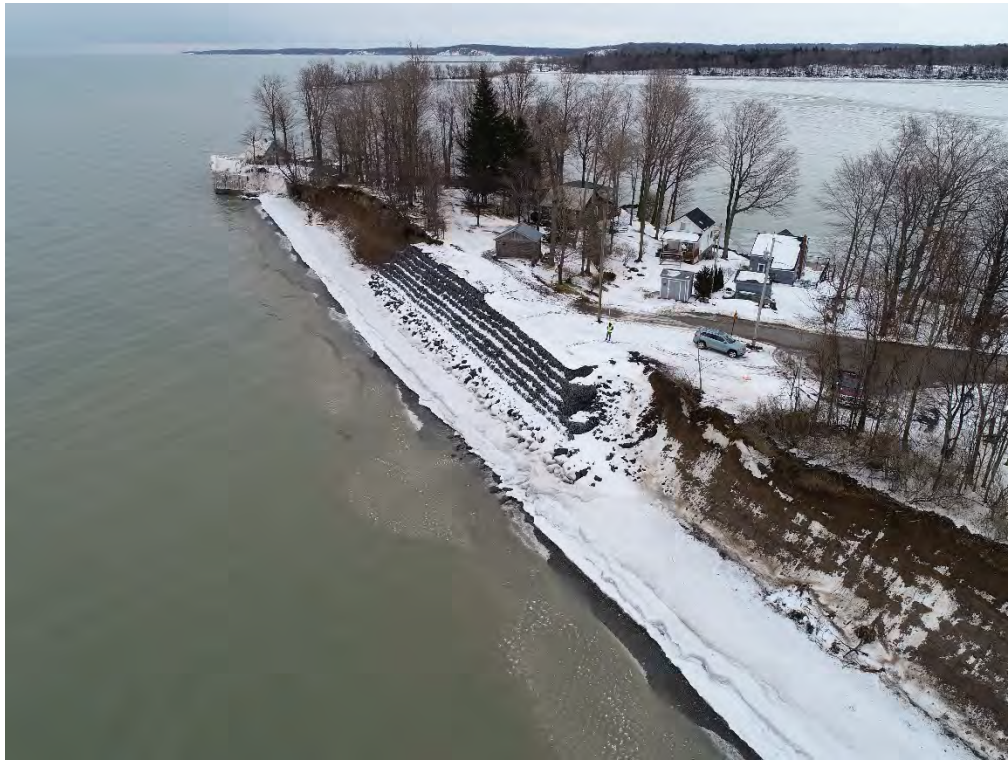
**Figure 4-2** Recently constructed gabion wall

Qualitative evaluation of the gabion wall (**Figure 4-2**) suggests that wave flanking and erosion around the sides of the gabion wall are an important concern. Forthcoming design efforts for the remainder of the bluff will need to carefully consider how to best tie into this structure and to mitigate for potential erosion around the sides of hardened features.

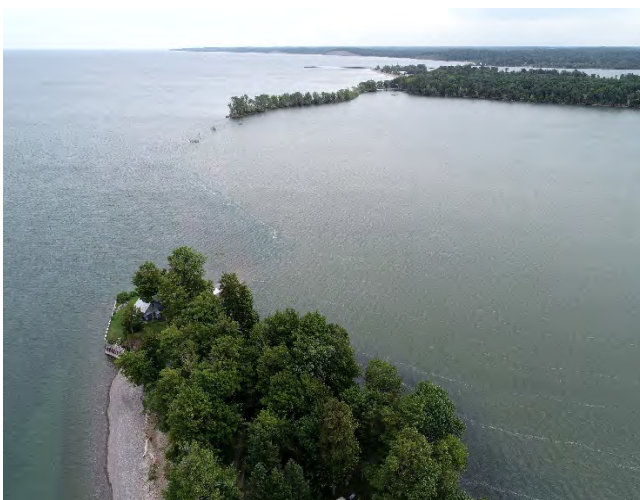
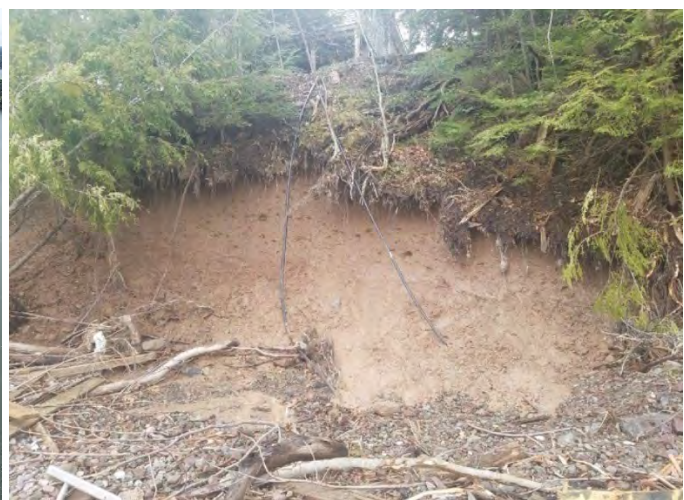
Because the eastern portion of the barrier bar remained largely intact during the 2019 high water, no action for this area could be warranted. However, most of this barrier was flooded, likely causing stress to the trees present on the barrier. Should tree health decline, increased erosion is possible due to the loss of the existing ecological services and sediment stabilization provided by the existing tree roots. Observations of tree health in this area during the 2020 growing season will be important to guide design decisions and next steps for the eastern portion of the barrier bar.

**Figure 4-6** Alternative A, No Action. The barrier bar used to extend across the entire north end of the bay. The time required for natural recovery of the barrier bar is likely at least three years if not longer (right). During that timeframe the shoreline in the bay will likely continue to be subject to severe erosion (right; image provided by the Wayne County Soil and Water Conservation District).

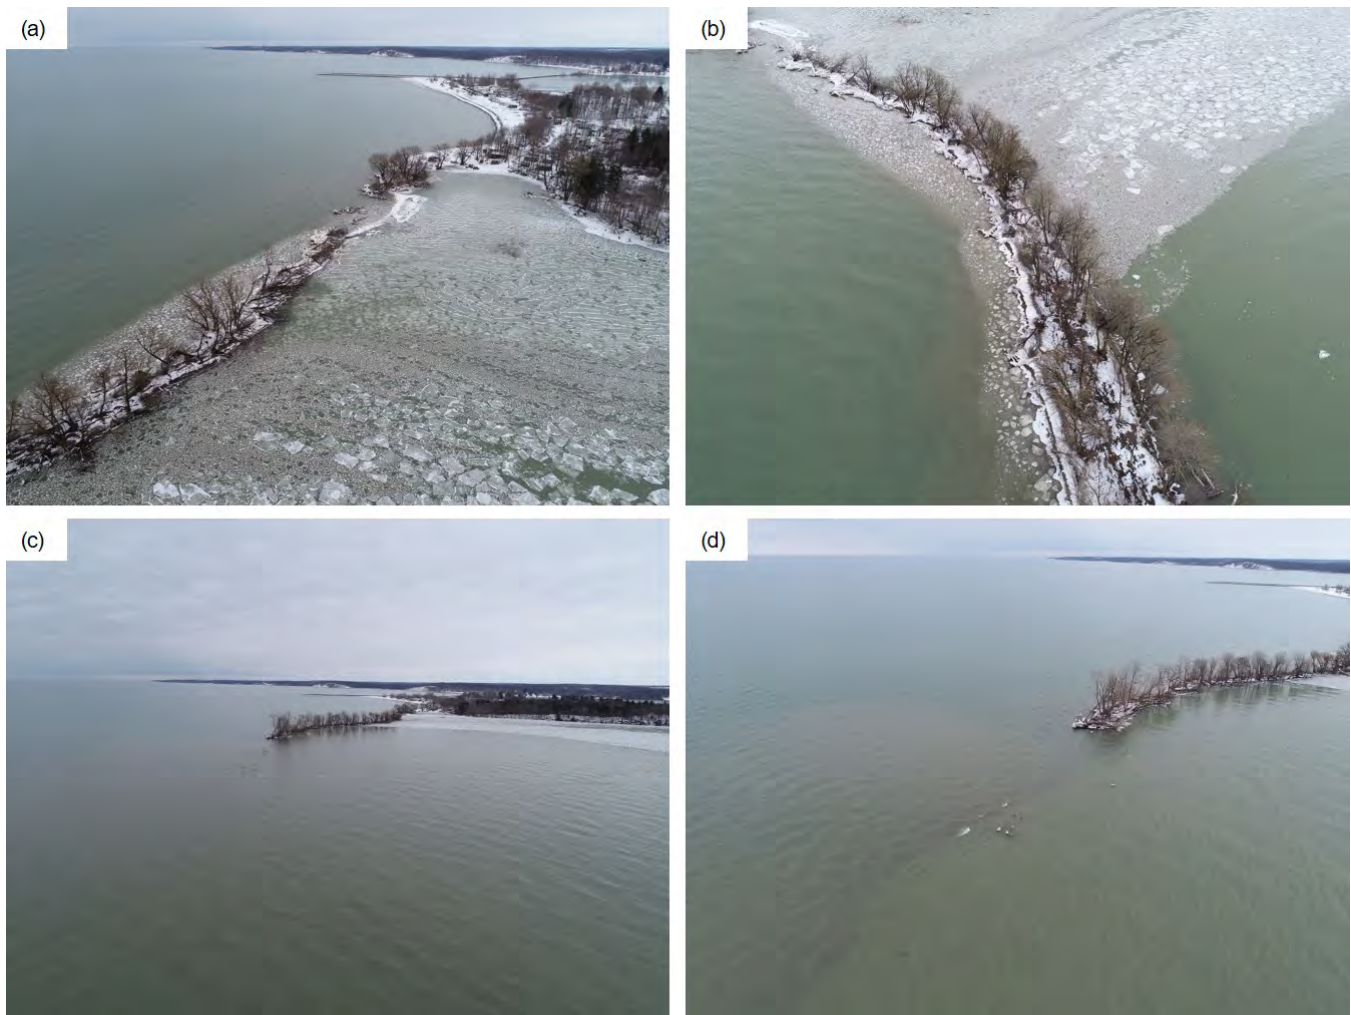
**Figure 4-9.** Recent drone images, collected February 11, 2020, showing current and ongoing deterioration of the eastern (a,b) and western (c,d) reaches of the Blind Sodus Bay barrier bar.

Based on the data available to date, public input, conversations among involved agencies and the grantee, as well as the considerations provided herein, we recommend a stone revetment and regraded bluff to stabilize the bluff area. A nature-based barrier bar is recommended to maintain the ecological function of the embayment, sustain important nesting habitat for wildlife, and decrease risk of embayment shoreline property loss (**Figure 4-6**). It is recommended that the reef breakwater be implemented to provide additional protections to the restored barrier bar due to extensive and ongoing loss (**Figure 4-9**). The recent and ongoing deterioration of the barrier bar, as documented in February 2020, suggests that supplemental protections will be needed under future high-water scenarios to avoid similar losses that have occurred in 2019-2020.
