2011 Agricultural Group Drainage Program

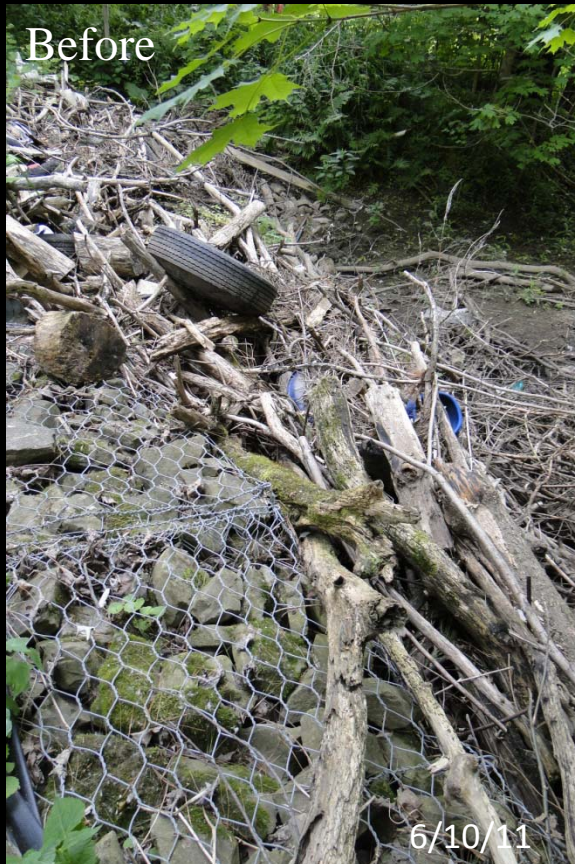
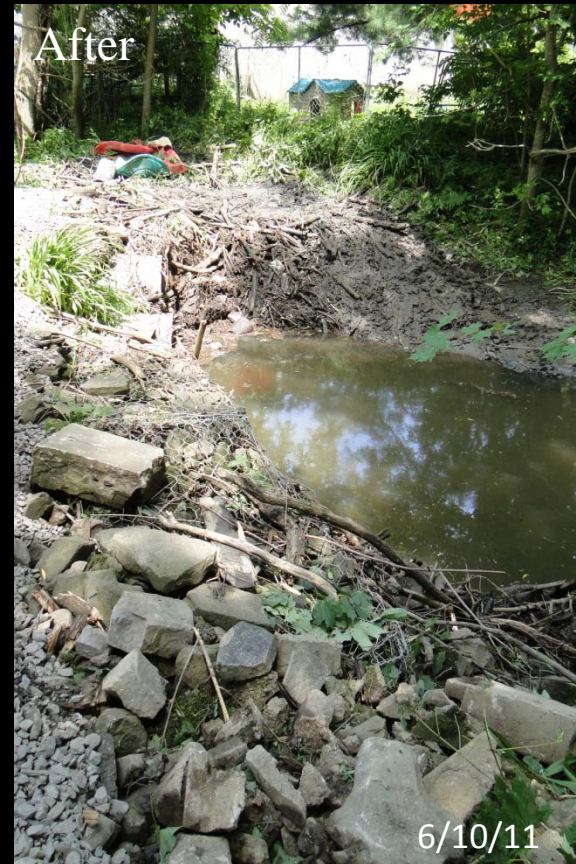
Sodus Ditch North

This was a maintenance project in the town of Rose. We began this project last fall, when we trapped beaver and removed their dam, as well as doing some mowing. This spring we finished the mowing, and repaired a crossing that we had installed as part of the original project. Project was ½ mile long and completed by Kenneth Morrison.

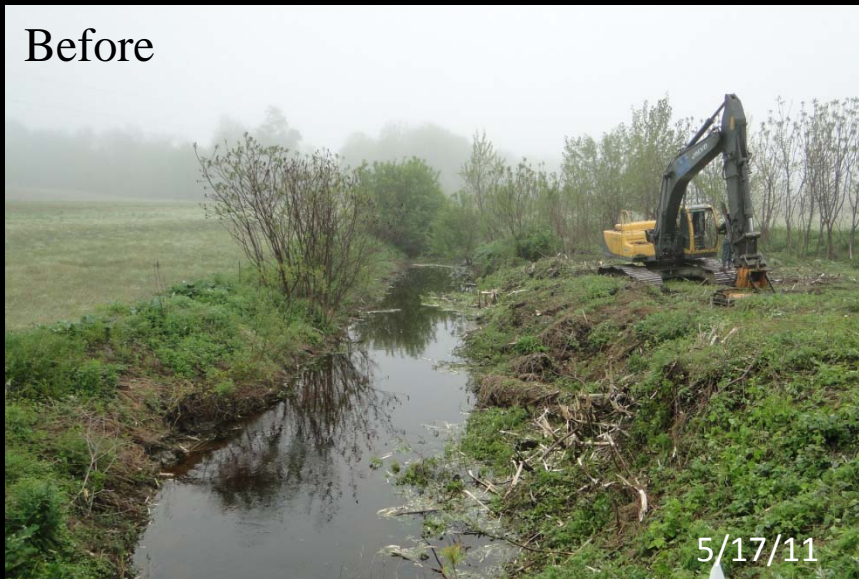
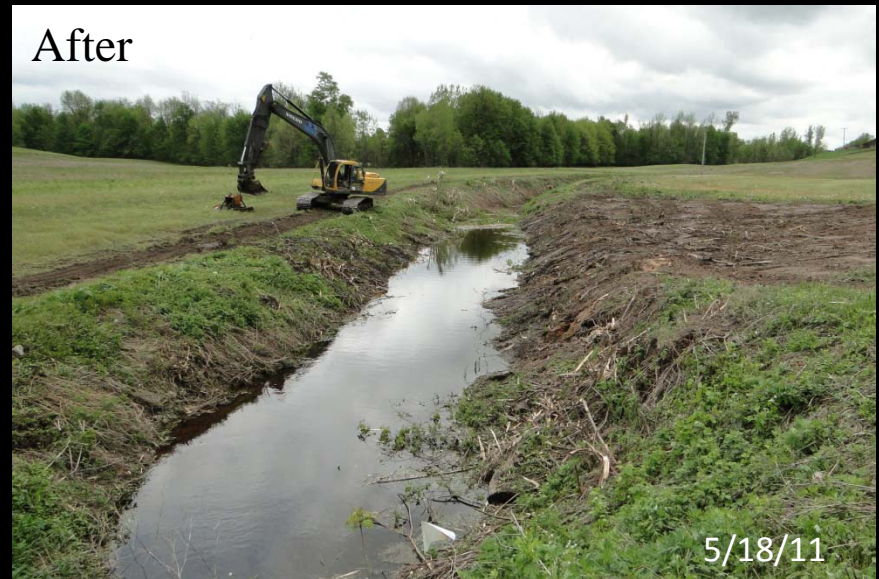
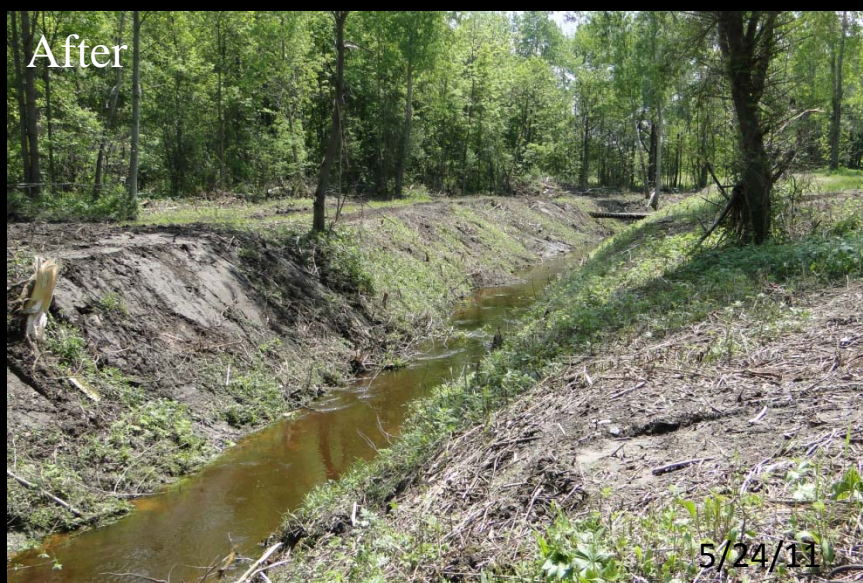
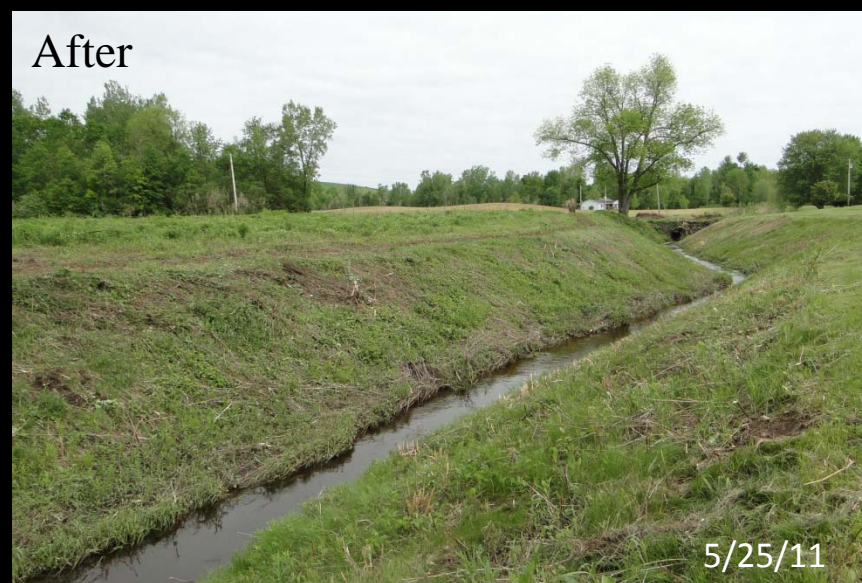
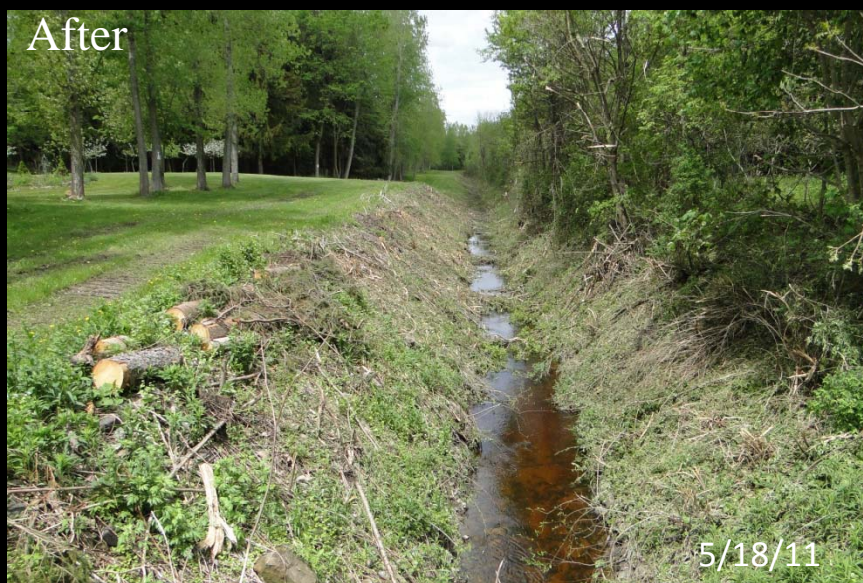
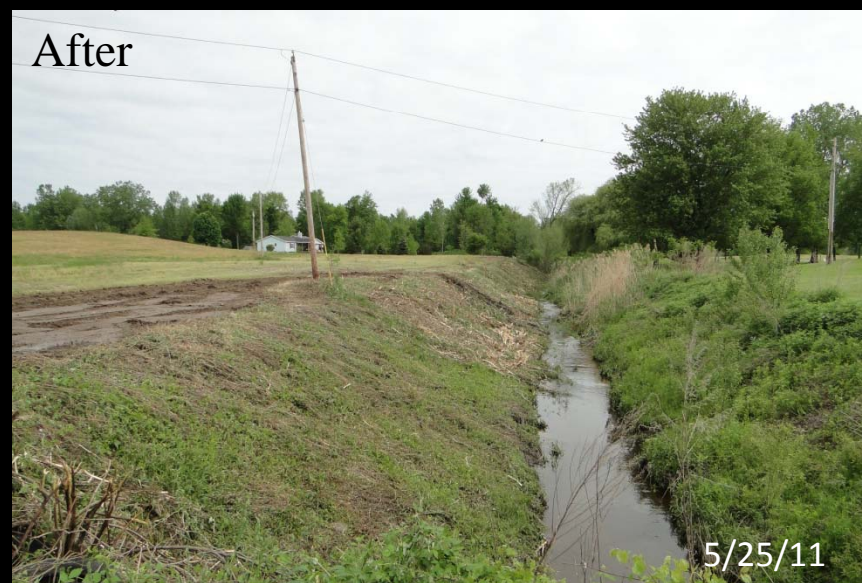
Hydesville Ditch

This was a maintenance project in the town of Arcadia. We mowed over two miles of ditch on this project, mowing both sides wherever possible. The project was completed by Kenneth Morrison and took eight days to complete.

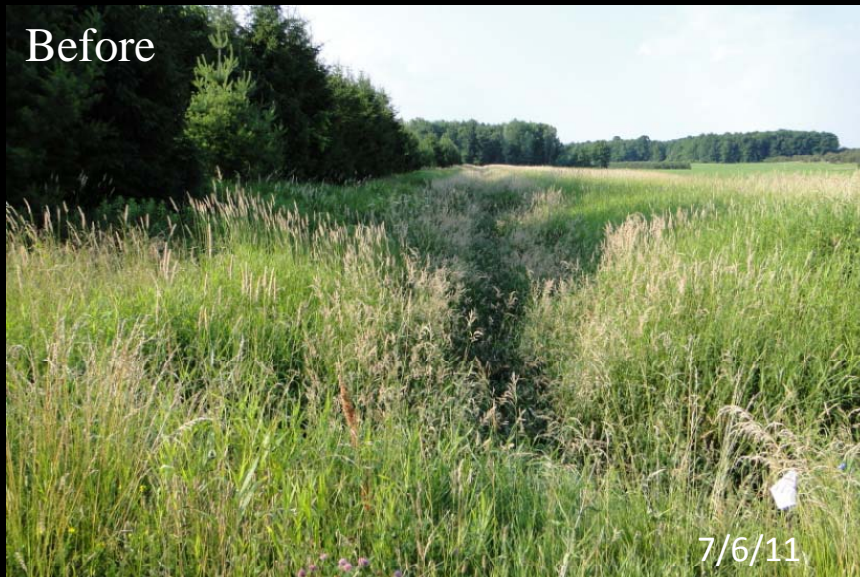
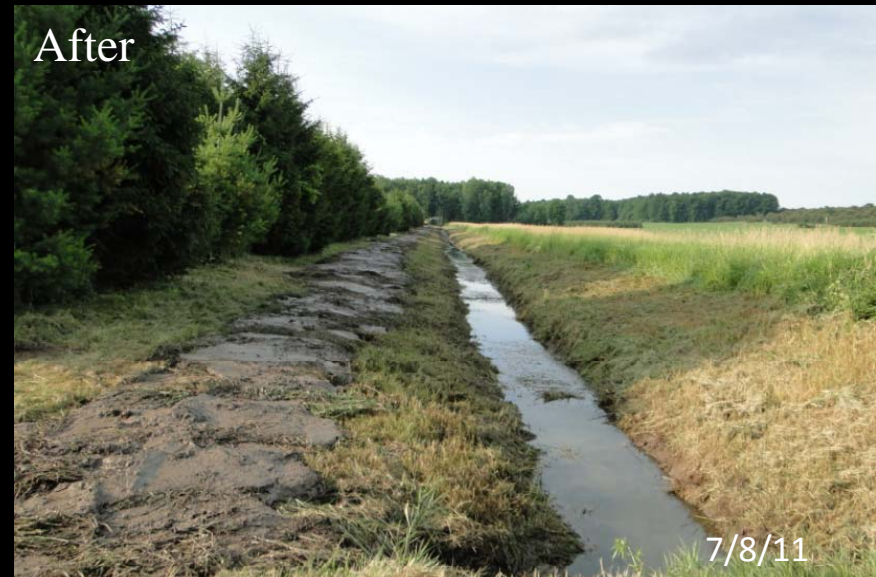
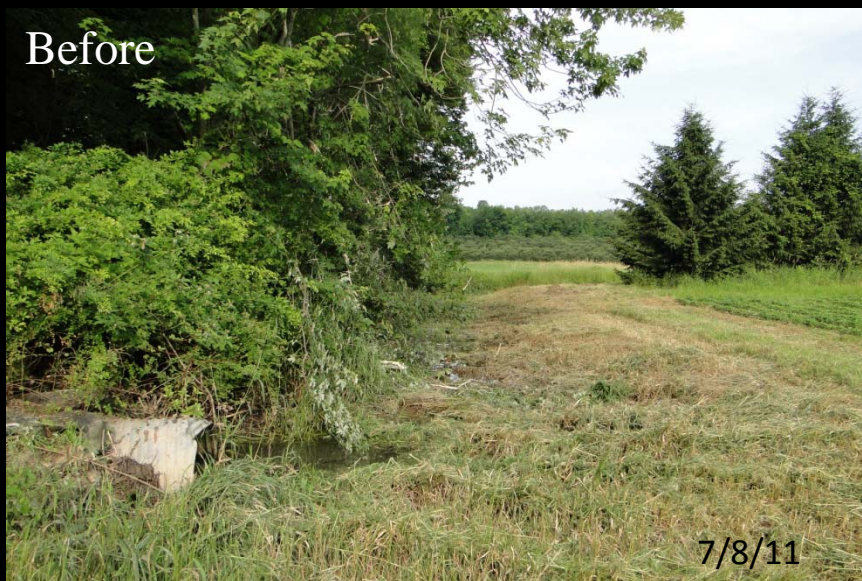
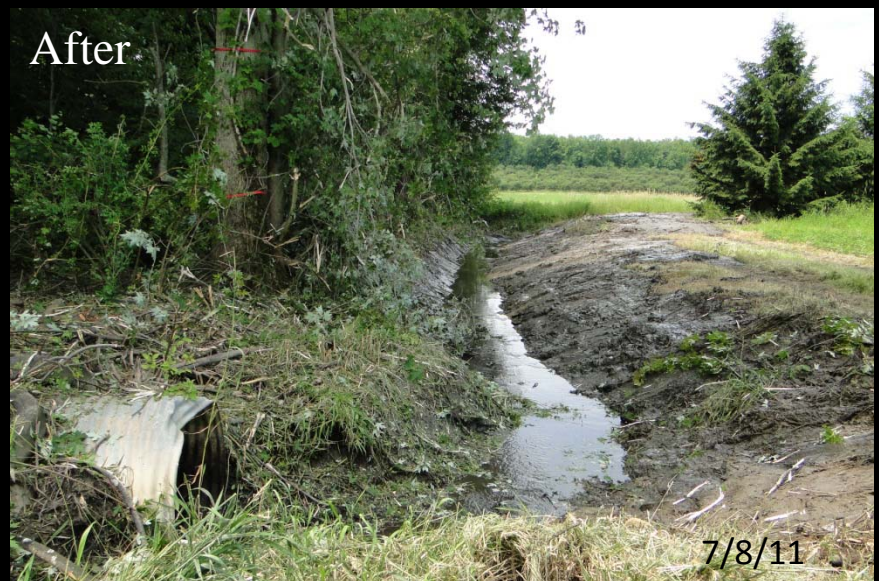
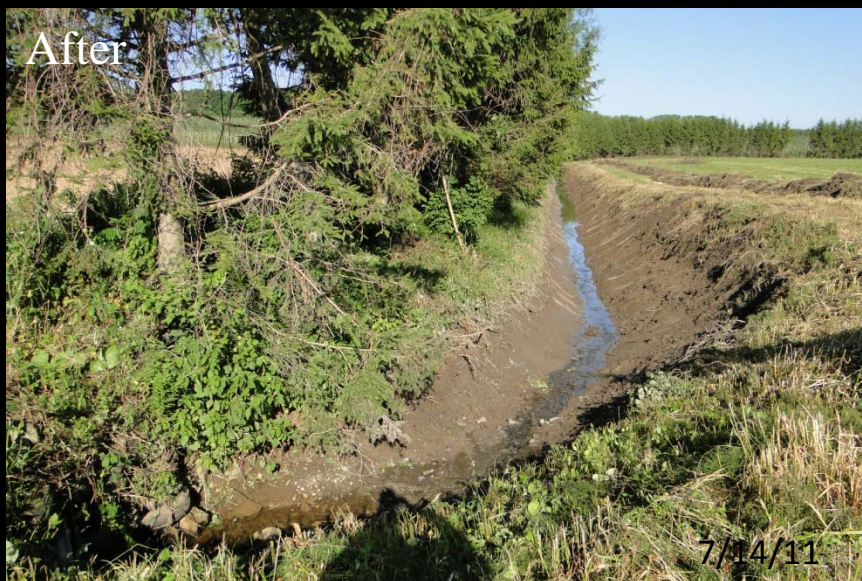
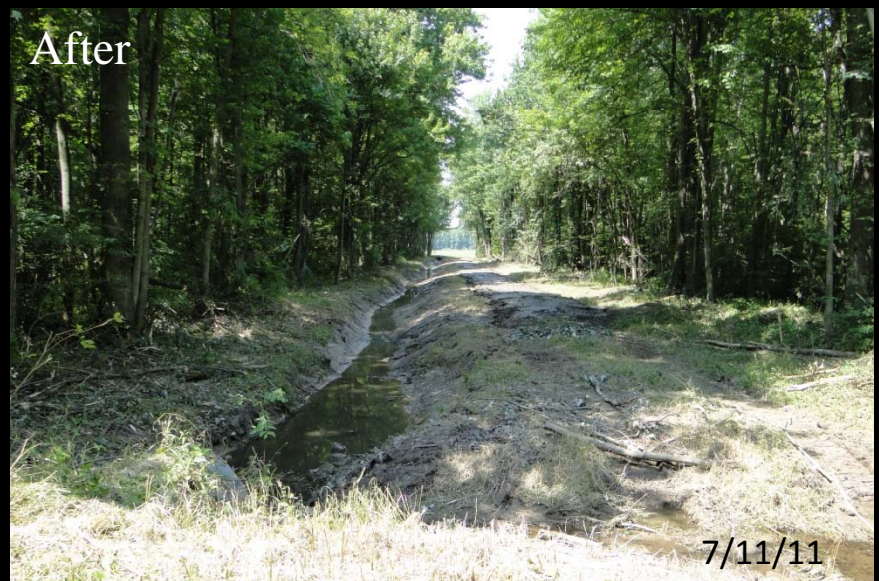
Dutch Street Ditch

This was a maintenance project located in the town of Huron. Work on this project consisted of mowing about 2 miles of ditch as well as dipping about 1 mile of ditch that had become choked up by sediment accumulation. Work on the project helps maintain proper drainage for multiple farmers covering hundreds of acres of agricultural land. This project was completed by Kenneth Morrison.

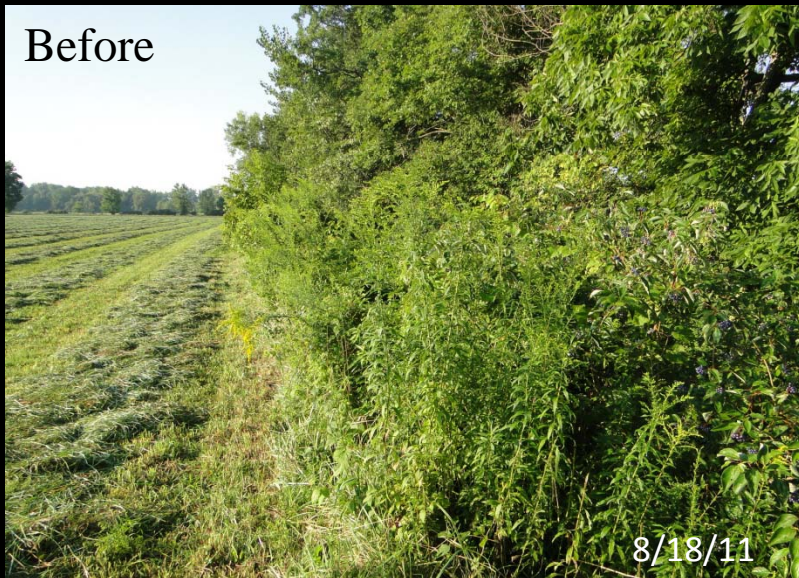
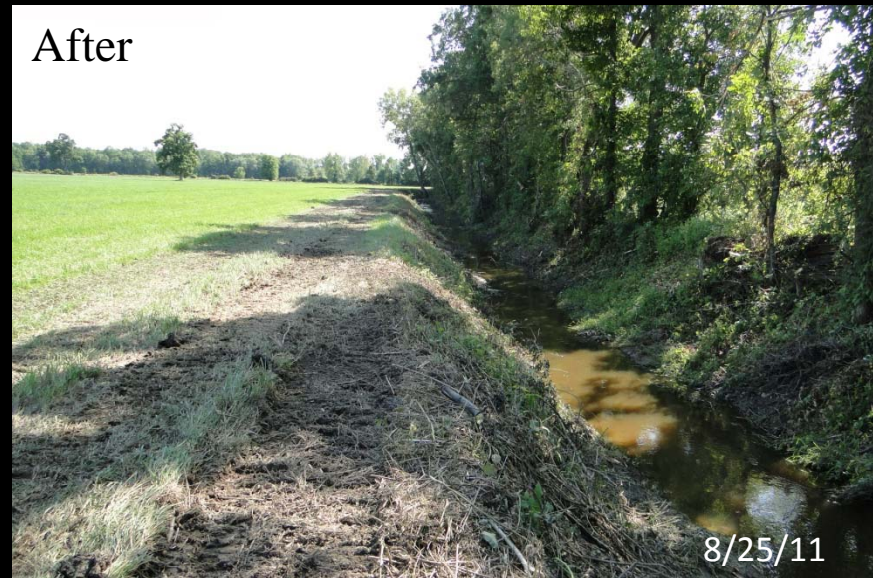
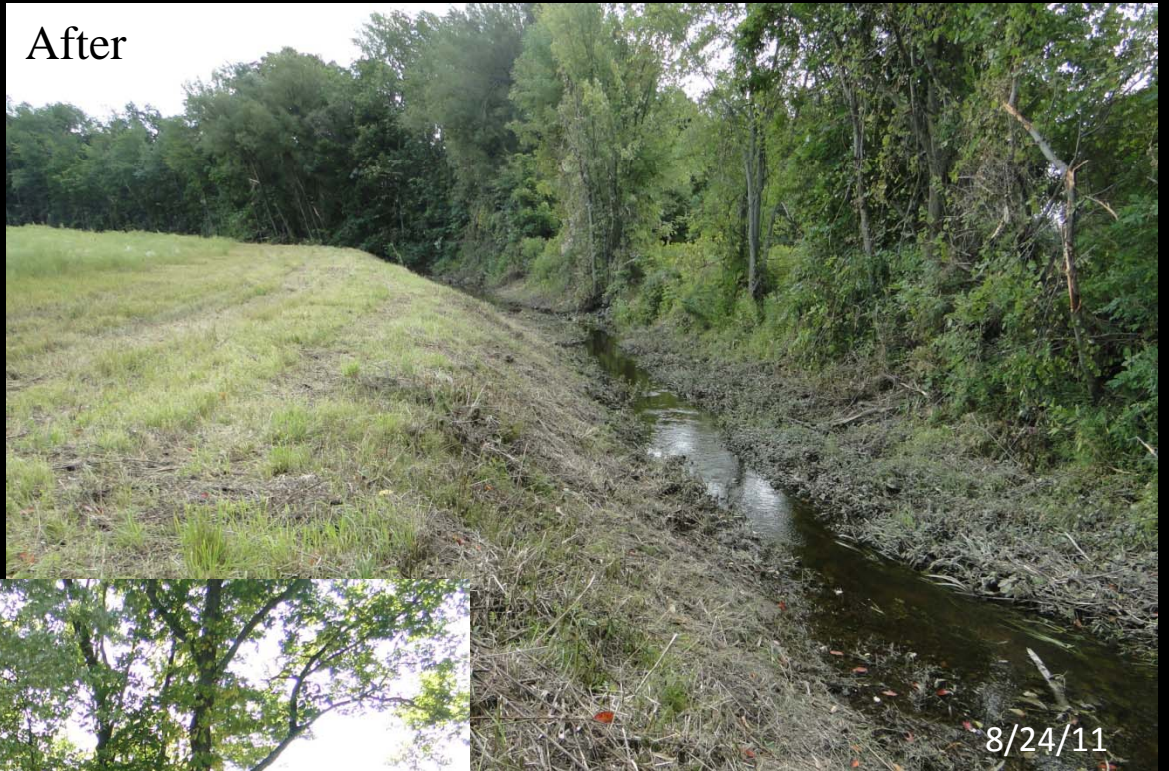
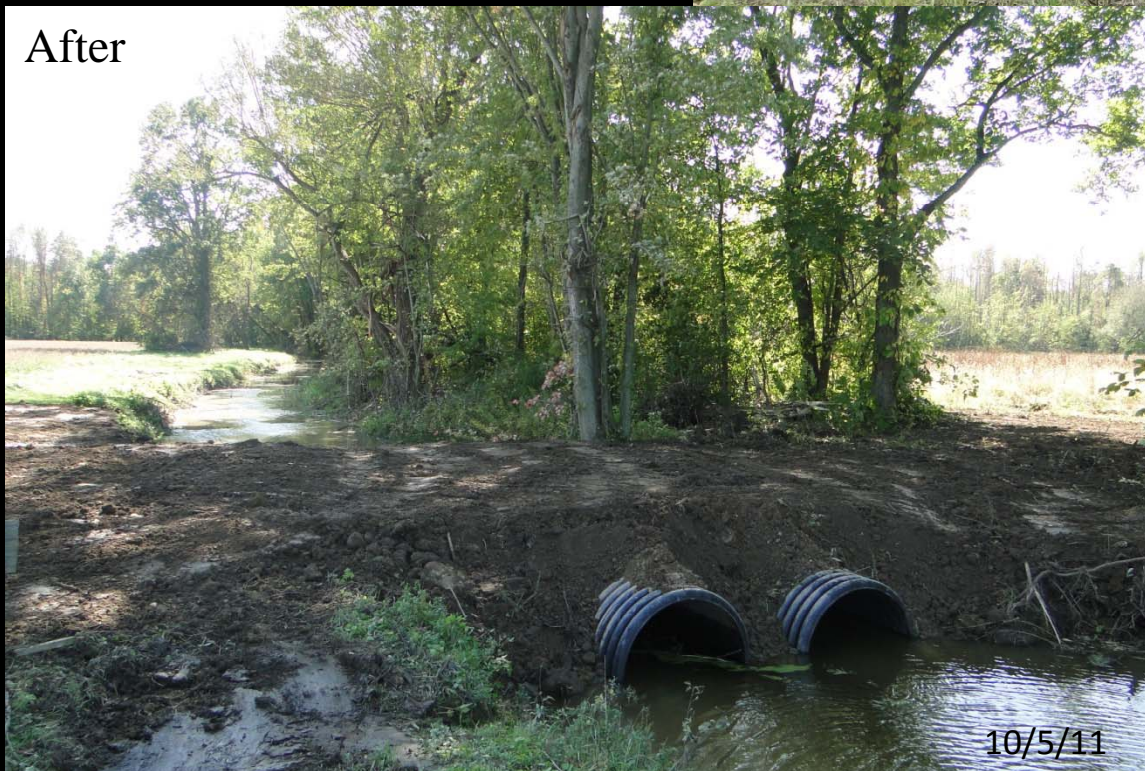
Melvin Brook

This was a maintenance project in the town of Galen. Work on this project included mowing about 1 ½ miles of ditch and snagging trees and debris from ¾ of a mile of the project. We also installed a culvert crossing that will allow the landowner and farmer to access a field on the opposite side of the creek. Two sections of this project were skipped, one due to crops and the other because of wetland issues. Ken Morrison completed the maintenance work and Decker Excavating installed the culvert crossing.

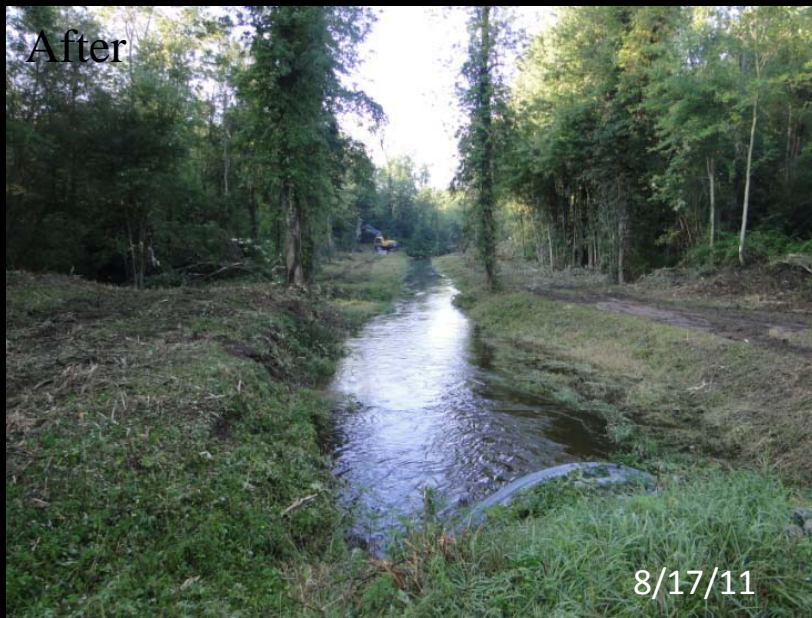
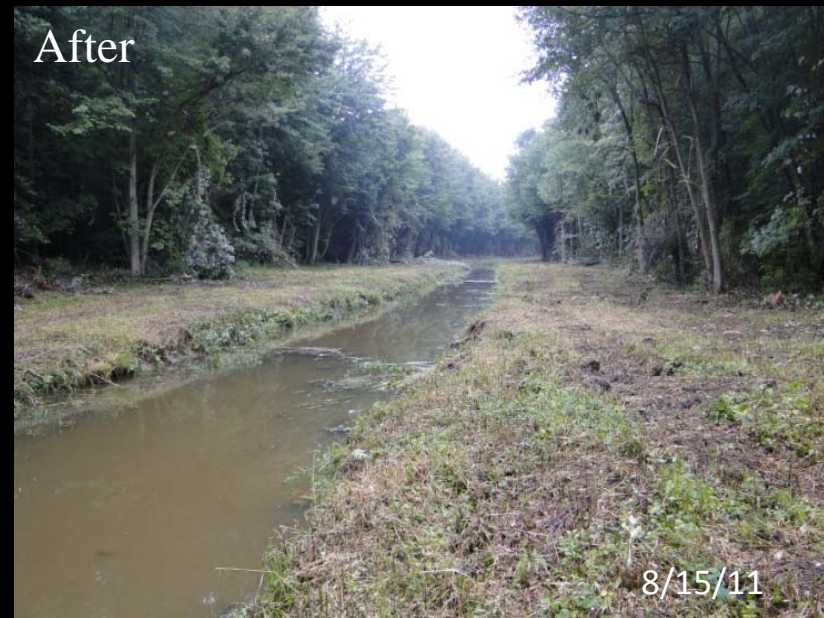
Black Brook

This was a maintenance project in the town of Galen. We mowed our maintenance corridor along about a mile of the creek, mowing both sides on about half of the project. We couldn't mow one section because of abnormally high water levels during the project. The work was completed by Ken Morrison.

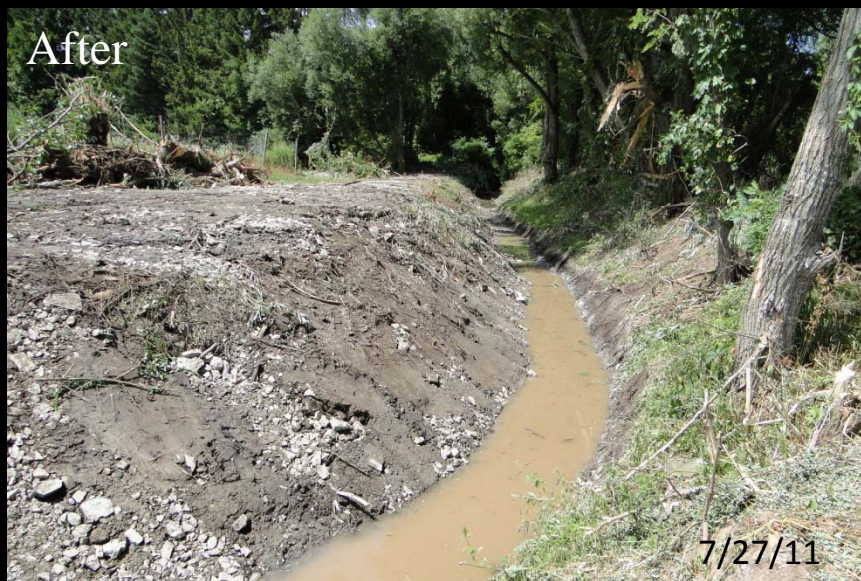
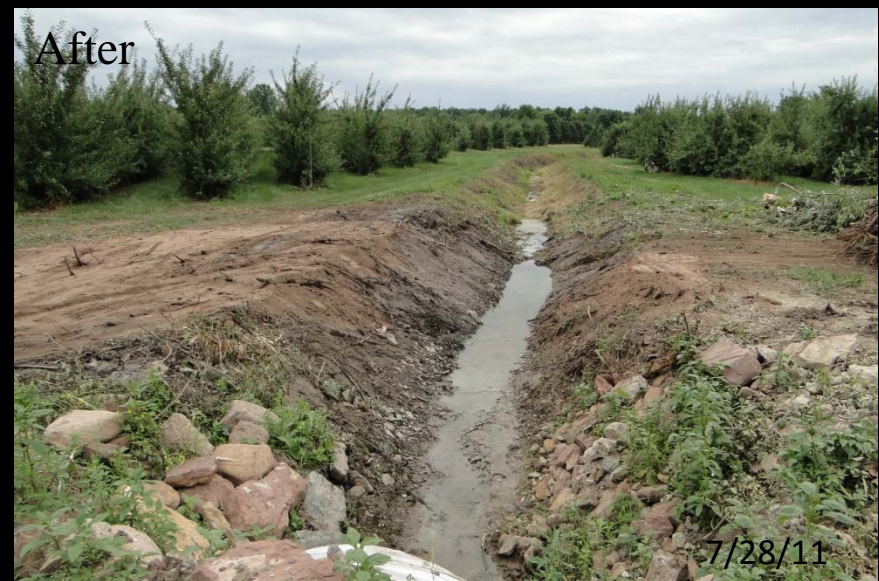
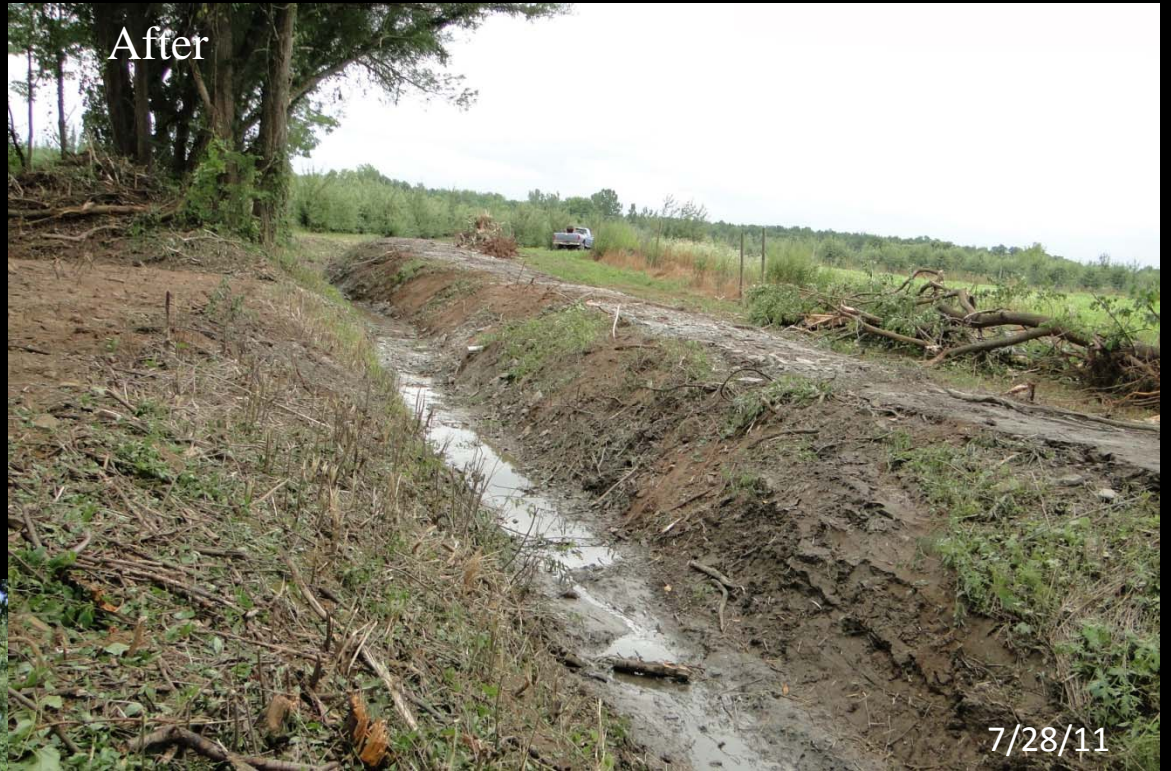
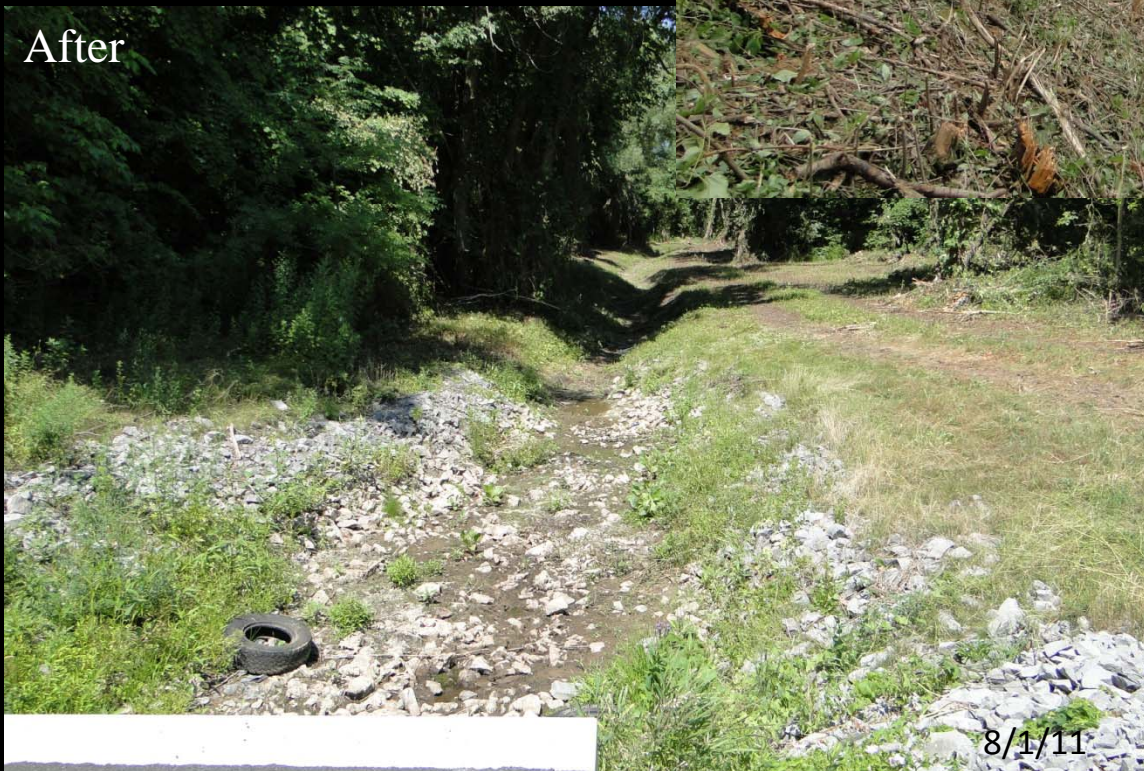
Mink Creek

This was a maintenance project in the town of Williamson. Work on this project involved mowing about a mile of ditch, as well as clearing some trees along the ditch and dipping about 1000 feet. Project Completed by Ken Morrison.

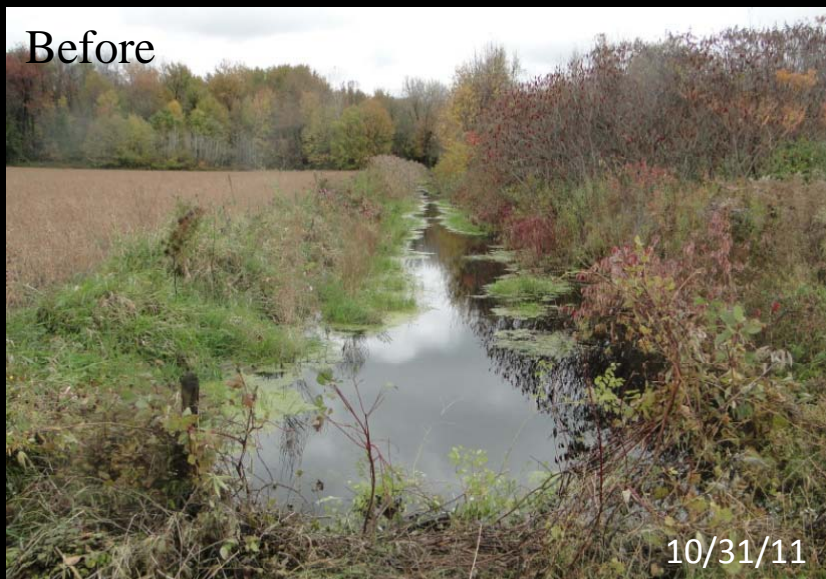
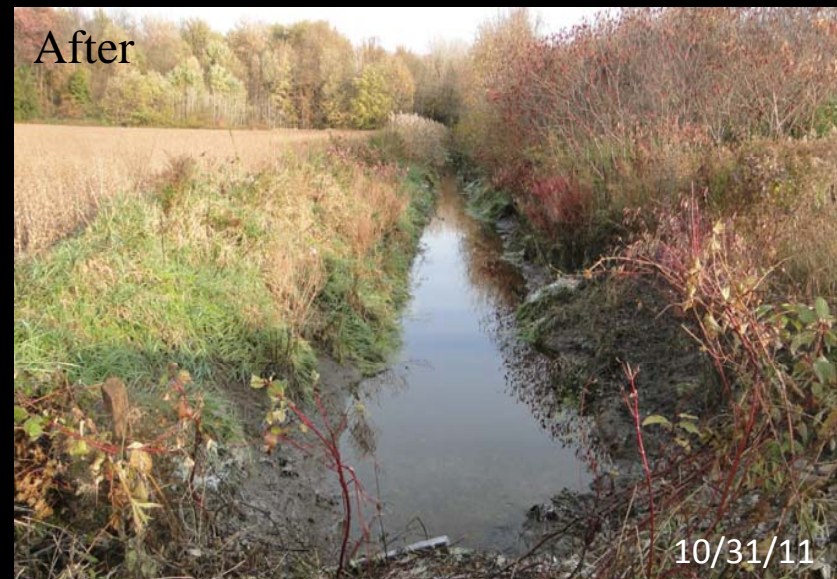
Sodus Center Ditch

Beaver moved into the area, plugging up two culvert crossings. We obtained the permit and coordinated a trapper to remove the beavers. We then removed the beaver dams as well as cleared trees from the ditch that the beaver had toppled. Work on this project was completed by Decker Excavating.

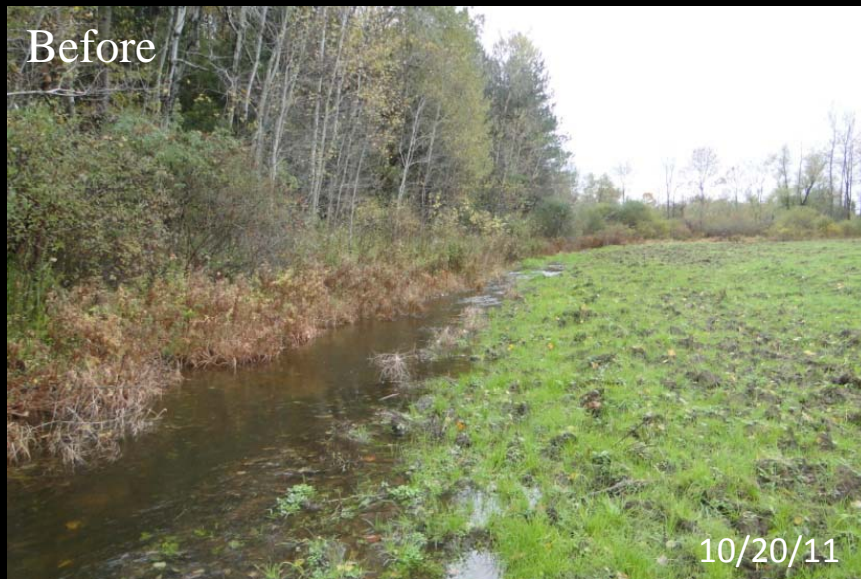
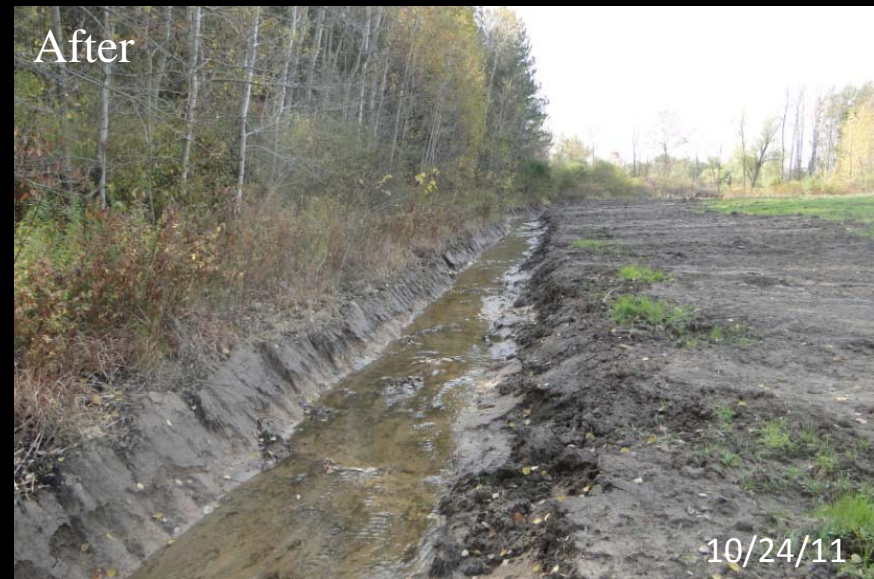
Jack Creek Extension

This was a quarter mile extension of our Jack Creek project. This extension was done to relieve flooding problems that were occurring where our original project ended. The channel through this section had silted in to the point it was almost non-existence. We re-dug the channel to where our original project ended. The work completed on this project will help relieve residential flooding and improve agricultural drainage. Decker Excavating completed this project.

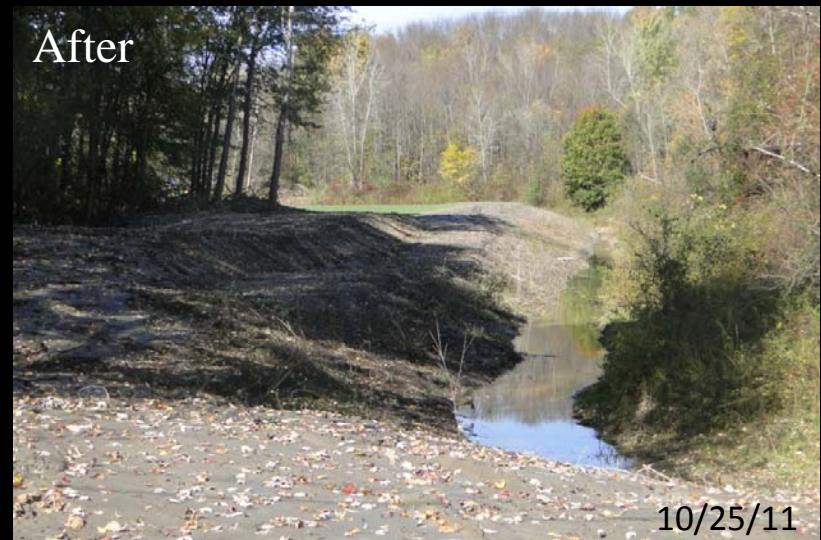
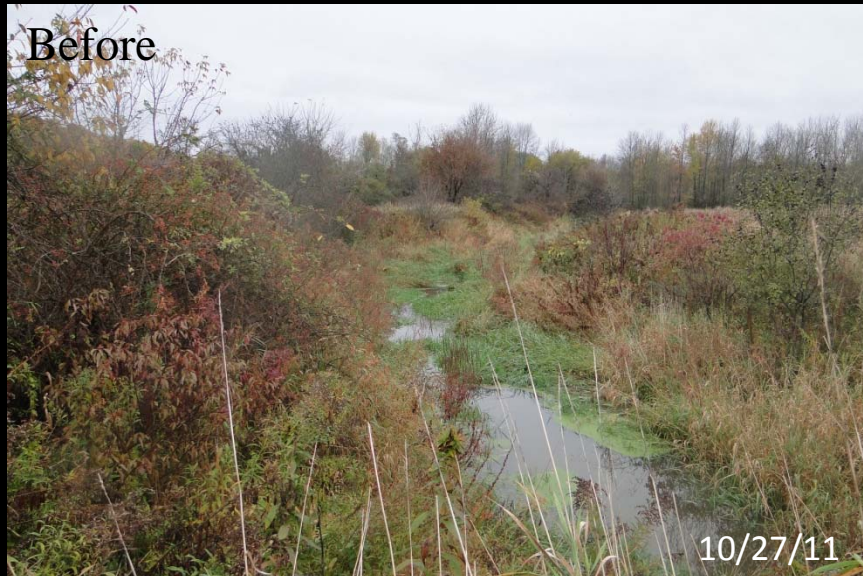
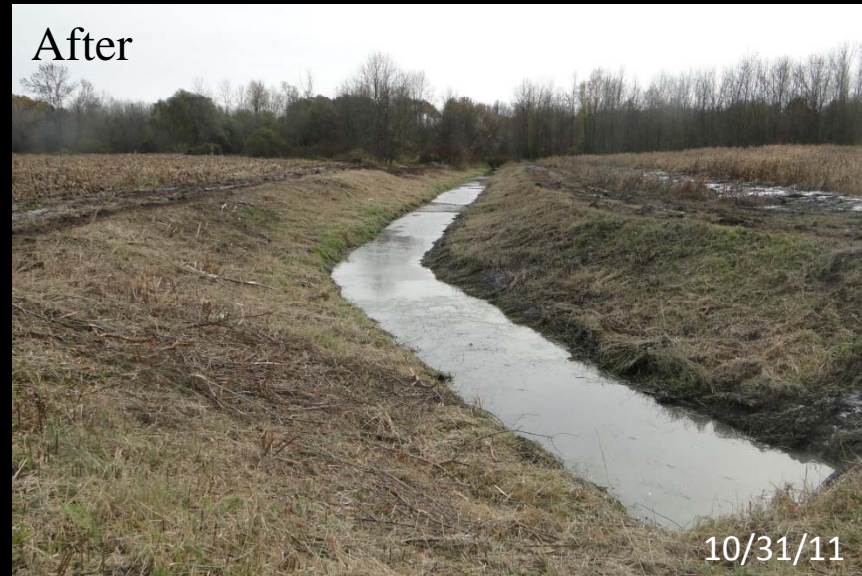
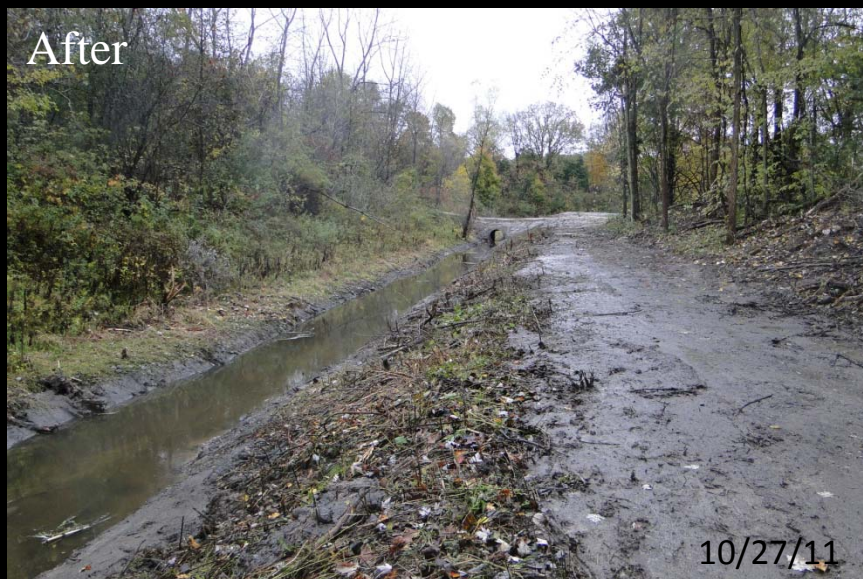
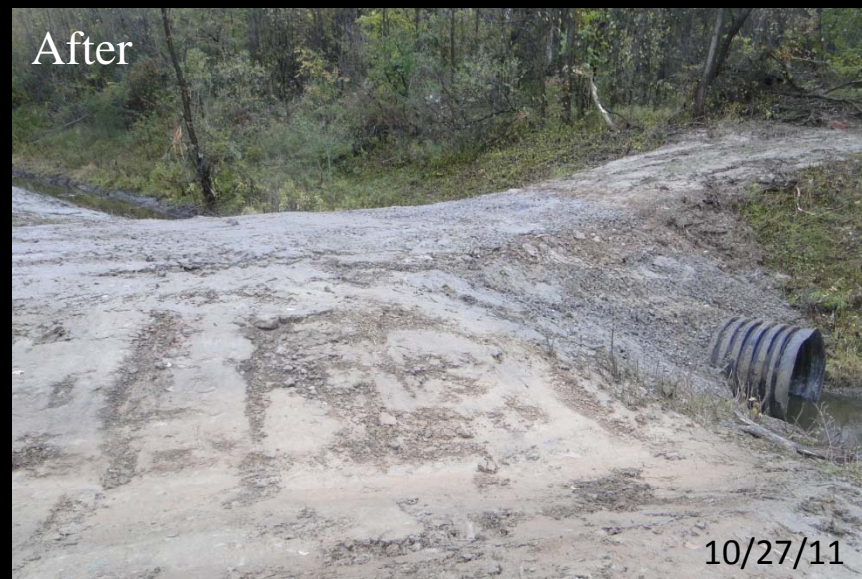
Clyde School Ditch

This was a new project in the village of Clyde. The purpose of this project was to help resolve some of the flooding and drainage issues that the Clyde-Savannah school district has suffered from for years. The first step of this project was to mow everything along and in the ditch channel that we could. Next, we removed all trees from the channel that were too large to mow. Once everything was cleared out of the way we began digging out the bottom of the channel, reestablishing its original hard bottom. Excavation ranged from one to two feet throughout the project. We also dug up and then reinstalled a four foot culvert that was originally installed too high and was impeding proper flow. The project covered a total of about three quarters of a mile of ditch and should vastly improve the schools, as well as surrounding residents, storm water drainage. There is still more that could be done to further improve the drainage for this area, although we were not able to this year because it involved a NYS DEC wetland which would require a permit to enter. Ken Morrison completed the excavating work and Decker excavating did some dozer work to level off spoil.

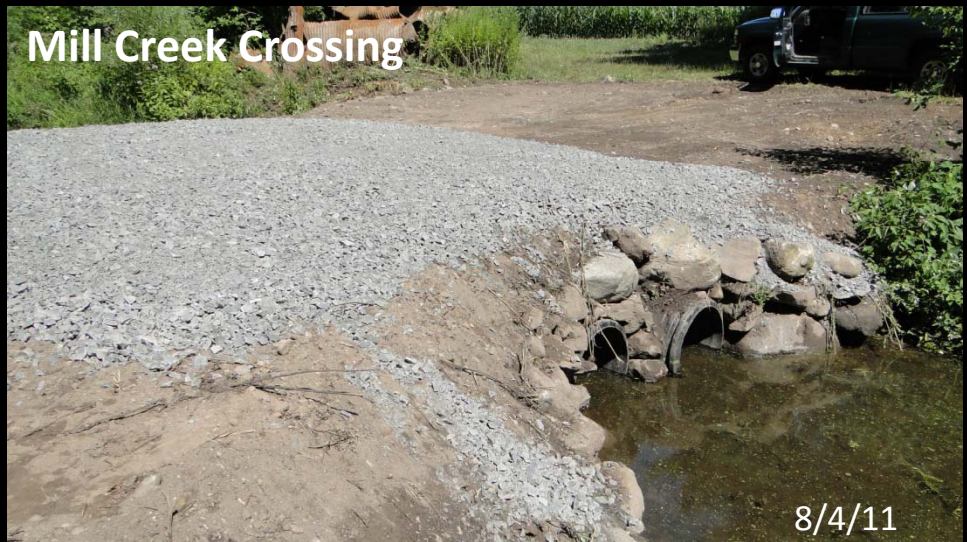
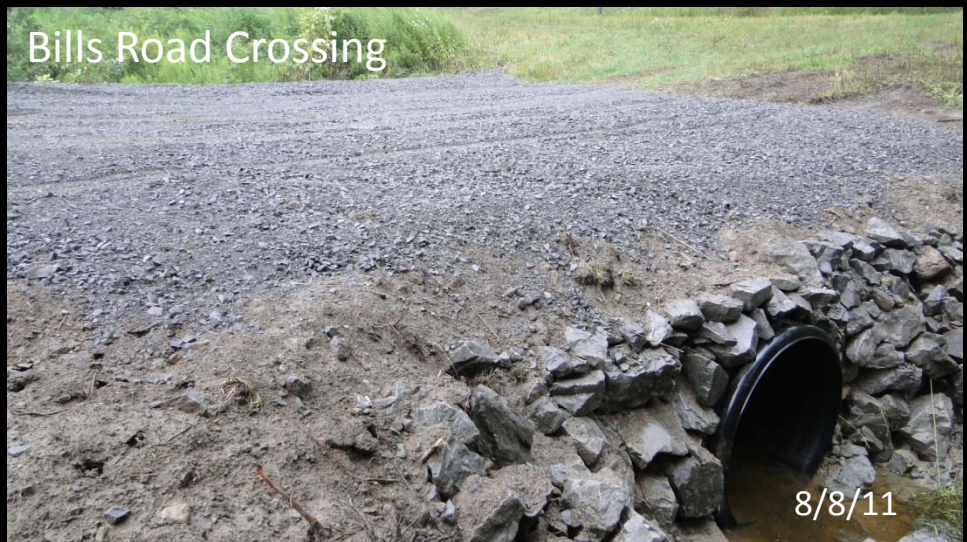
Stream Crossing Replacements

We replaced culvert crossings on two maintenance projects, Mill creek and Bills road ditch. The Mill creek crossing was originally constructed using culvert pipe and old tanks together, which were severely degraded and impeding proper flow. We installed 60 feet of two foot pipe on this project as well as brought in gravel and rip-rap to stabilize the crossing. This crossing allows greater access for agricultural activities. The Bills road ditch crossing was replaced because the banks were constantly eroding back and the crossing was too narrow for today's farm equipment. We installed 40 feet of 5 foot culvert pipe for this crossing. We also brought in fill as well as rip-rap to stabilize the inlet and outlet of the pipe. Both of these projects were completed by Decker excavating.

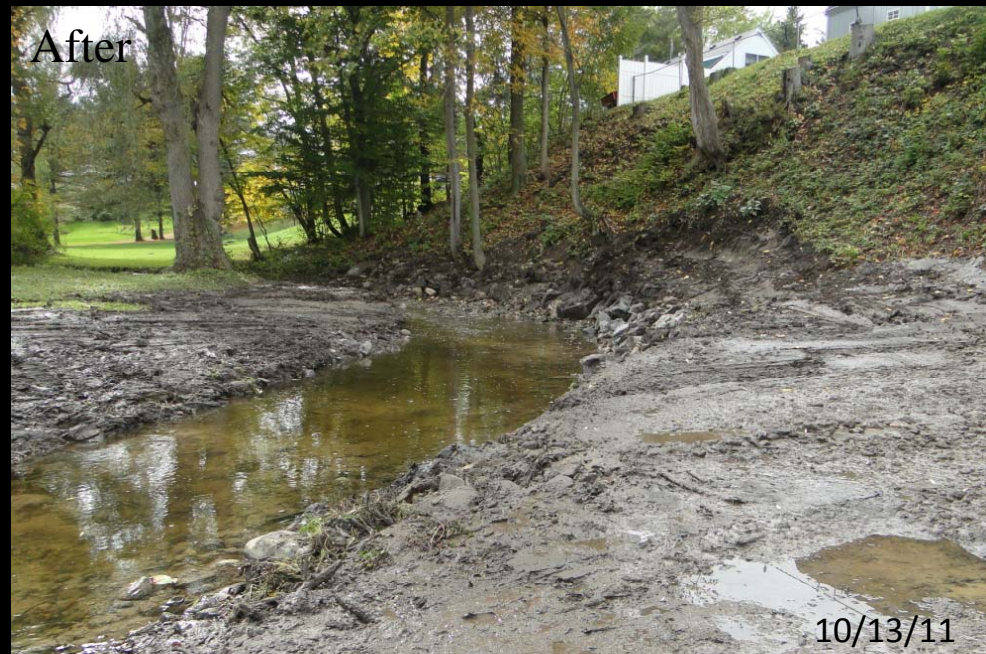
Trap Brook: This was a small stream bank stabilization project. The goal of this project was to stop trap brook from continuing to undercut a steep bank. We accomplished this by bringing it heavy rip-rap, average size of about 24 inches in diameter, to place along the toe of the bank. Protecting the toe of the bank should completely stop the undercutting that was occurring, hopefully allowing the bank to stabilize by re-vegetating naturally.

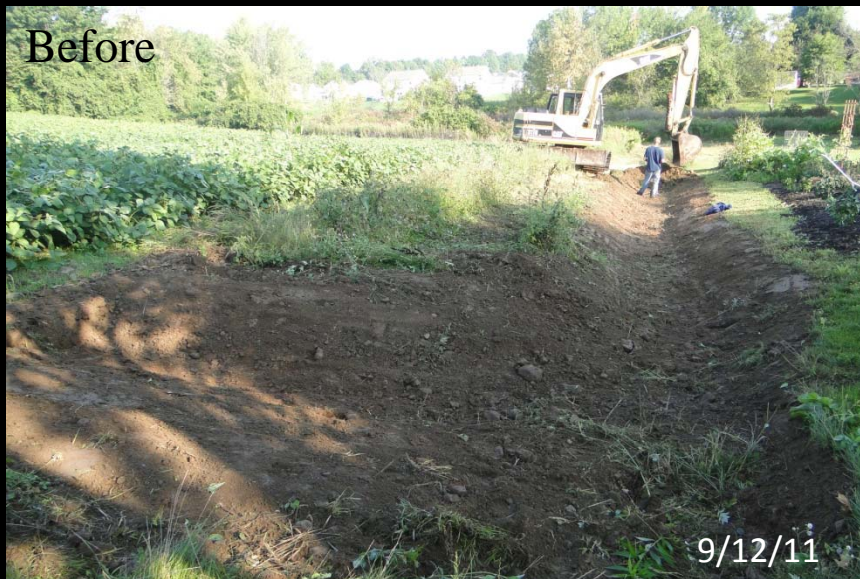
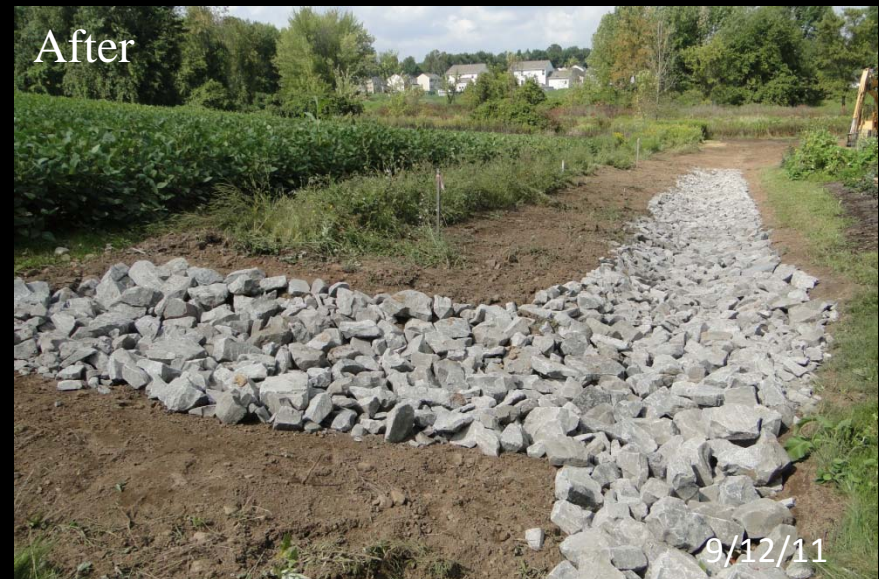
Contestible Diversion Swale

The purpose of this project was to stabilize a failing diversion swale and route it to a suitable outlet. To complete this we re-dug the existing swale to an appropriate depth and width that would allow us to bring in light rip-rap to stabilize the steeper section of the diversion. We also seeded and mulched the entire swale to further reduce erosion. The work completed on this project protects the landowners house and garage as well as reduces erosion and sedimentation issues.
