2011 Agricultural Group Drainage Program

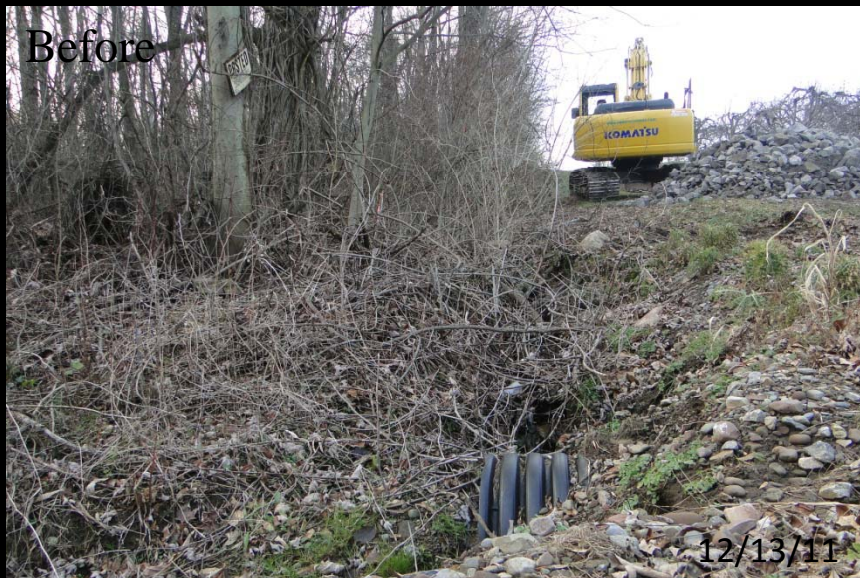
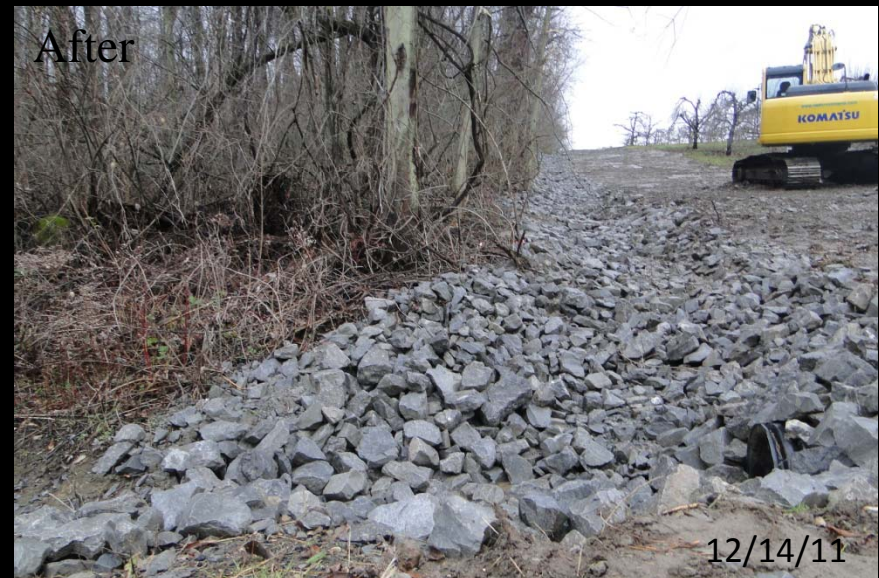
Defisher Road Project:

The major issue on this project involved a severely eroded ditch that flows directly down a steep slope and into a road ditch perpendicular to it at the base of the hill. There is also a farm lane that goes up the hill along the ditch experiencing constant erosion problems. The idea on this project was to first stabilize the ditch going up the hill using rip-rap to armor the channel and slow down the flow. With the ditch stabilized we can then divert water off the farm driveway into it by installing two or three small diversion swales across the driveway. These diversion swales will cut water off, forcing it into the ditch instead of continuing straight down the driveway. We were only able to complete the stabilization of the ditch this fall, but plan on completing the driveway work in the spring.
