# Lower Ganargua Creek Watershed Assessment

**2012 - 2013**

**Wayne County Soil & Water Conservation District**

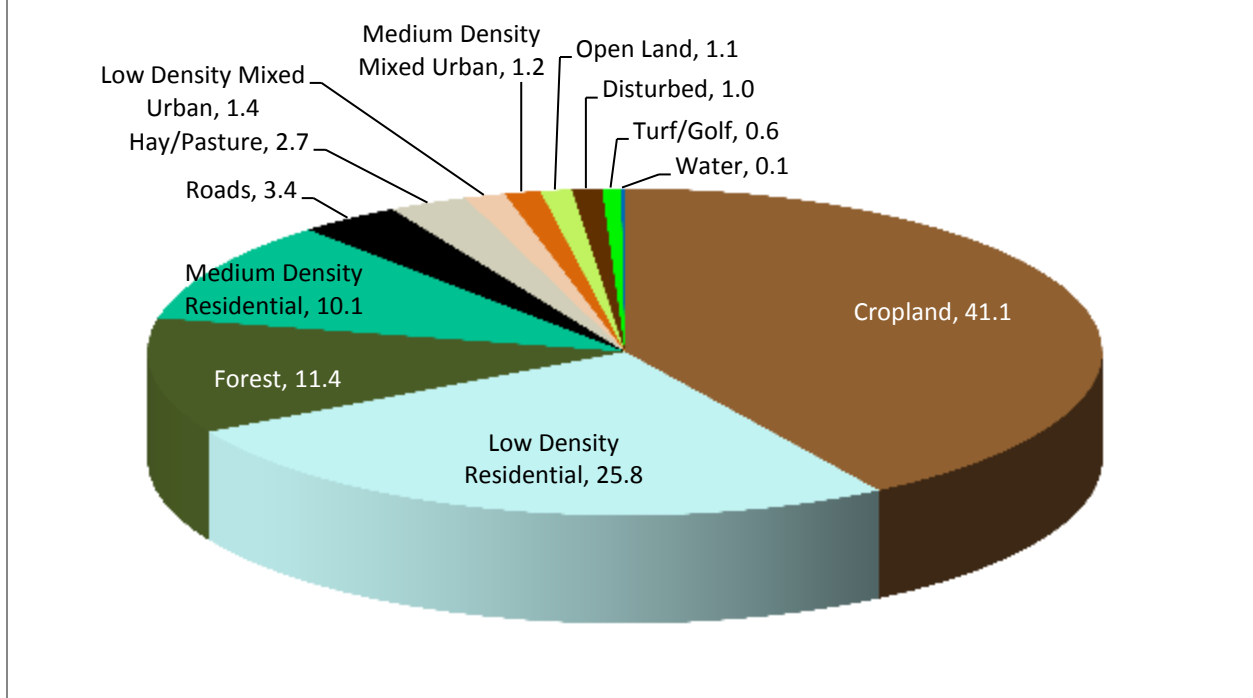
**Figure 1. Percent Land Use, Lower Ganargua Creek**

Figure 1 provides a fairly accurate representation of current land uses within the Lower Ganargua Creek watershed. It is important to note that the Low Density Residential category has a high probability of containing agricultural lands. With that in mind, in combination with Cropland and Hay/Pasture, approximately 70% of the watershed is made up of some form of agricultural land. This information can be used in conjunction with water quality data to determine potential areas of concern and aide in prioritizing implementation efforts to reduce pollution loading.

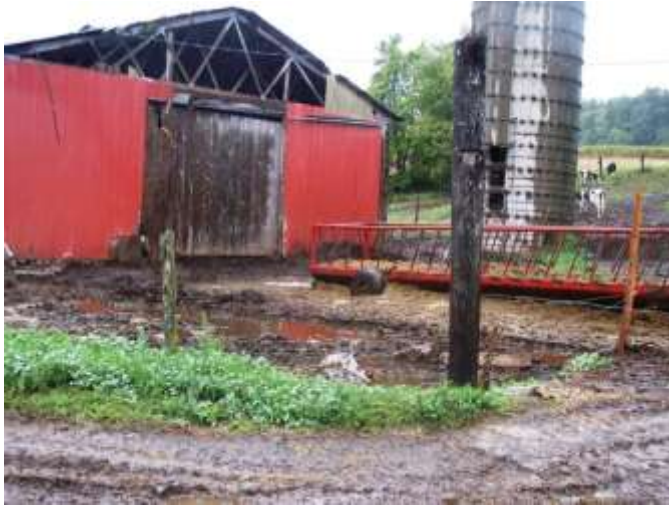
Barnyard area in need of runoff structures, heavy use stabilization, and manure management structures.

- roof runoff structures to collect and transport clean water away from livestock areas,
- heavy use area stabilization for people, animals, and vehicles,
- exclusion fencing,
- manure management structures,
- sloped concrete surface with retaining wall to a screen collection box, and
- conveyance system to vegetated treatment area.

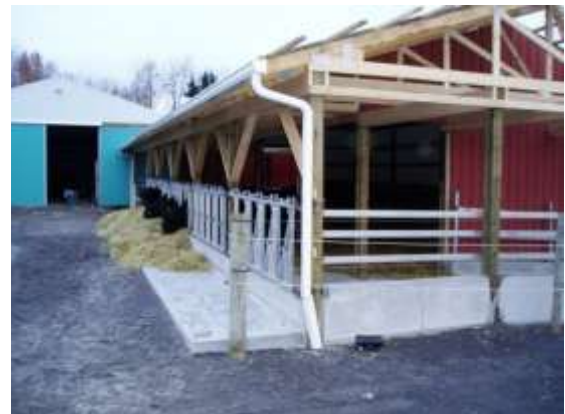
Left: Example of a barnyard management plan designed to contaminated runoff. Below: Installed barnyard management

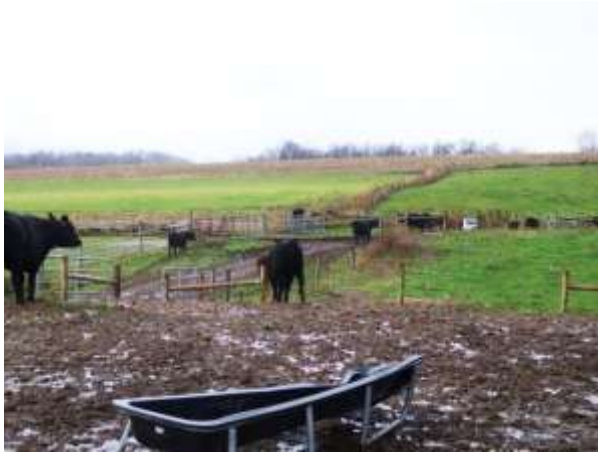
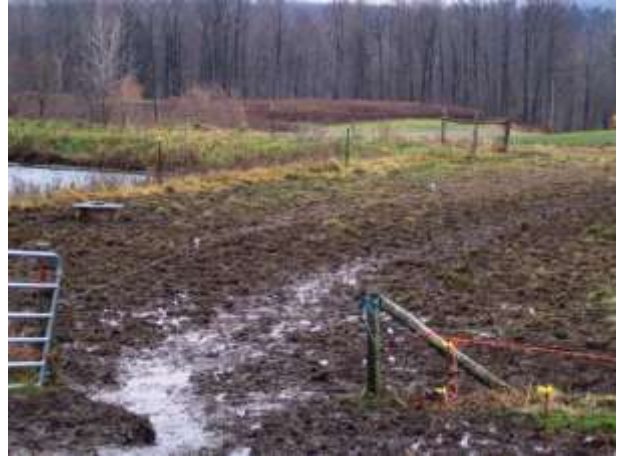
Animal trails and access roads in need of stabilization.

- animal exclusion fencing,
- forage harvest management,
- prescribed grazing,
- livestock watering pipeline and facility,
- improve and increase livestock forage with compatible biomass planting, and
- animal trails and access roads.

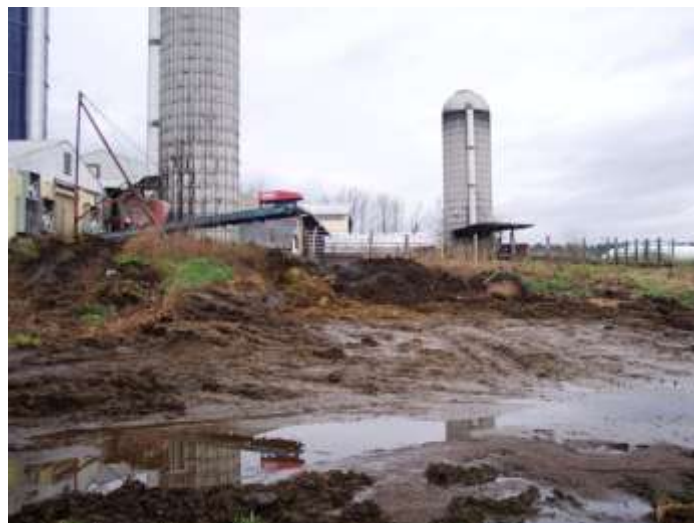
Lack of adequate buffer/filter between the crop field and the stream. Photo taken during high flow conditions.

Practices to implement buffers and filter strips consist of:

- contour buffer strips to reduce erosion and prevent sediment and nutrient transport,
- herbaceous vegetation filter strip to intercept runoff, and
- riparian forest buffer along watercourses to improve wildlife habitat and intercept runoff.

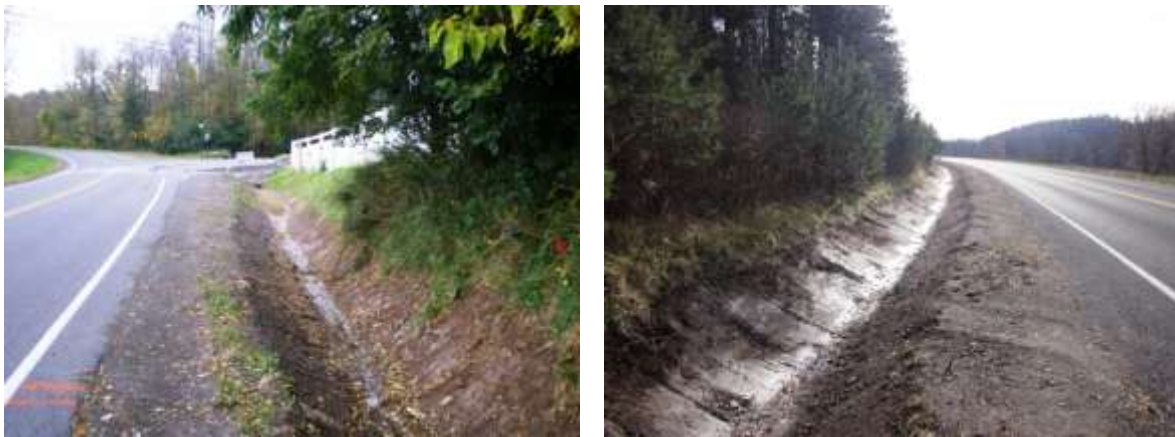
Unseeded roadside ditch observed in the Lower Ganargua Creek Watershed.

- remove as little material as possible during cleaning,
- seed immediately after cleaning,
- hydroseeding will re-establish vegetation quickly,
- reshape ditches to a shallow, trapezoidal or rounded profile that allows routine mowing,
- establish rock check dams to slow water velocities and capture sediment along steep roads,
- disconnect ditch-to-stream systems using infiltration basins, retention basins, constructed wetlands, or forested areas, and
- decrease landscape routing of stormwater to ditches using rain gardens and infiltration basins.

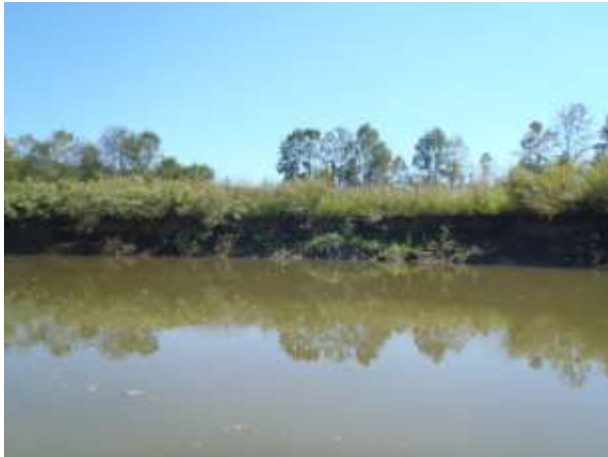
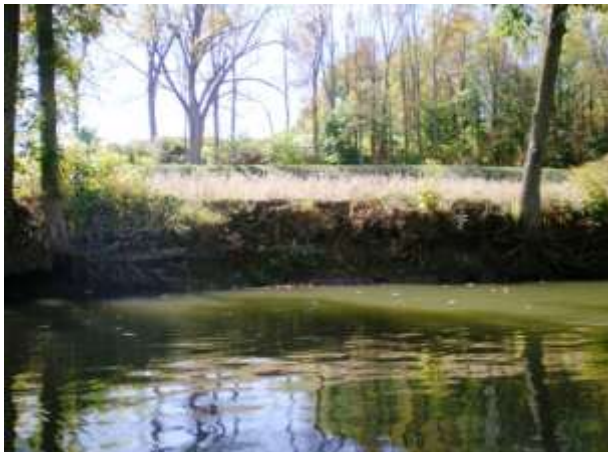
The width of a stream is the most easily altered characteristic impacted by flowing water. Bank erosion is a result of a change in the water-sediment interaction. Before attempting to 'fix' an eroding streambank, it is important to investigate if the situation is caused by a system-wide or localized condition. Once the cause has been determined, then strategies to address the problem can be evaluated. Unfortunately, the natural movement of streams is often incompatible with human development, such as bridges, roads, buildings, and agriculture. Determining whether or not to expend resources on remediating a stream is most often dependent on what is at stake. Through field investigation of Lower Ganargua Creek by SWCD staff, streambank failures were commonly associated with degradation (deep channel, high banks) and a lack of vegetative buffer. Streambank impairments that occur in heavily forested areas would not pose as much of a threat compared to one adjacent to road foundations or agricultural operations. Streambank stabilization issues

observed on Lower Ganargua Creek were most commonly adjacent to agricultural production fields. Further investigation of each individual site is necessary to determine the appropriate remediation strategies. These strategies must also meet the needs of the landowner. With the most suitable strategies in place, the overall stability of Lower Ganargua Creek can be maintained and improved.

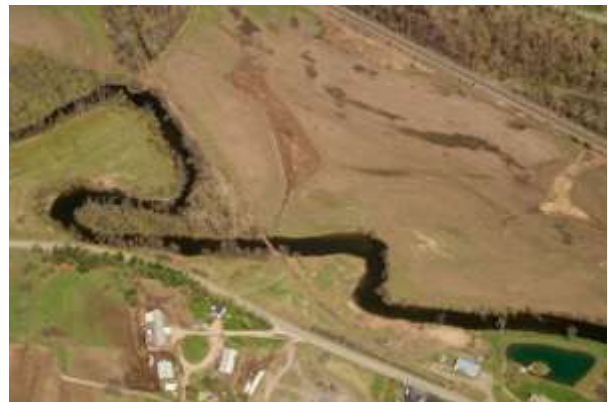
As previously stated, the implementation of buffers and filter strips along watercourses are important in erosion control, but they also provide other benefits. Vegetation along a stream acts as a filter between the adjacent land and the flowing water. Vegetated buffers function in a way that they:

- slow water movement,
- stabilize streambanks,
- reduce bank and upland erosion,
- moderate the stream's water temperature,
- provide wildlife habitat, and
- enhance the landscape.

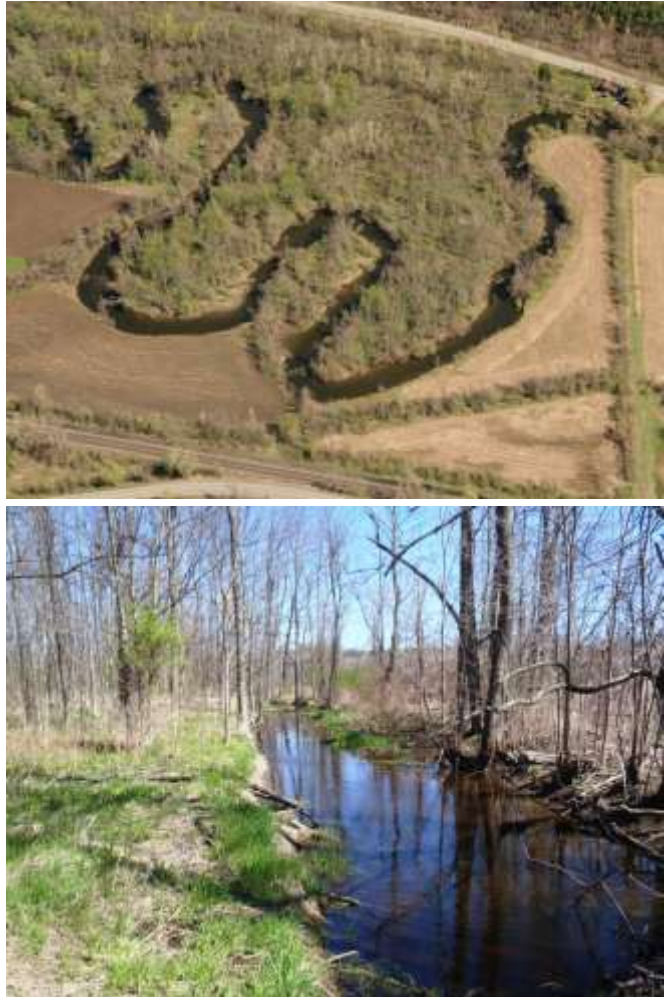
Top: Lack of buffer along field. Bottom: well established riparian buffer along Lower Ganargua Creek tributary, sampling site 4.

Well-established riparian areas are generally the most effective, cost efficient long-term protection for a stream system. A common misconception is that grass along a stream is sufficient enough to protect a streambank from erosion. Replacing native plant communities with agricultural crops or residential lawns can significantly affect a stream's stability. Riparian buffers provide the greatest benefit when they contain a variety of plant types; including trees, shrubs, and grasses. Different plant types provide a variability of root depths and strengths that aid in soil stabilization. Trees and shrubs slow floodwater and diminish stream energy that is available to erode soils.

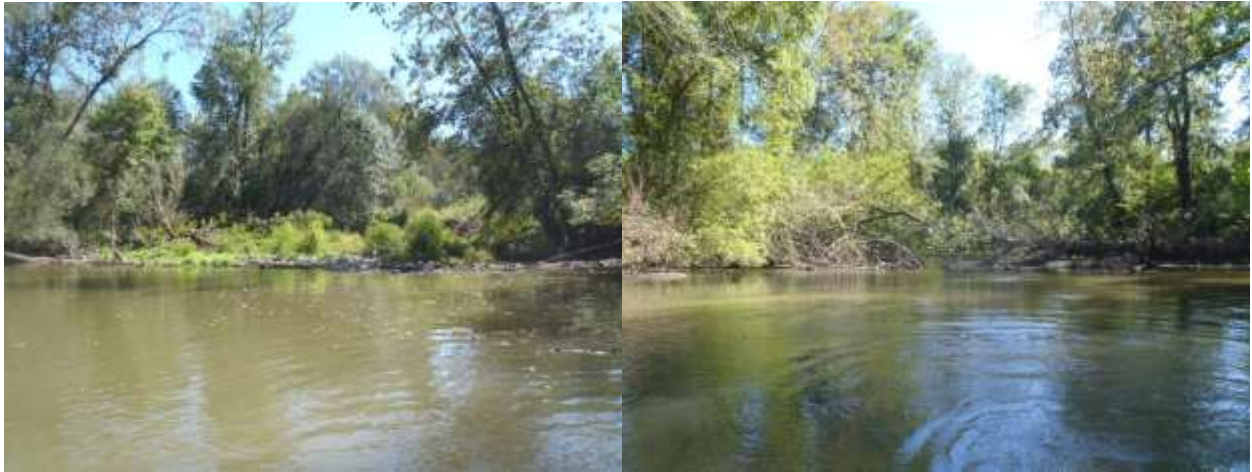
Lower Ganargua Creek has been recognized as a high priority recreational opportunity for the residents of Wayne County and for people that visit. The creek is enjoyed by numerous canoes and kayakers who can access it from any one of its three (3) car-top launching sites located at Swift's Landing Park (Palmyra), Norsen Bridge Park (Arcadia), and Abbey Park (Lyons). Trails.com "Flatwater Paddling and Canoeing" characterizes Lower Ganargua Creek as a "paddler's paradise" with a few "small chutes and white water patches to make it interesting. At the time that the trails.com summary was written, the author(s) noted a number of downed trees creating a "slalom course." Through the SWCD staff field investigation for this report, areas with downed trees have become impassable log jams with limited ability to portage watercraft around them. SWCD staff took GPS coordinates and photographs of the log jams for reference. It would be beneficial to the users of the stream to remove these log jams to improve access and the experience of paddling Lower Ganargua Creek. The goal would not be to

completely remove the jam, but to open a portion for paddlers to pass through. Keeping large woody debris in place is extremely important to providing habitat to fish and wildlife.
