REVISED FINAL REPORT

New York State Office of General Services

# Engineering Report for WA.01 Port Bay

March 18, 2020

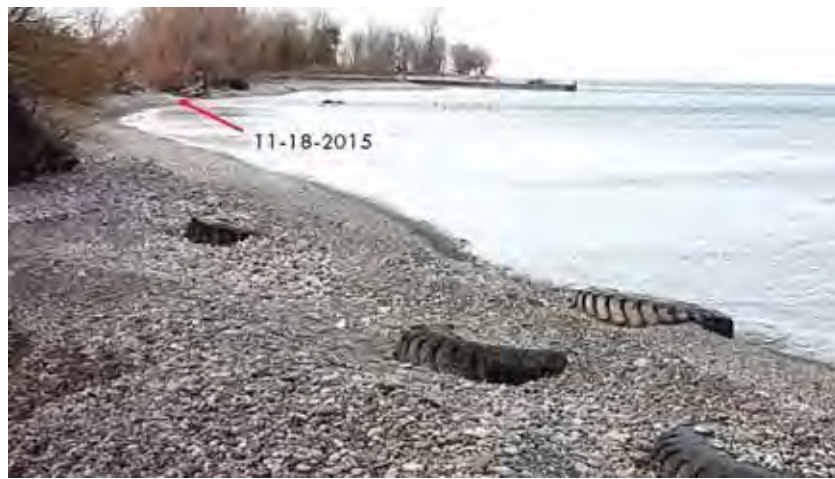
Location of the breach in Nov. 2015 (~WL 244.5 IGLD85)

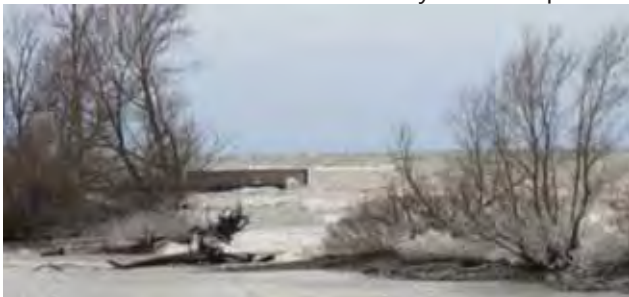
Trees washed into the bay (~WL 246.4 IGLD85)

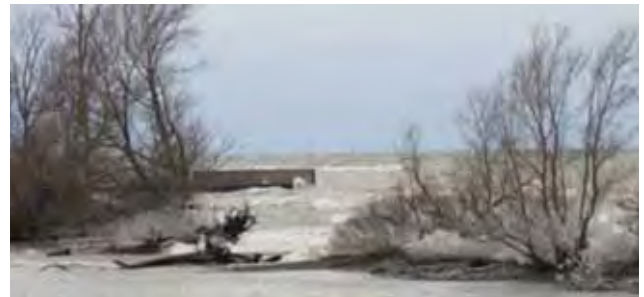
Trees washed into the bay (~WL 246.4 IGLD85)

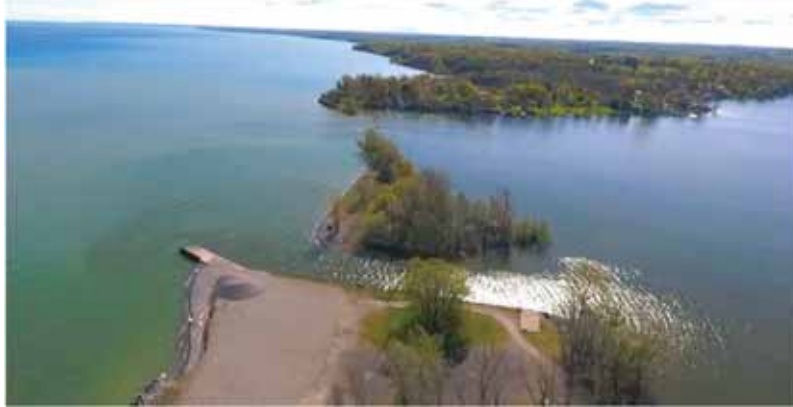
East barrier bar breach wide open because of high water level

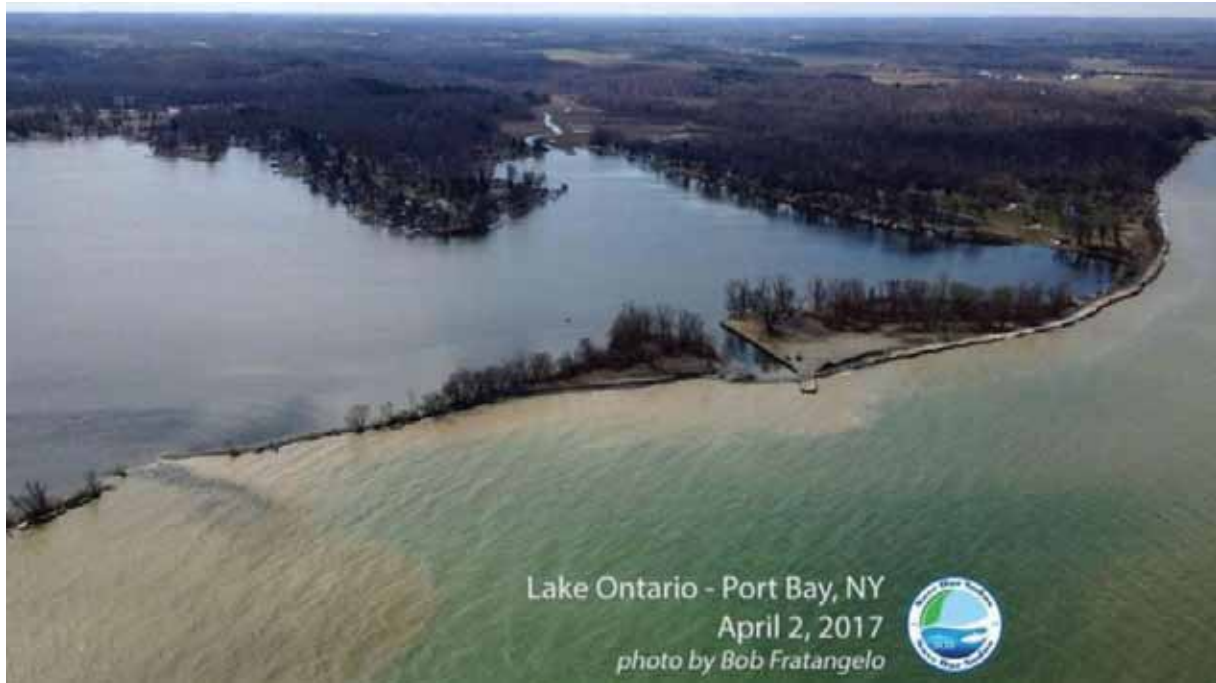
Breach of Apr. 3, 2017; channel outlet is filled in; WL=247.21 ft; Normal average WL=245.67 ft

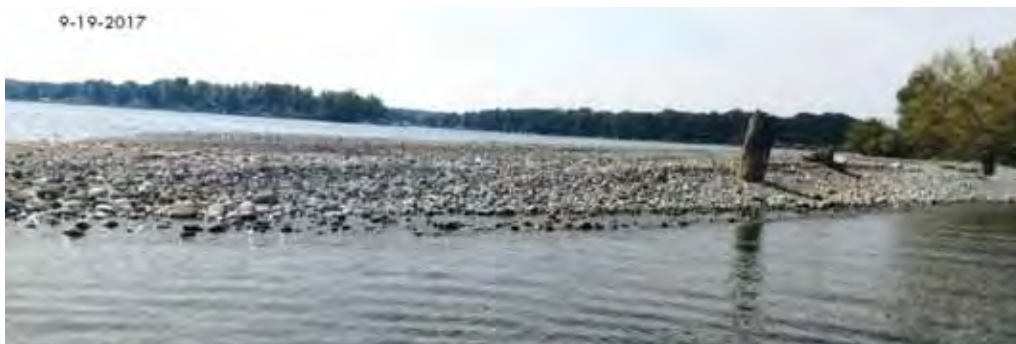
Location of the 2016-repair as of Sep. 19, 2017 9 (~WL 246.2)

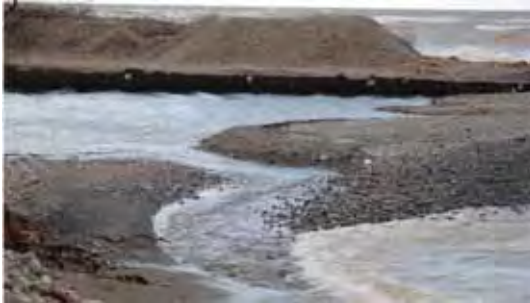
An obstructed channel allows the water levels in the Bay to rise to higher than lake levels. Eventually the channel/bay flow forces an opening to relieve water (Spoil #2 in the background)

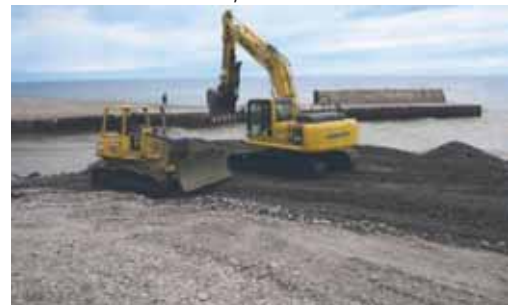
Access to the east side of the channel is critical for proper dredging and placement of materials on east bar

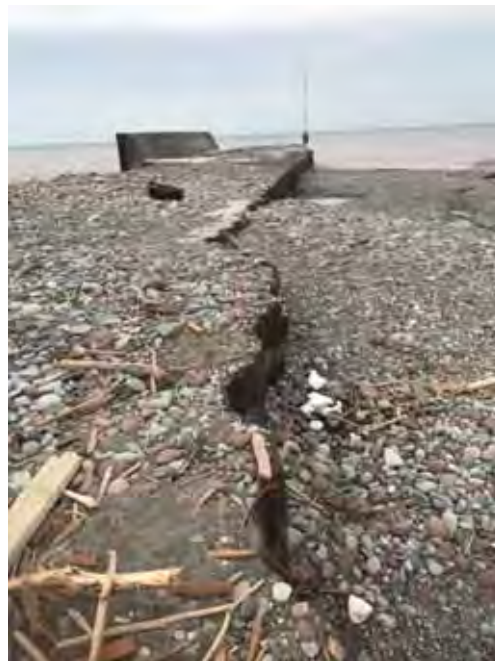
(b) Sediment deposit on and near the eastern edge of the pier

Note: The deposition pattern in (b) shows large accumulation of gravel immediately south of the concrete wall, an indication of gravel moving across and over the pier.

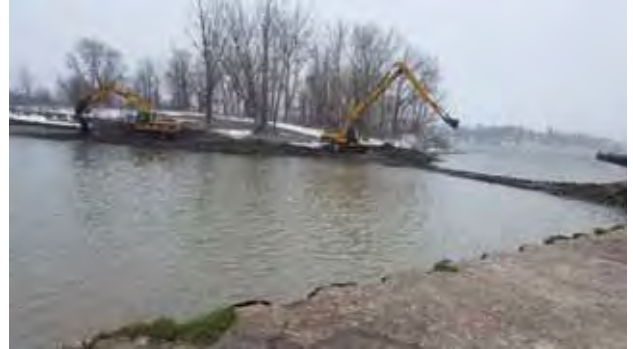
Dredging on April 6, 2016; looking south.  
Note gravel bar across the entire outlet.

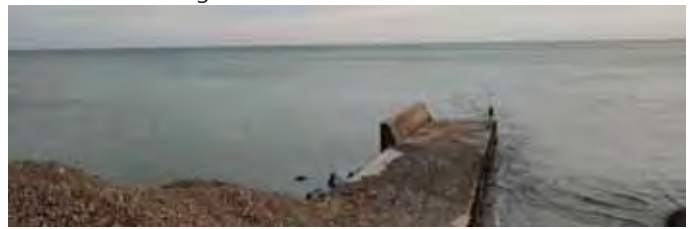
(a) Pile of gravel on the pier next to concrete wall from longshore sediment transport (LST); looking northeast  
(Drone view, Mar. 27, 2018; Photo credit: David Aldrich, PBIA)

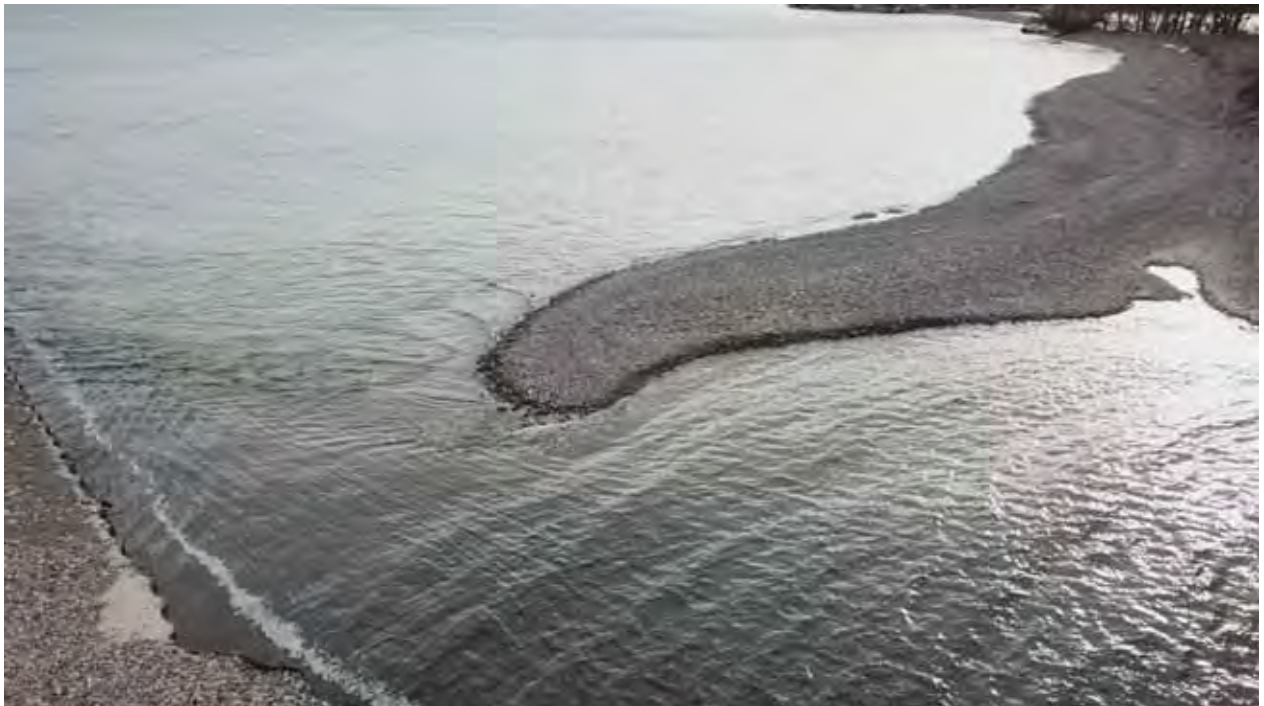
Gravel bar across the outlet; a narrow gap has been created by flow from the bay into the lake; Looking east from pier bend  
(Drone view, March 27, 2018; Photo credit: David Aldrich, PBIA)

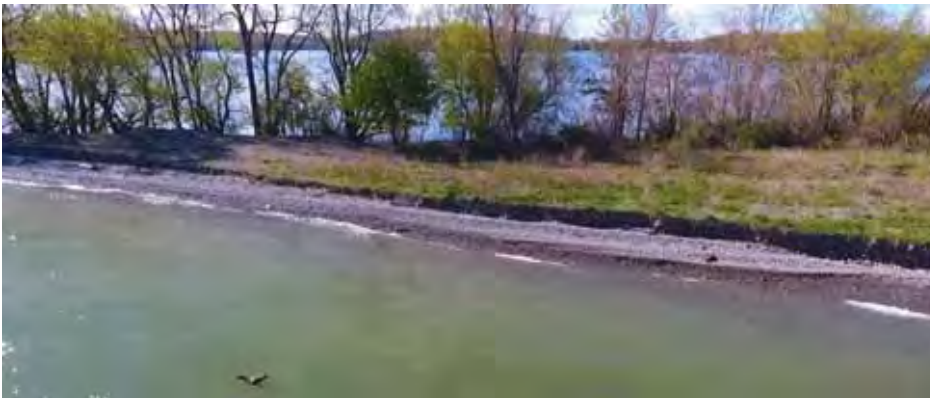
West side of the breach looking south, May 10, 2017 (drone view) (WL~248.6)

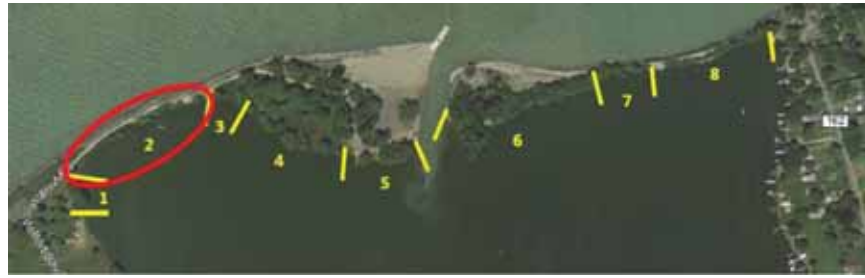
Figure 2.3-5 Littoral Zone Habitat Segment 2 (looking east-northeast from west end)
