FINAL REPORT

New York State Office of General Services

Engineering Report for WA.37 Blind Sodus Bay

February 14, 2020

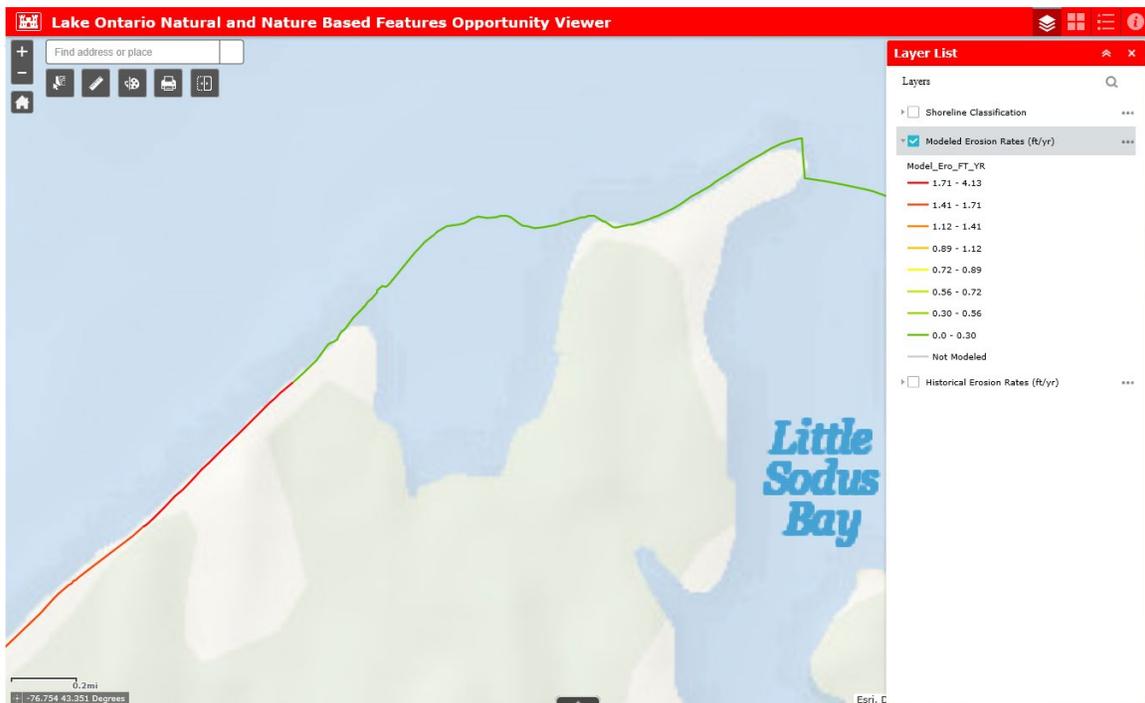
Figure 2-12, obtained from Lake Ontario Natural and Nature Based Features (NNBF) opportunity viewer, indicated significant historical erosion on the bluff side as well as on the bar. The rates are as high as 1.7 ft/year and above for the western half of the project area. Modeled erosion rates, shown in **Figure 2-13**, indicated a loss of less than 1 ft/year, which suggests one portion of this reach has stabilized. A more detailed analysis of shoreline evolution and sediment transport is recommended for the next stage of the design process.

Figure 2-13 Modeled Erosion Rates

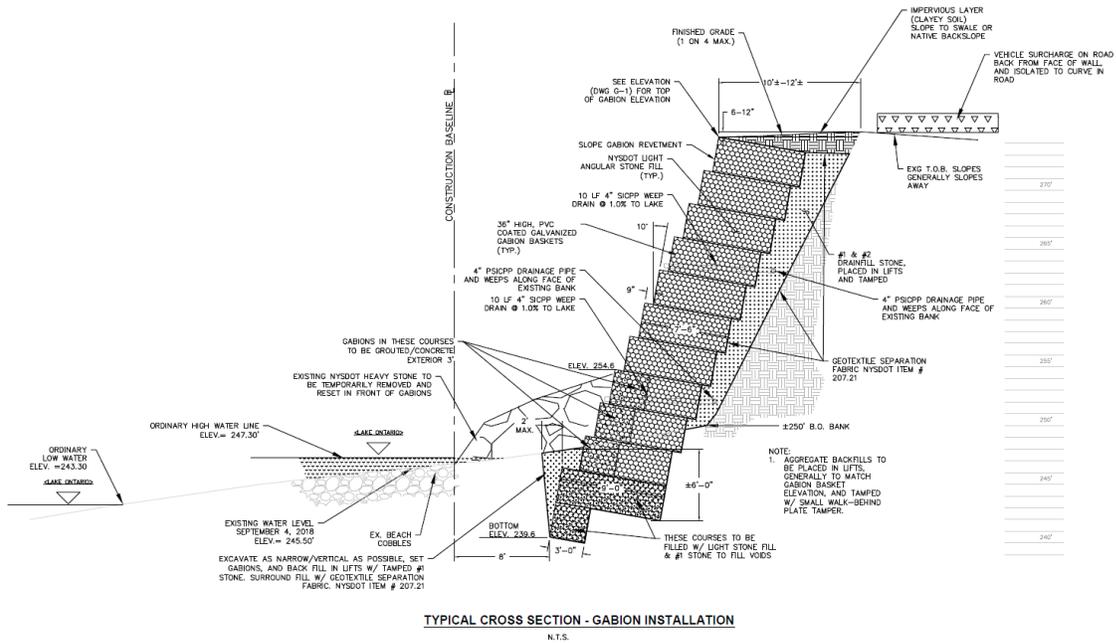
MRB Group completed a design and set of plans for a gabion wall for 260 linear feet of the bluff along the unpaved access road, approximately from STA 5+50 to 8+10. The gabion design is battered at 10 degrees with gabions offset 9 inches from the front face of the underlying basket. The wall is bearing at El. +239.6, which based on the borings is likely top of rock, though no note requiring top of rock to be exposed is shown. Riprap is to be placed and grouted in front of the gabion wall to El. +254.6. See **Figure 4-1** below, Sheet 4 of 5 from the Contract Drawings.

Figure 4-1 Shoreline Repair Detail Sheet – MRB Group

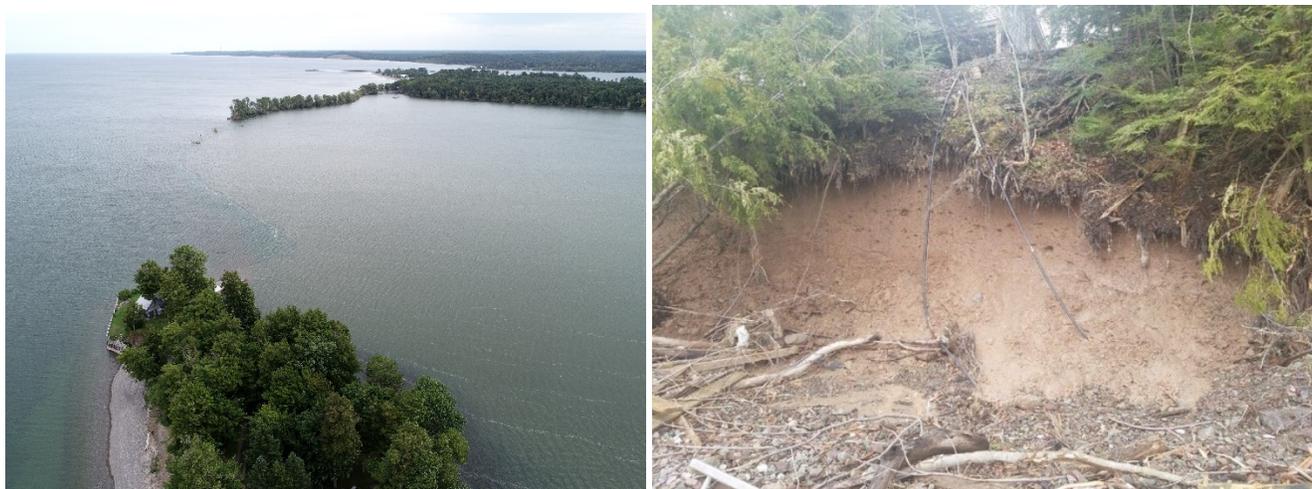
Alternative A, the no action alternative, presented in **Figure 4-6**, shows recent drone aerial image by Ramboll showing the eroded/breached barrier bar. As of the publication date of this report, barrier bar erosion has progressed such that approximately 25% remains visible above water. The combination of high-water levels and lack of ice cover appear facilitate ongoing loss of the barrier. This alternative represents a no additional measures option, and management of the bar continues as it has previously. There will be no future reactive measures, maintenance measures or modifications. Hence, the alternative has no cost implications from construction and maintenance perspective. Adaptive management under this alternative includes ongoing monitoring and maintenance dredging of the channel, though that action may not be needed if the barrier bar does not return naturally.

While the western portion of the barrier bar has been absent, significant erosion has been ongoing in the bay due to wave action (and likely high-water levels; **Figure 4-6**).

Figure 4-6 Alternative A, No Action. The barrier bar used to extend across the entire north end of the bay. The time required for natural recovery of the barrier bar is likely at least three years if not longer (right). During that timeframe the shoreline in the bay will likely be subject to severe erosion (right; image provided by the Wayne County Soil and Water Conservation District).

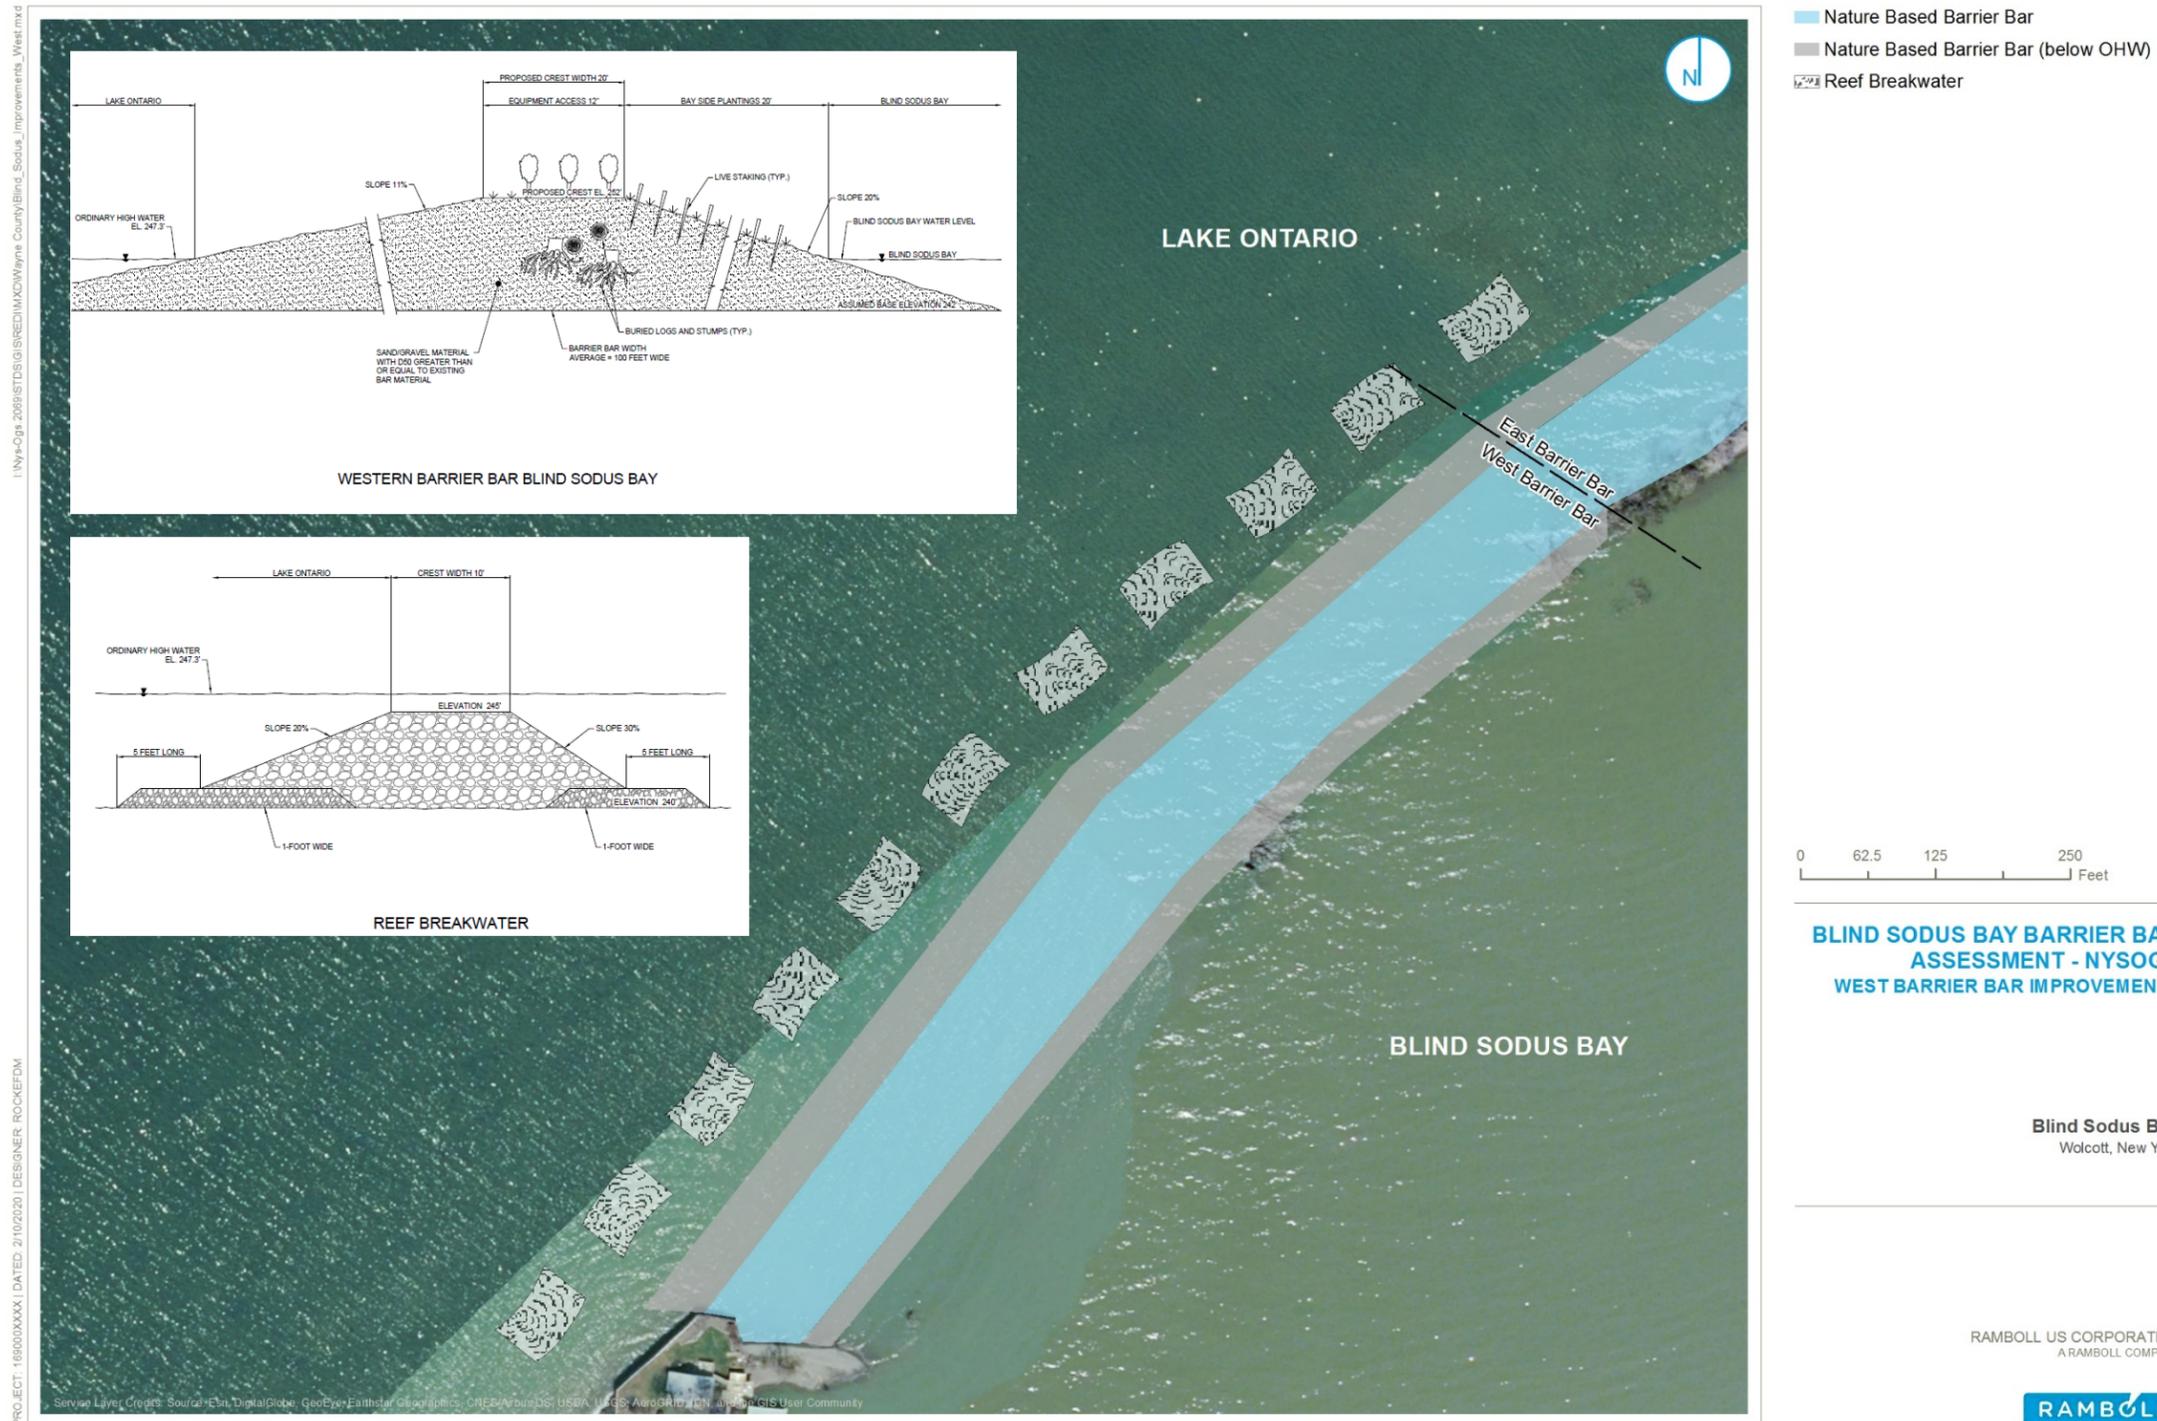
On the western portion of Blind Sodus Bay, the barrier bar will be rebuilt to an elevation of 252 feet (IGLD 85) along approximately 1,820 linear feet and tie into the existing bulkhead located on the western side of the bay. This crest elevation is considered to be the minimum to achieve protectiveness of the bay, given the FEMA AO classification of the barrier bar (Figure 2-8) and to optimize material needs, however consideration of a 254 ft. crest is likely to be warranted in design or as an adaptive management measure. The base of the rebuilt bar will be approximately 160 feet wide which will give the barrier an approximate 20-foot wide crest and slopes ranging from 11% on the north side (lake side) of the bar to 20% on the south side (bay side) of the bar. The gentle slopes and wide base of the bar will help to increase resiliency of the system by encouraging waves to

Figure 4-7 Alternative B – Nature Based Barrier Bar, West Side. This figure also illustrates the reef breakwaters included as Alternative C.

Note that previous accounts have indicated that spiny softshell turtles (*Apalone spinifera*) have historically utilized the western portion of the barrier bar to nest in the sandy substrate (per input from NYSDEC). An additional design alternative for consideration of the western extent could include unvegetated areas supplemented with sandy nesting zones (above ordinary high water, see Figure 4-7) to increase available nesting zone habitat on the bay side of the nature-based barrier bar.
