REVISED FINAL REPORT

New York State Office of General Services

Engineering Report for WA.01 Port Bay

March 18, 2020

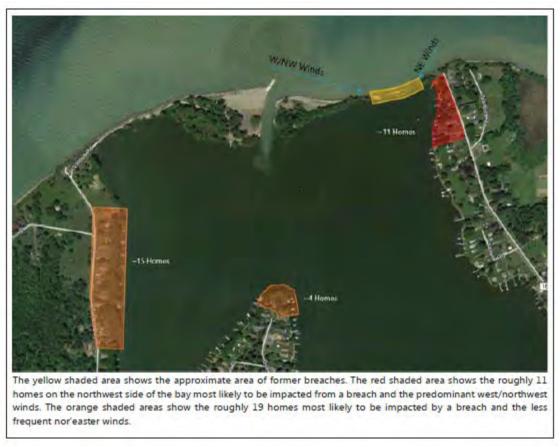
During the 2017 high water and breach, extensive damage occurred to Port Bay and it's 8-miles of shoreline. Damages include but is not limited to repair, failing break walls, erosion behind break walls, structural flooding, damaged to homes, sheds, and garages (Bergmann 2019). During breach events, the homes along the northeastern and northwestern sides of the bay are most likely to be impacted from a breach **(Figure 4-6)**. Strengthening the barrier bar will help to reduce risks to Port Bay and its residents along the shoreline from future damage. It is important to note that high water alone may cause future damage regardless of the wave attenuation value of the barrier bar.

Figure 4-6 Homes Likely to be Damaged During a Breach Event (Bergmann 2019)

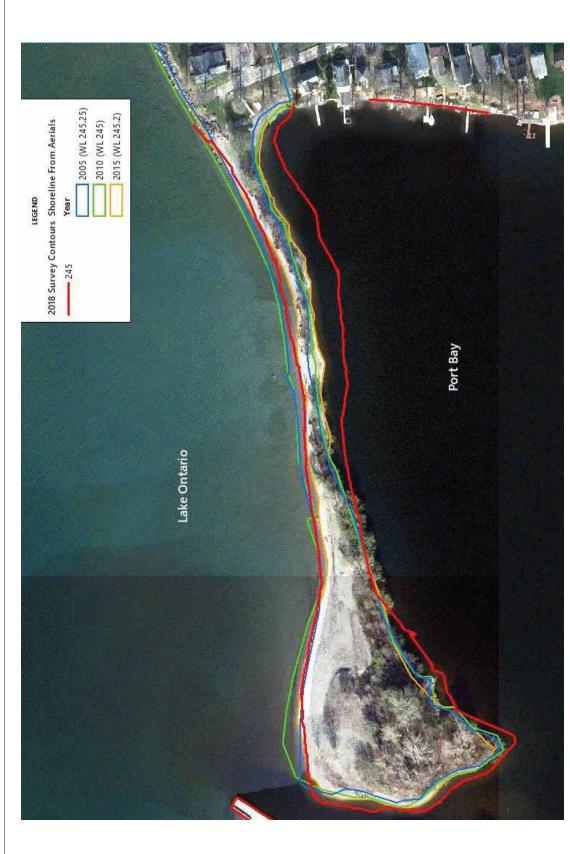
Overall Erosion and Recession of the Lake Side of the East Barrier Bar, 2005-2018 Figure 2.1-2

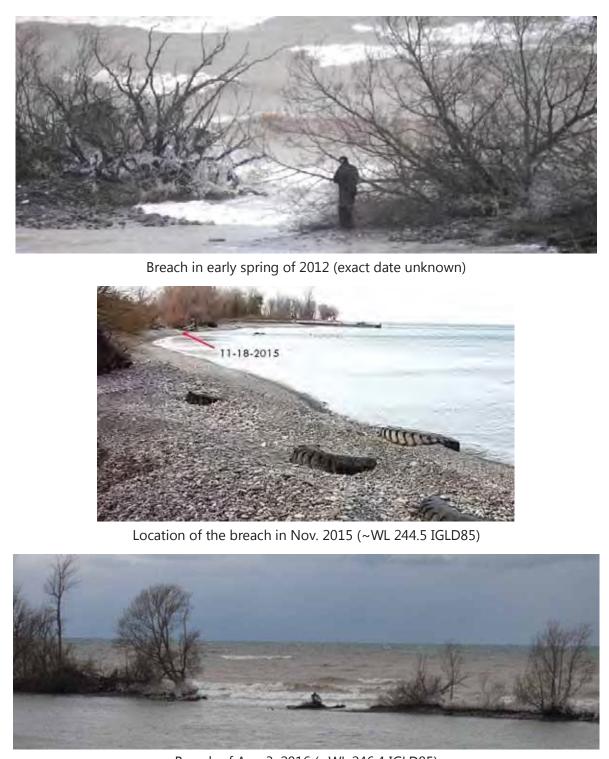
Breach of Apr. 3, 2016 (~WL 246.4 IGLD85)

Figure 2.1-6 East Barrier Bar Breach, April 2016

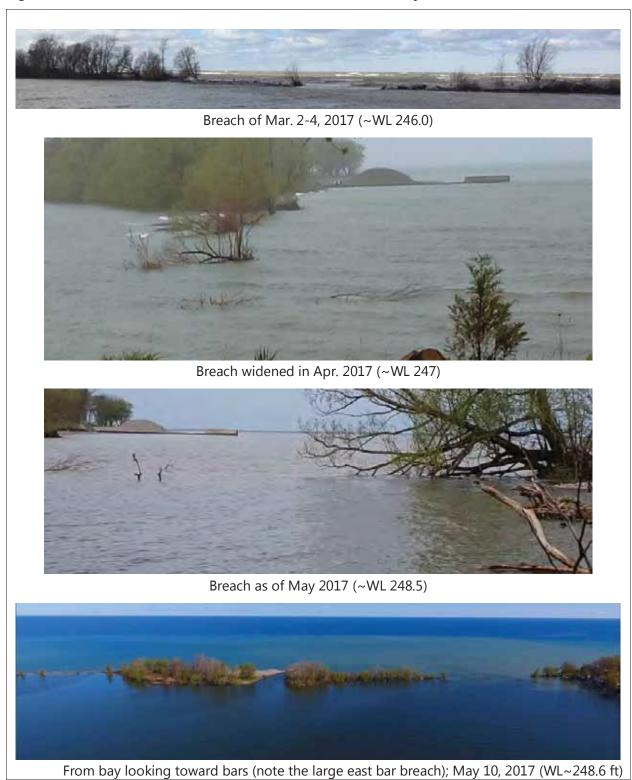
Figure 2.1-7 East Barrier Bar Breach 2017 (viewed Mar. – May 2017)

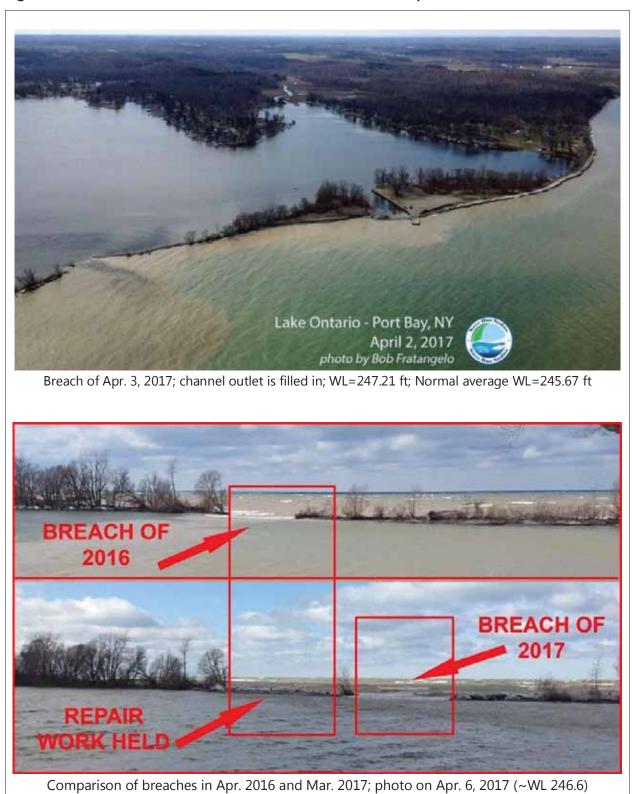
Figure 2.1-10 East Barrier Bar Breaches of 2017 and 2016 Compared

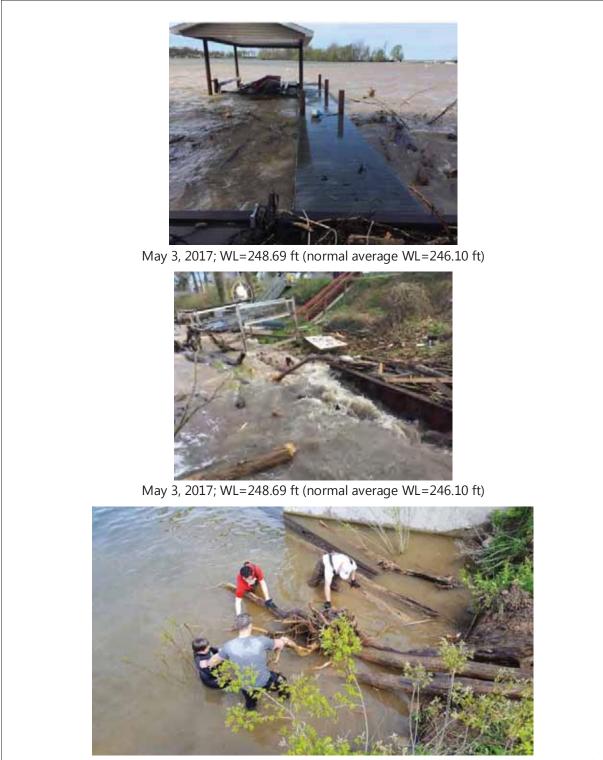
Logs & debris swept into the bay; May 29, 2017; WL=248.72 ft (normal average WL=246.23 ft)

Figure 2.1-14 Survey Comparison of Bar Changes During 2017 Breach

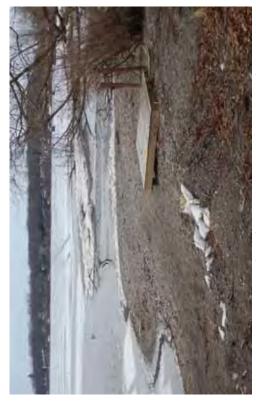
Figure 2.1-15 East Barrier Bar Breach of 2017 and Its Natural Repair (viewed Feb. – Apr. 2018)

Looking east (some flow from the bay to the lake; left to right)

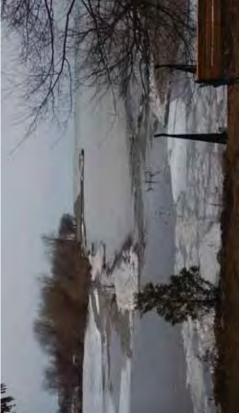
Looking west (notice the pier and Spoil #2)

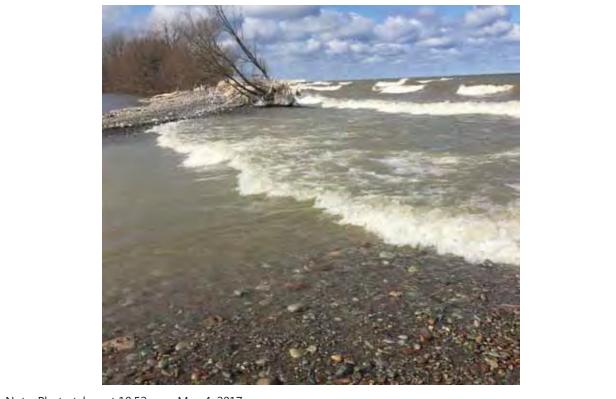
Figure 2.1-35 Wave Field in a Fairly Rough Lake Near East Barrier Bar Breach, Mar. 4, 2017

Note: Photo taken at 10:52 a.m., Mar. 4, 2017

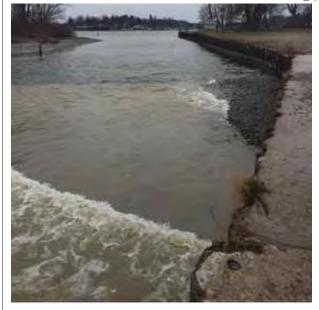
Waves from the lake to the bay through the 70-ft opening in the east barrier bar on Sunday Apr. 3, 2016

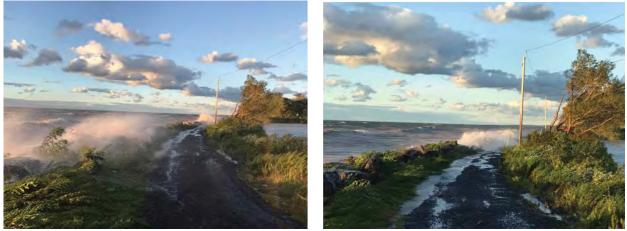
Wave action on the west barrier bar in early Aug. 2017; looking east; bay is on the right (~WL 247.8)

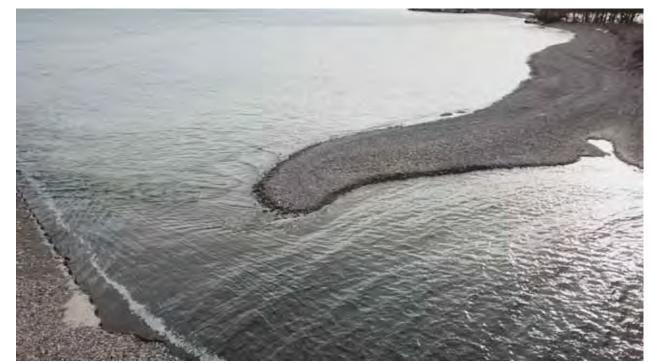
Gravel bar across the outlet; a narrow gap has been created by flow from the bay into the lake; Looking east from pier bend (Drone view, March 27, 2018; Photo credit: David Aldrich, PBIA)

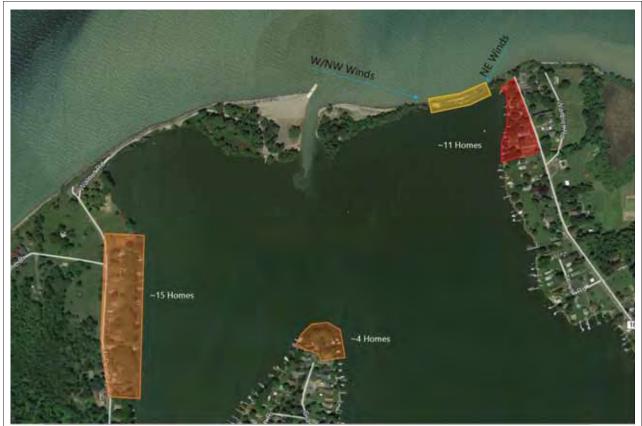
Figure 2.2-7 Estimate of Homes With Highest Likelihood of Damage During Breach Event

The yellow shaded area shows the approximate area of former breaches. The red shaded area shows the roughly 11 homes on the northwest side of the bay most likely to be impacted from a breach and the predominant west/northwest winds. The orange shaded areas show the roughly 19 homes most likely to be impacted by a breach and the less frequent nor'easter winds.
