REVISED FINAL REPORT

New York State Office of General Services

# Engineering Report for WA.01 Port Bay

March 18, 2020

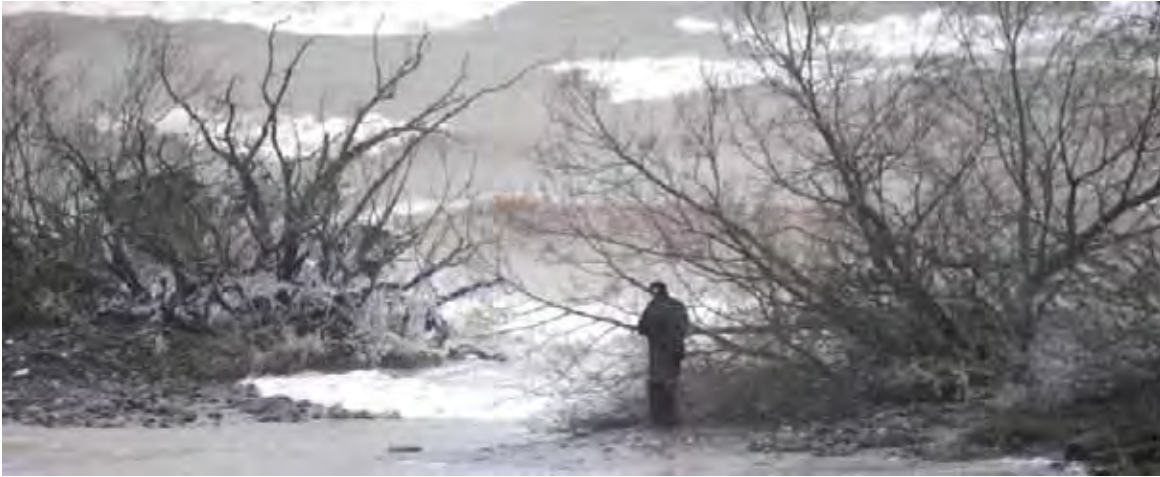
Figure 2.1-5 East Barrier Bar Breaches, 2012 and 2016

Breach in early spring of 2012 (exact date unknown)

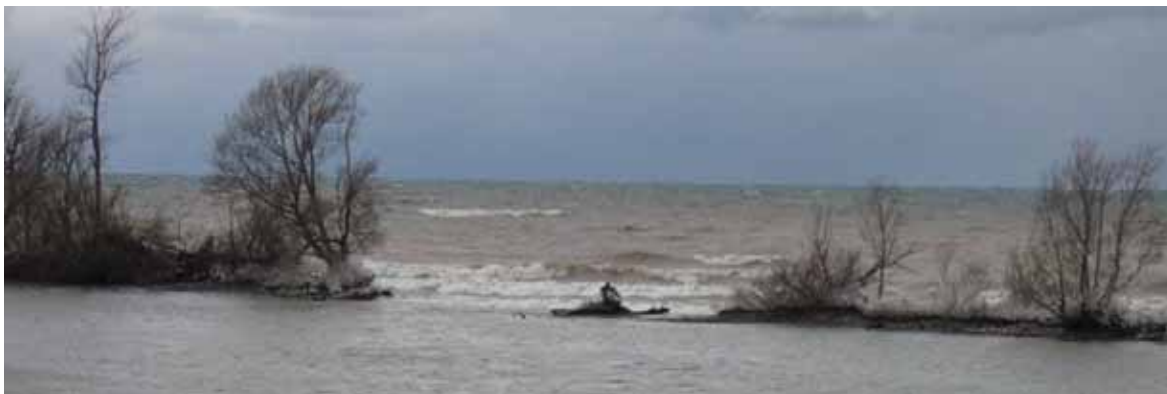
Breach of Apr. 3, 2016 (~WL 246.4 IGLD85)

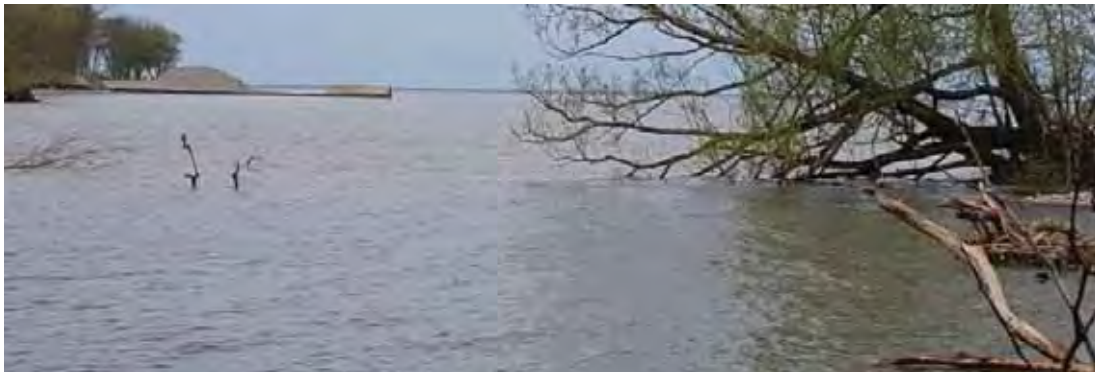
Breach as of May 2017 (~WL 248.5)

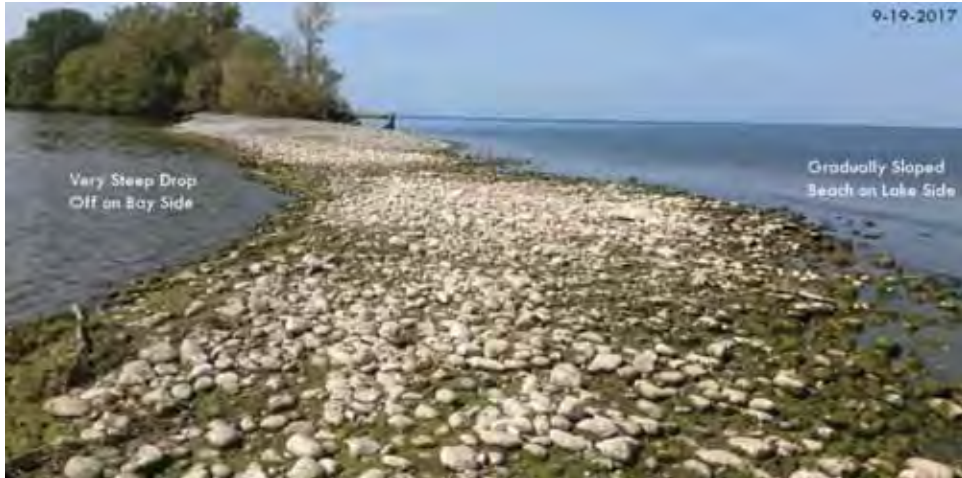
On the east barrier bar looking west, Sep. 19, 2017 (~WL 246.2)

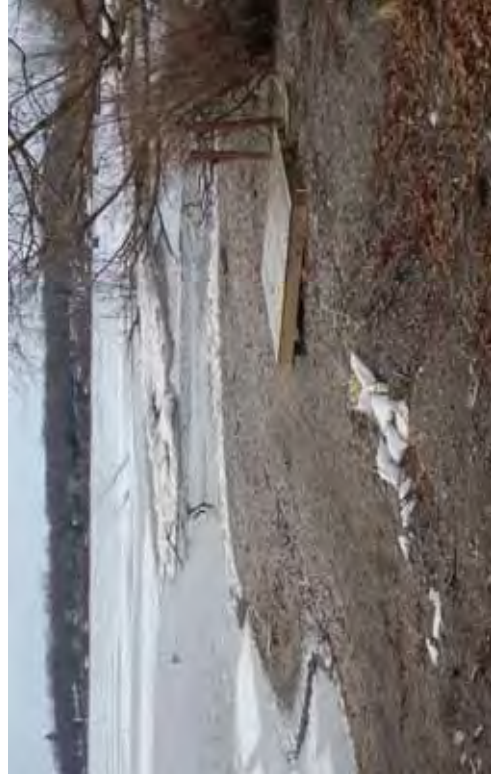
Looking east (some flow from the bay to the lake; left to right)

Above: Views of the breach of 2017 on the site visit of Feb. 17, 2018 (~WL 245.6)

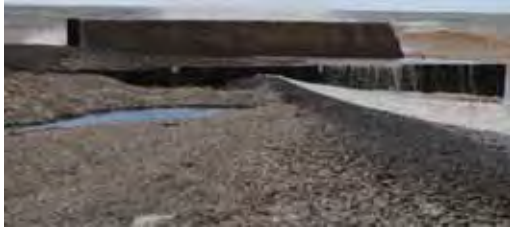
Fill in navigation channel outlet

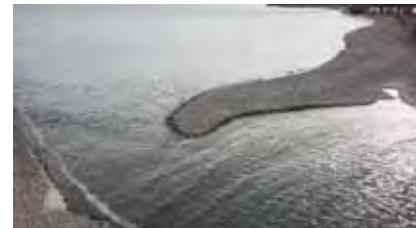
Deposition at the channel outlet to be dredged; looking east

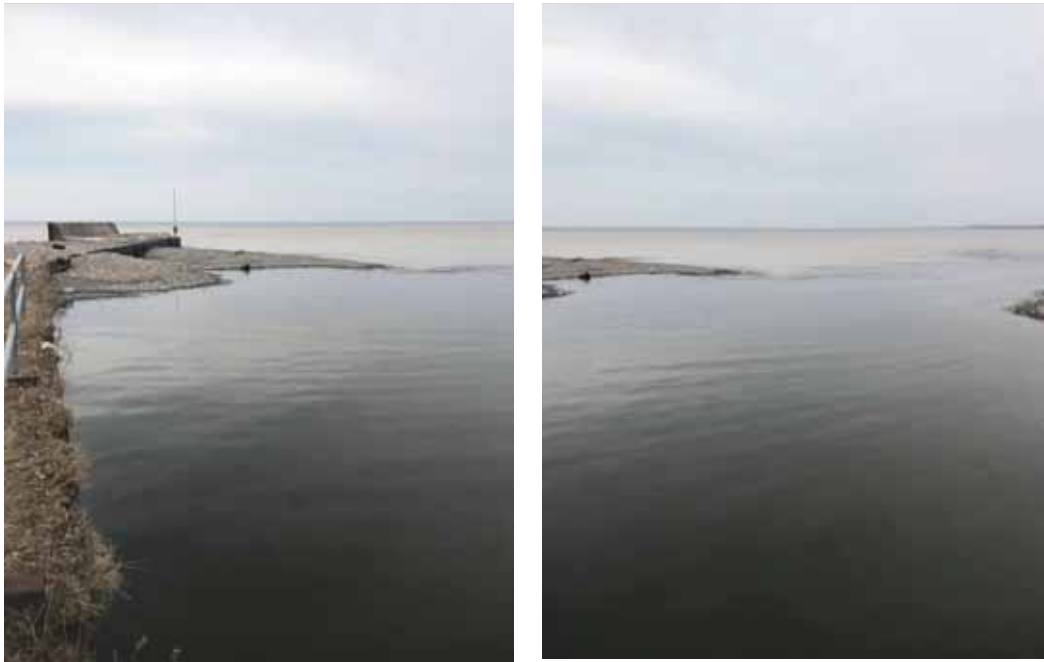
Figure 2.1-19 Sediment Deposition at the Channel Outlet as Viewed on March 24, 2019

During the development of this report, the PBIA conducted the annual channel outlet dredging on March 28, 2019. The estimated quantity of dredging in 2019 was 2,500 to 3,000 CY. **Figure 2.1-19** shows the condition of the channel just prior to dredging.

(a) Looking north towards the lake through the channel outlet

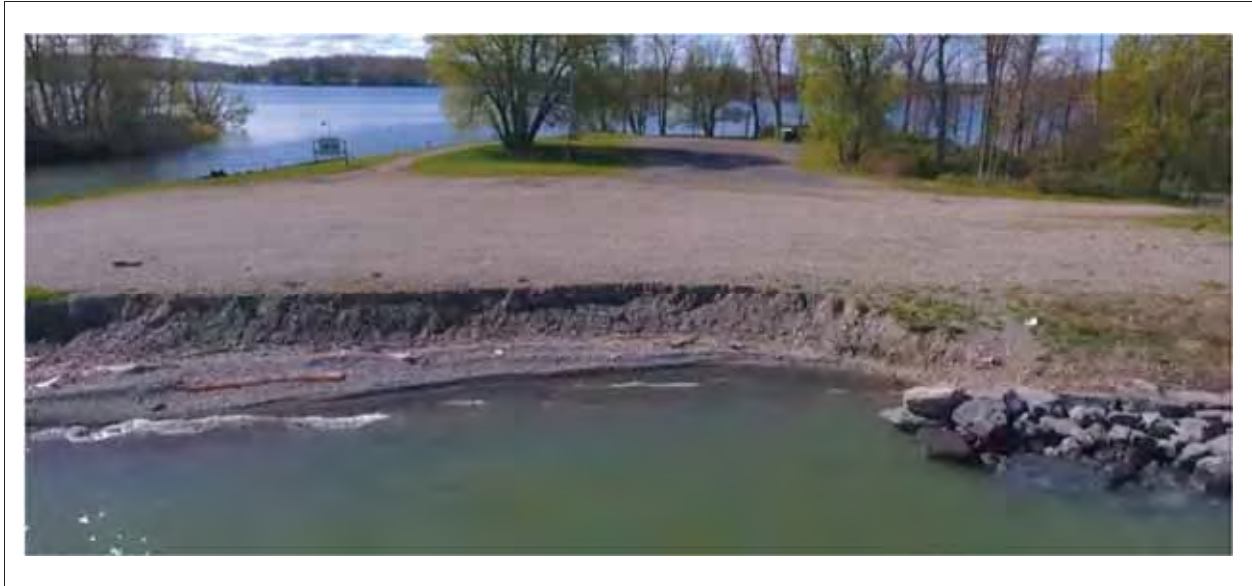
Figure 2.1-34 Wave-Induced Bank Erosion West of the Pier, May 10, 2017 (drone view)

Unprotected shoreline gap west of the pier. The cyclic erosion of the unprotected gap between the pier and the existing rock revetment on the west of the pier seems to be regularly and naturally filled up by LST during storm seasons. No repair of this gap using hard structures seems to be necessary.

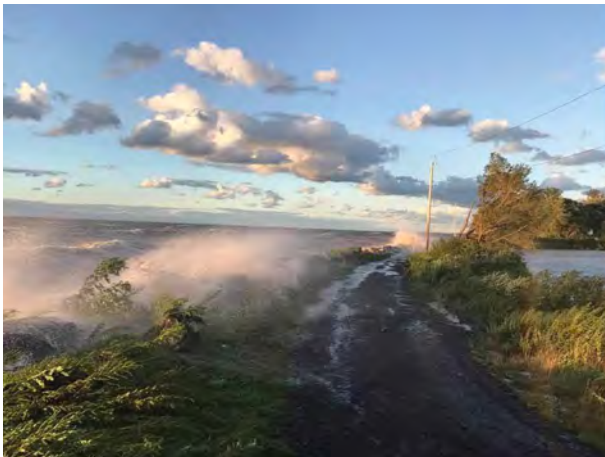
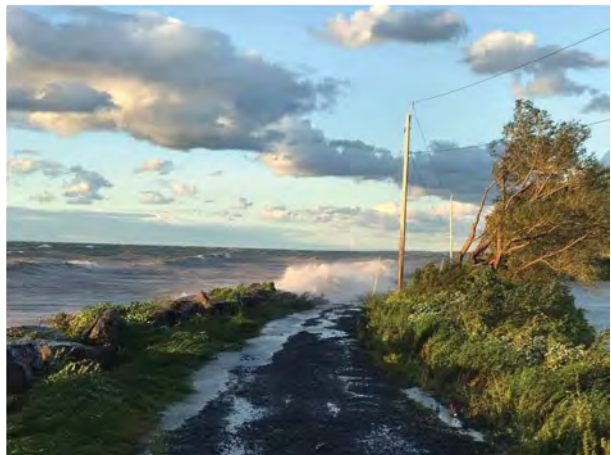
Wave action on the west barrier bar in early Aug. 2017; looking east; bay is on the right (~WL 247.8)

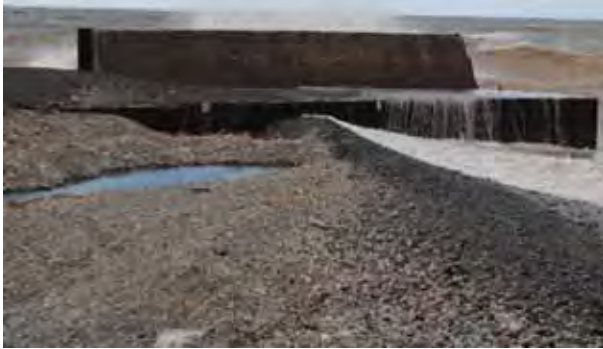
Figure 2.1-45 Sediment Transport and Deposition Along and Across the Outlet of the Navigation Channel

Filled-in navigation channel outlet; looking northwest.  
Note gravel on the pier.

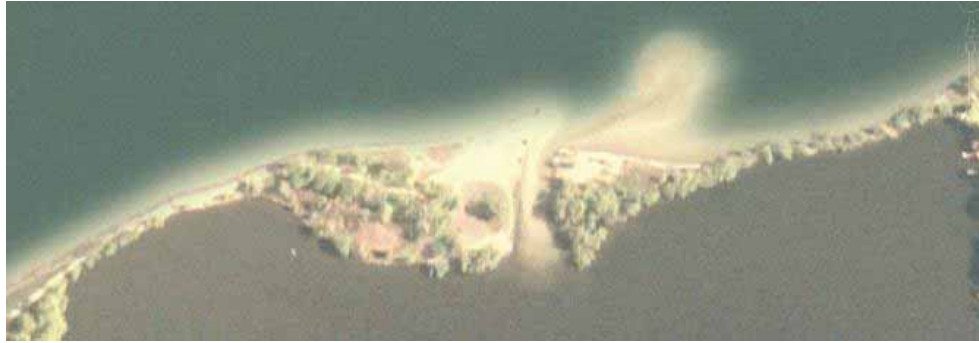
Deflection of LST due to the pier and channel flow, Oct. 11, 2008

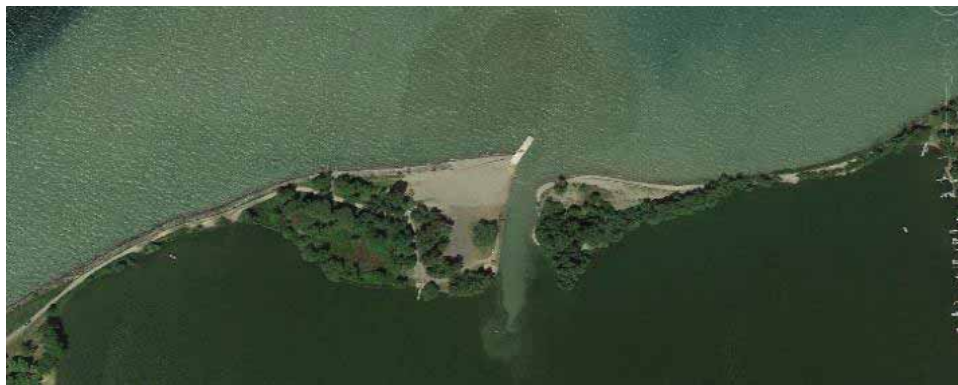
"Mud plume" into channel and near outlet,  
Jul. 15, 2015

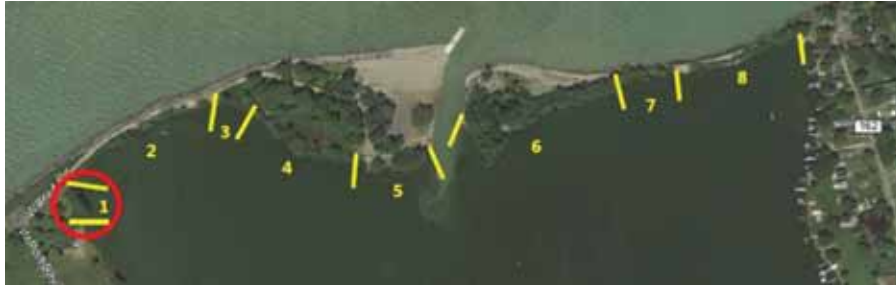
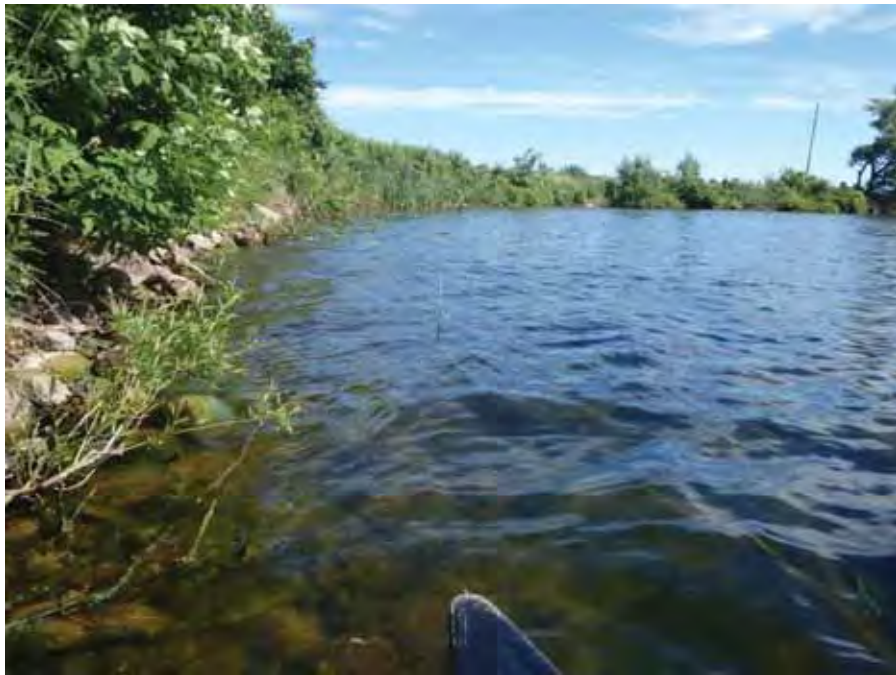
Figure 2.3-3 Littoral Zone Habitat Segment 1 (looking north from south end)

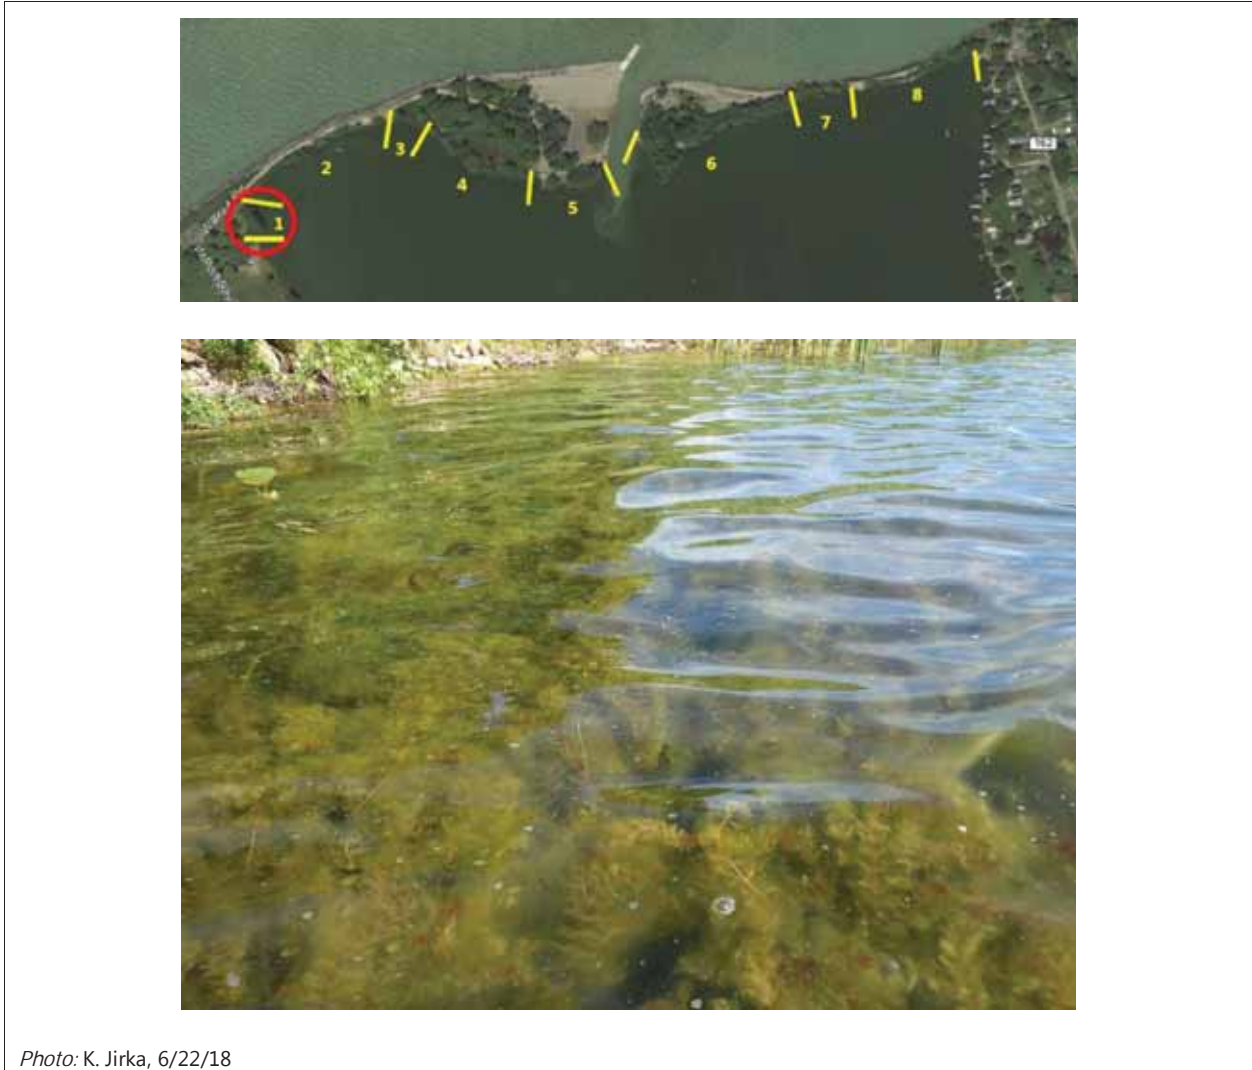
Figure 2.3-4 Littoral Zone Habitat Segment 1 Dense Macrophyte Growth

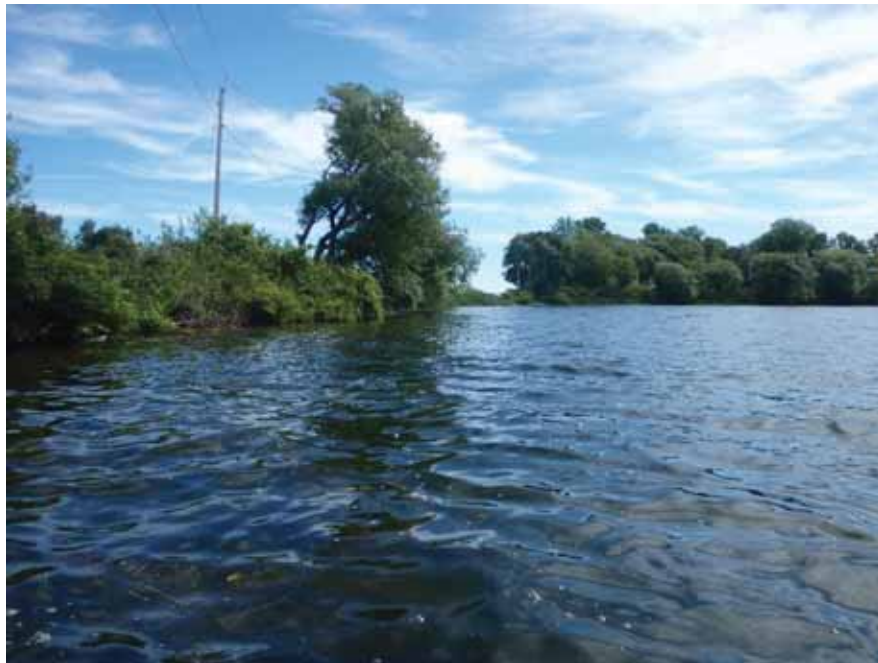
Figure 2.3-5 Littoral Zone Habitat Segment 2 (looking east-northeast from west end)

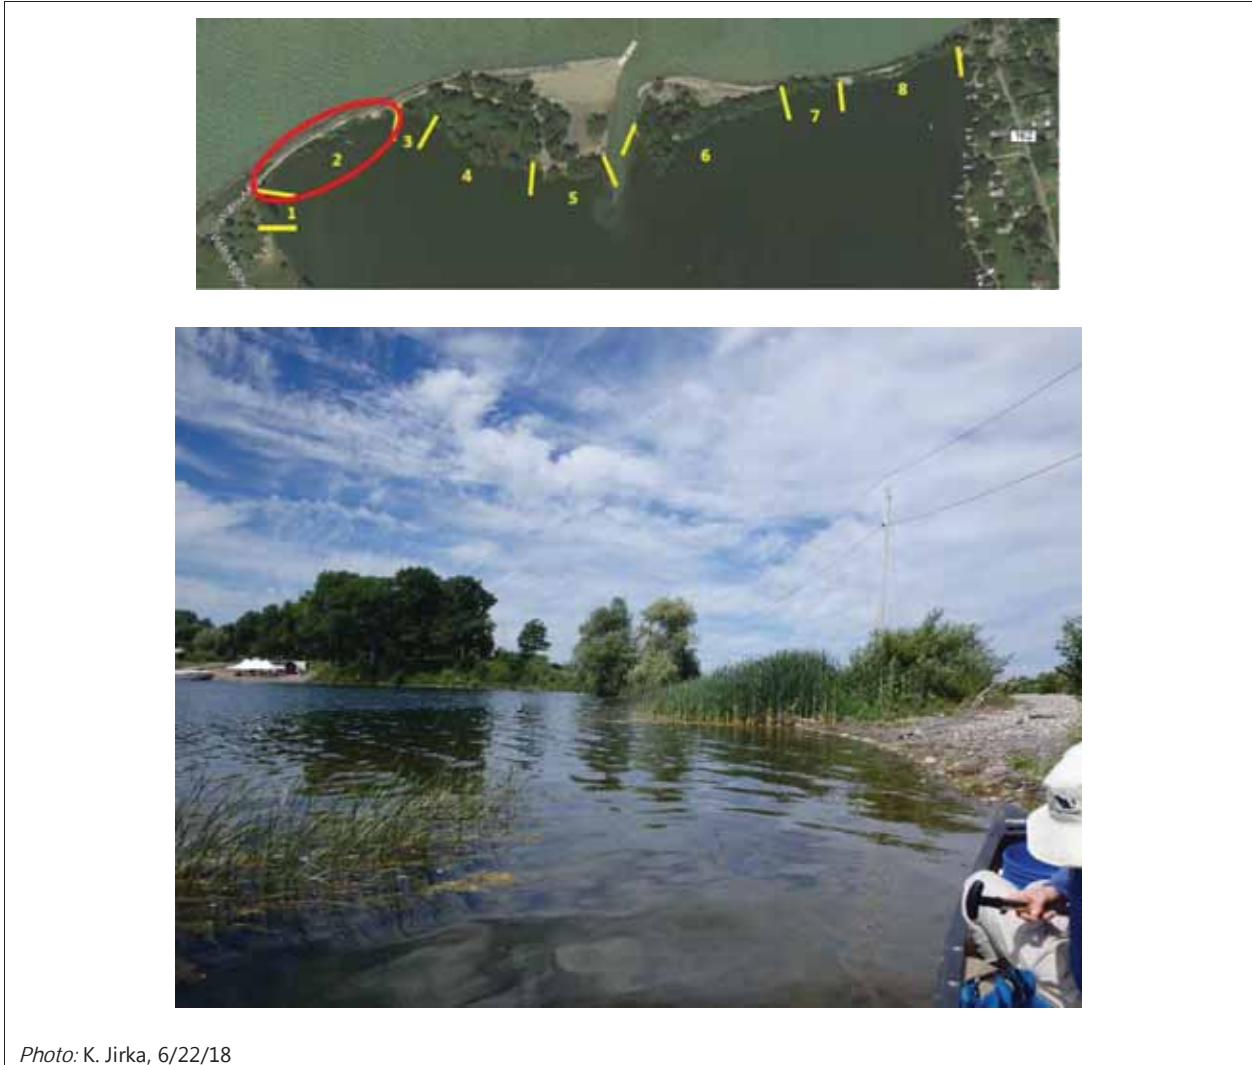
Figure 2.3-6 Littoral Zone Habitat Segment 2 (looking west-southwest from east end)

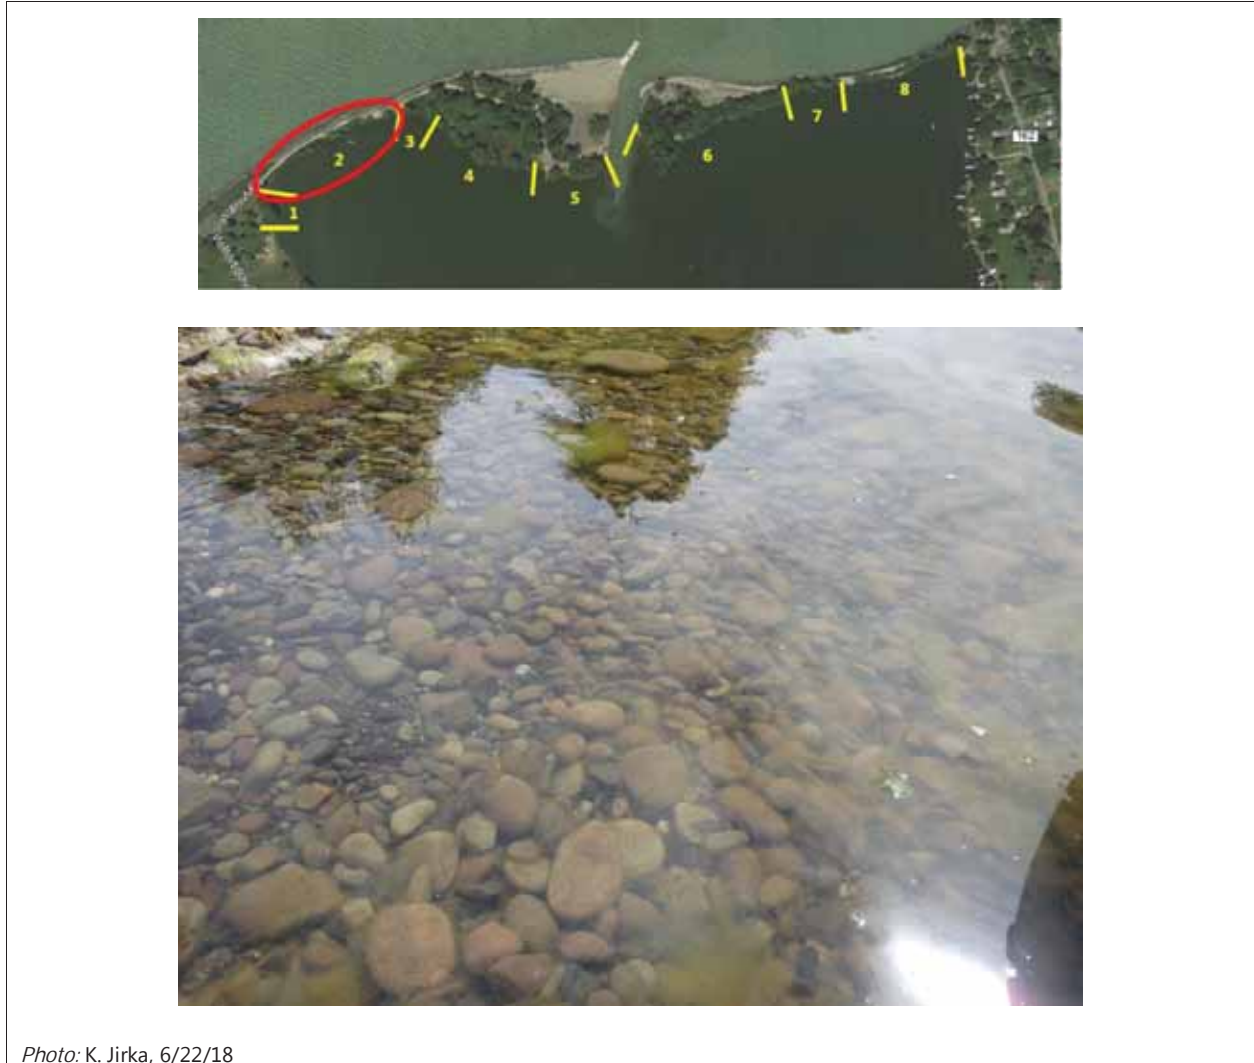
Figure 2.3-7 Littoral Zone Habitat Segment 2 Nearshore Gravel Substrate

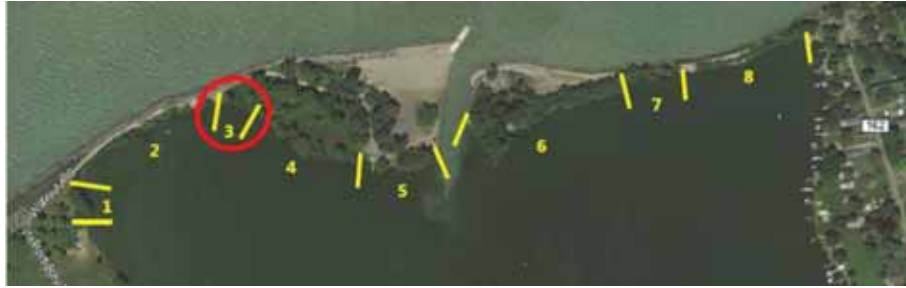
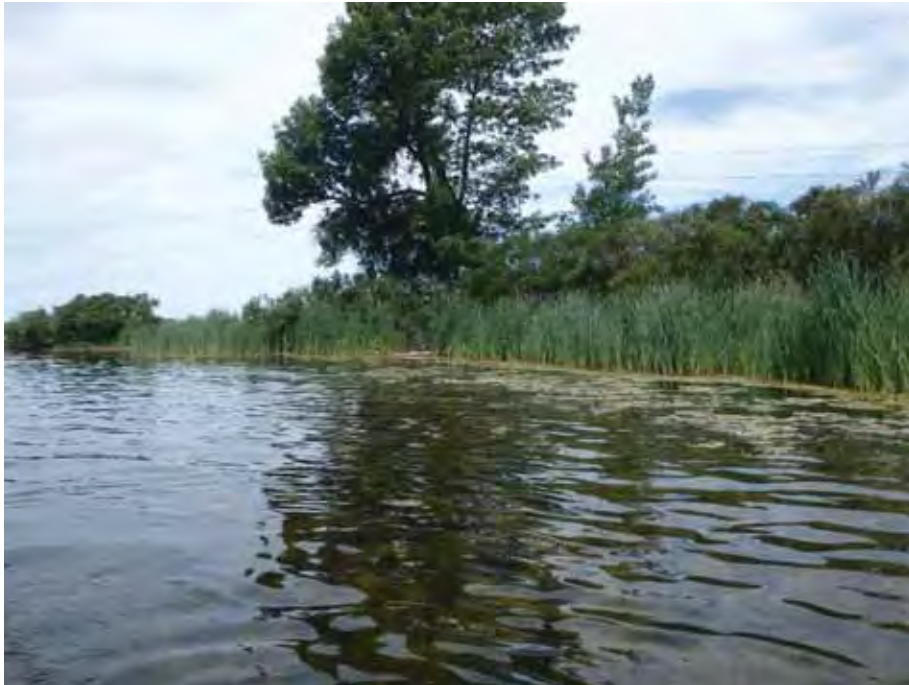
Figure 2.3-8 Littoral Zone Habitat Segment 3 (looking northwest from east end)

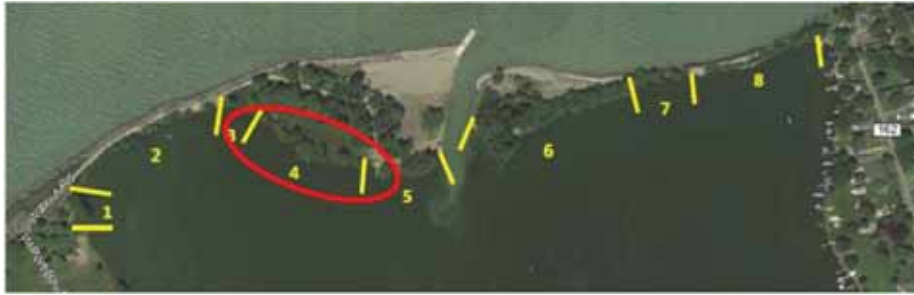
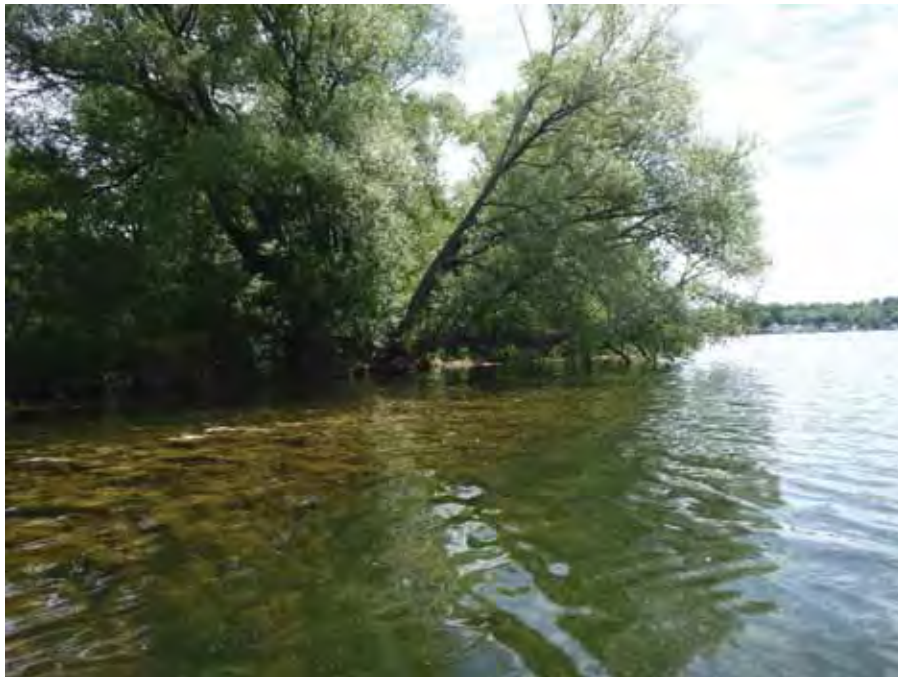
Figure 2.3-9 Littoral Zone Habitat Segment 4 (looking east from west end)

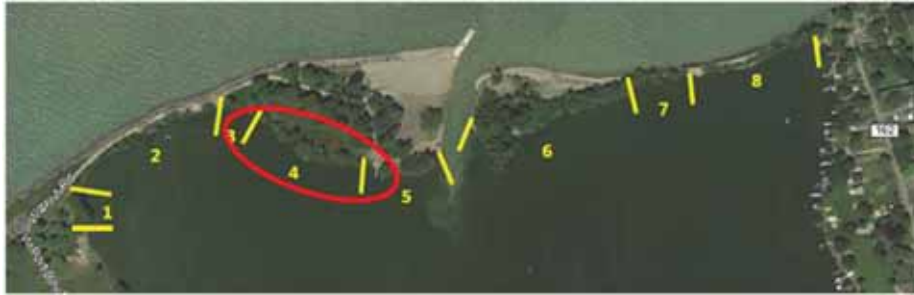
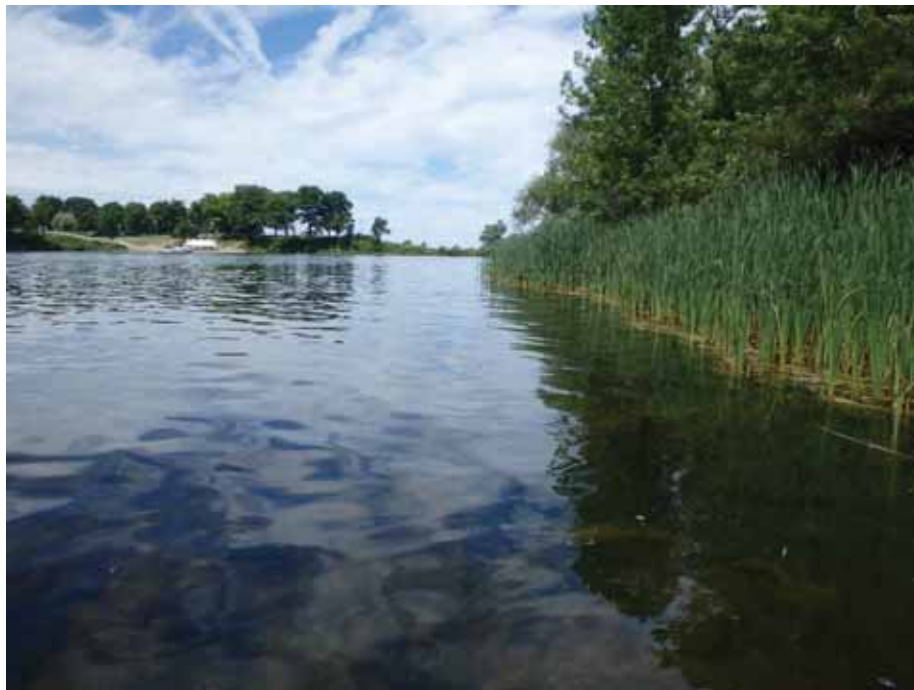
Figure 2.3-10 Littoral Zone Habitat Segment 4 (looking west from east end)

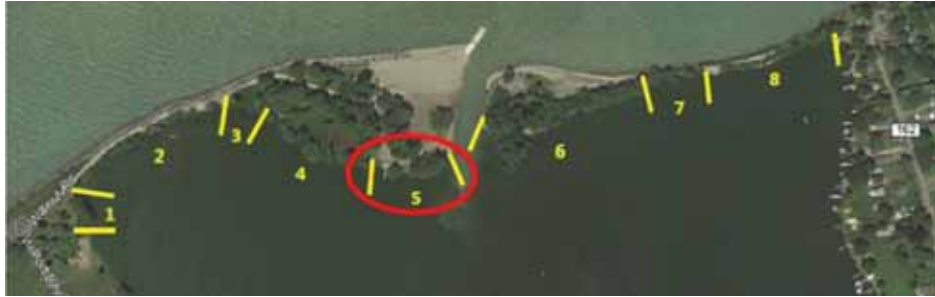
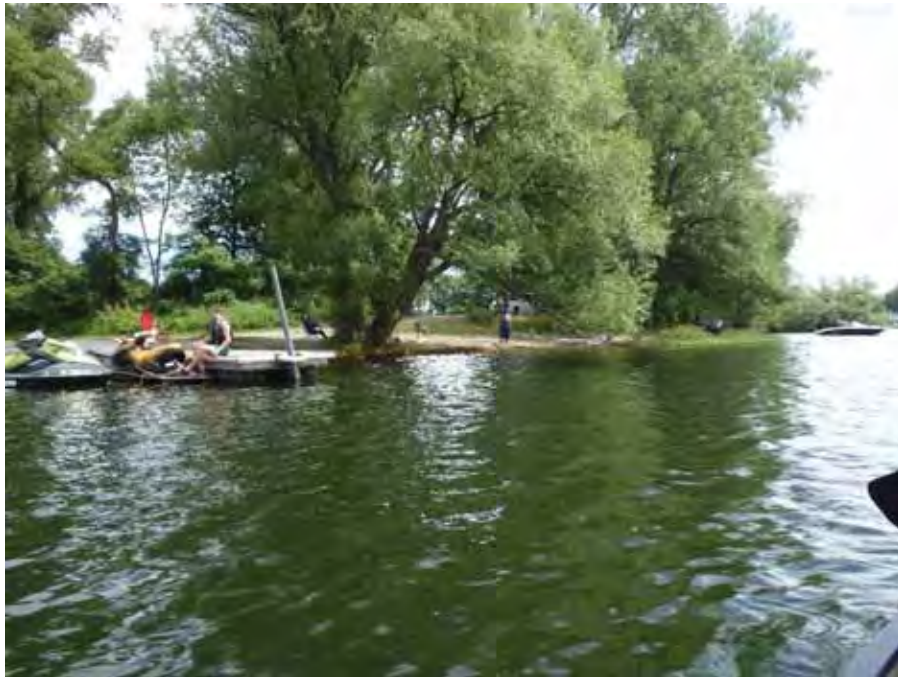
Figure 2.3-11 Littoral Zone Habitat Segment 5 (looking east from west end)

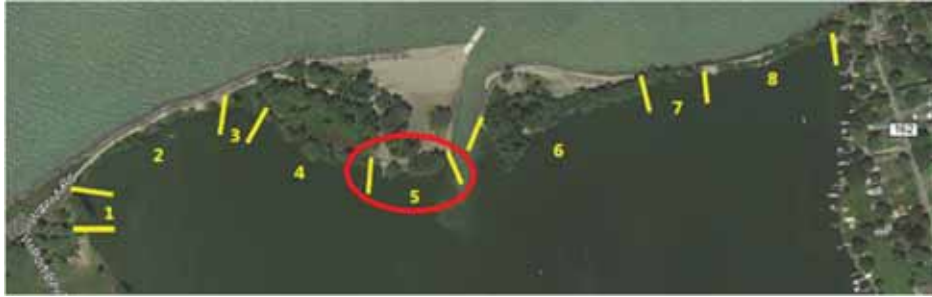
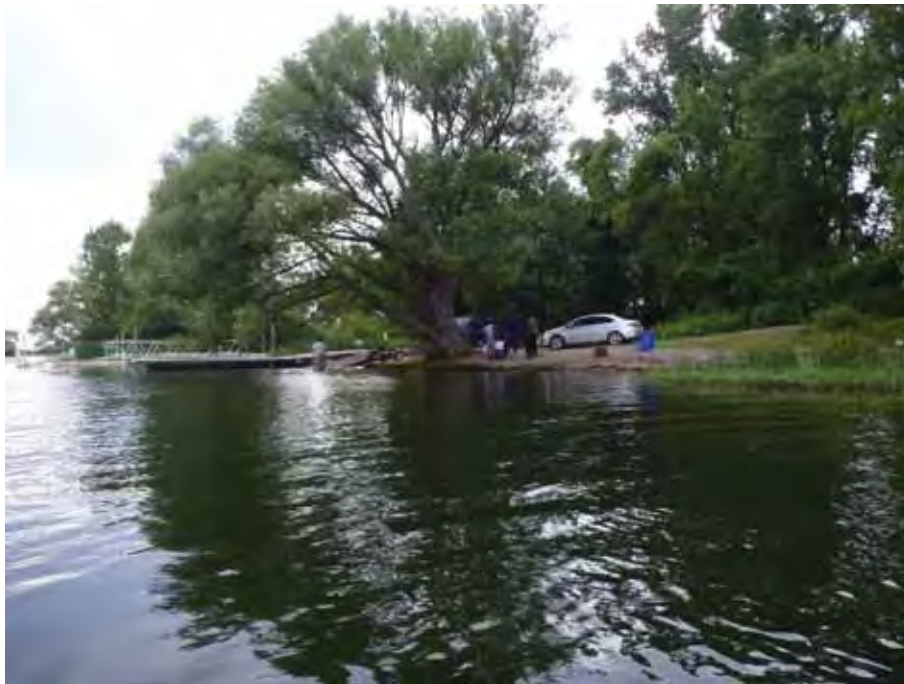
Figure 2.3-12 Littoral Zone Habitat Segment 5 (view toward west end from near midpoint)

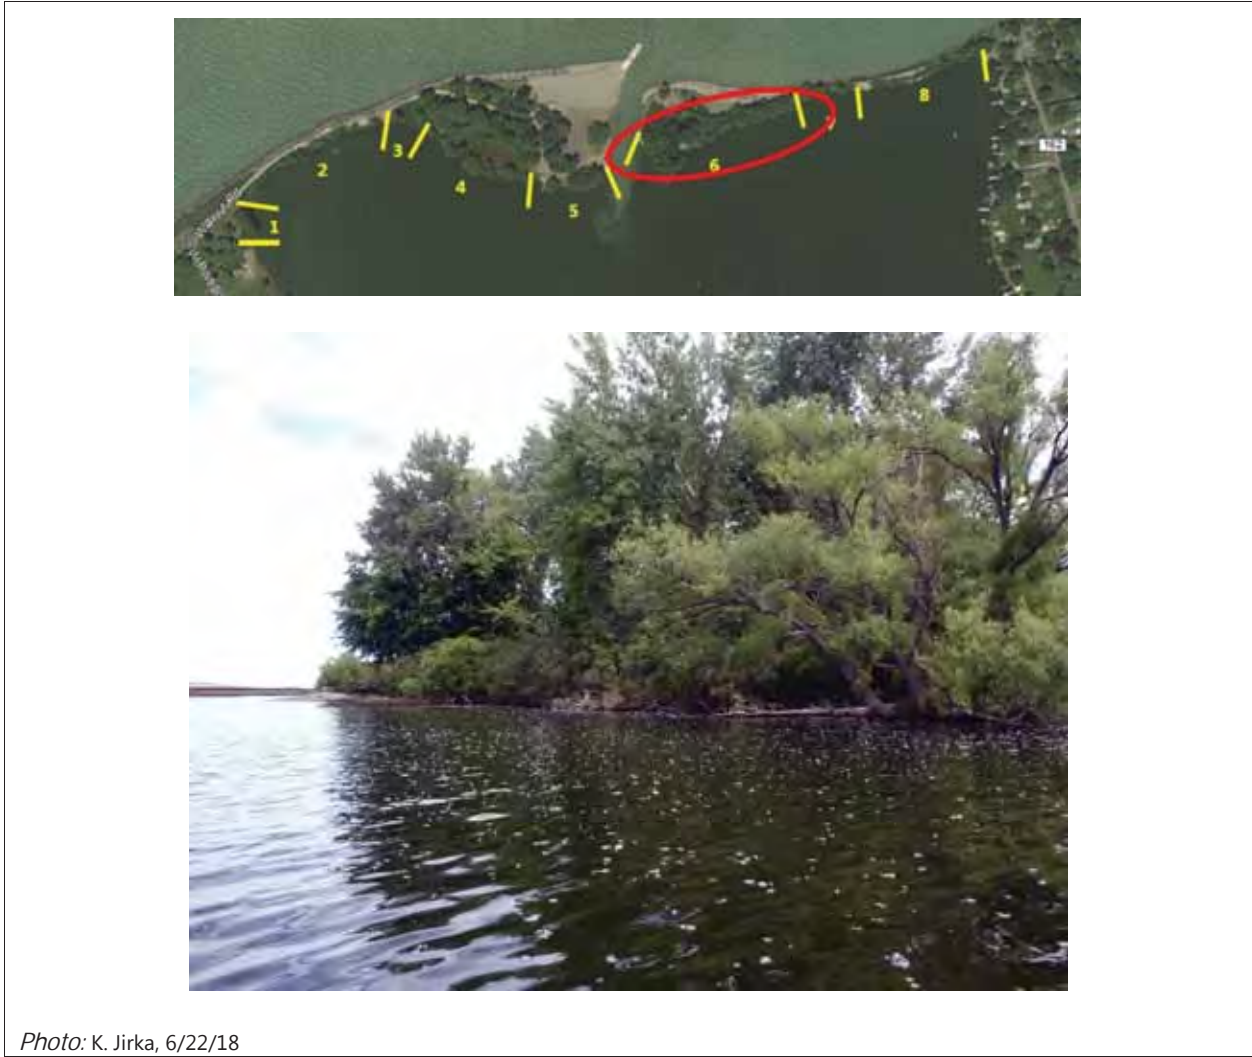
Figure 2.3-13 Littoral Zone Habitat Segment 6 (looking north-northwest at west end)

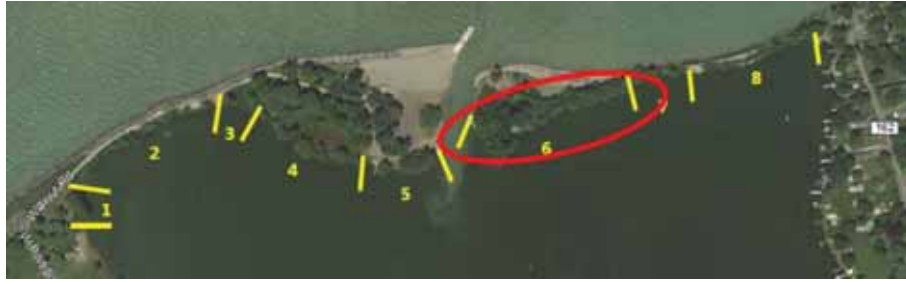
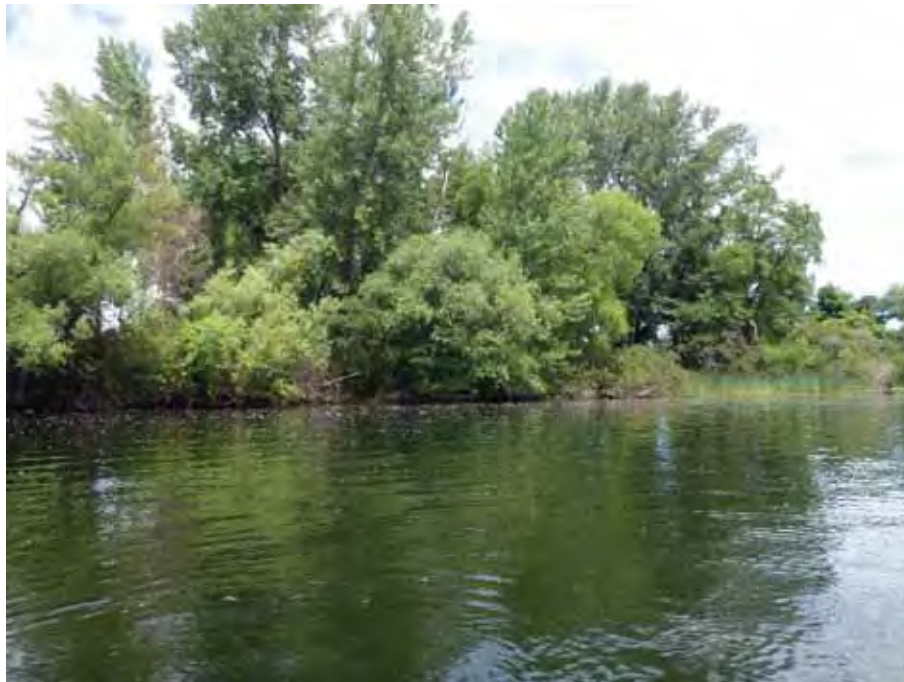
Figure 2.3-14 Littoral Zone Habitat Segment 6 (looking north-northeast at west end)

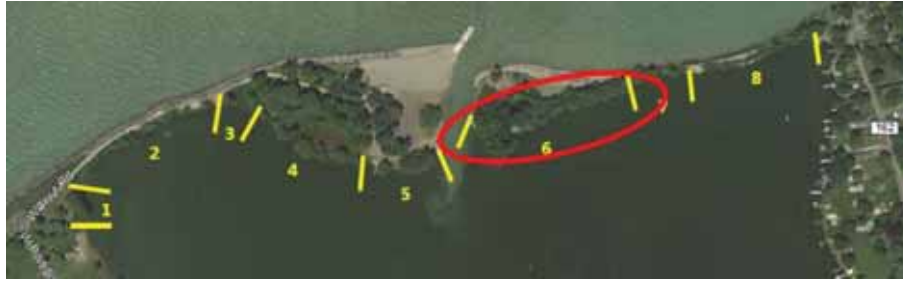
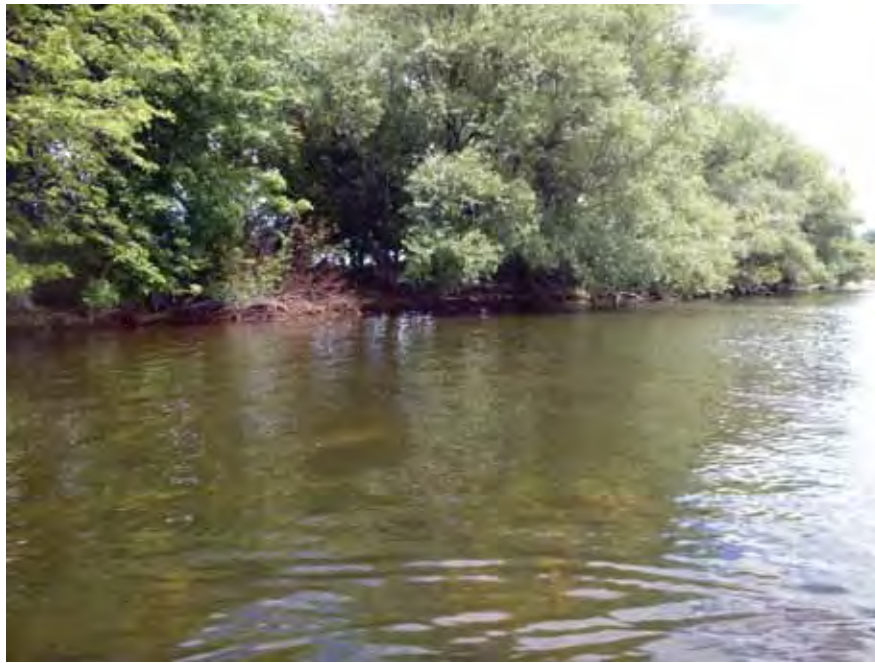
Figure 2.3-15 Littoral Zone Habitat Segment 6 (looking east from midpoint)

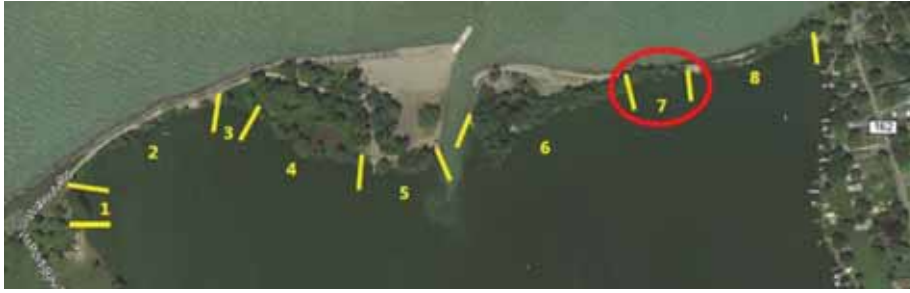
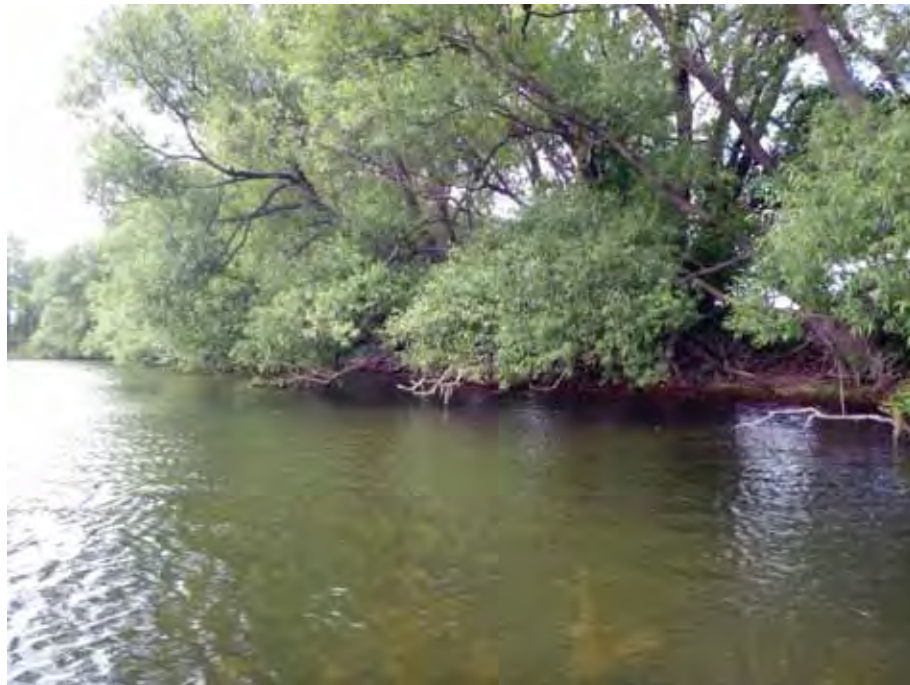
Figure 2.3-16 Littoral Zone Habitat Segment 7 (looking west from midpoint)

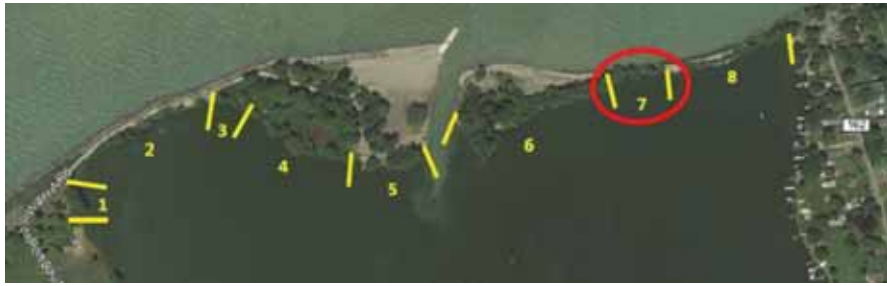
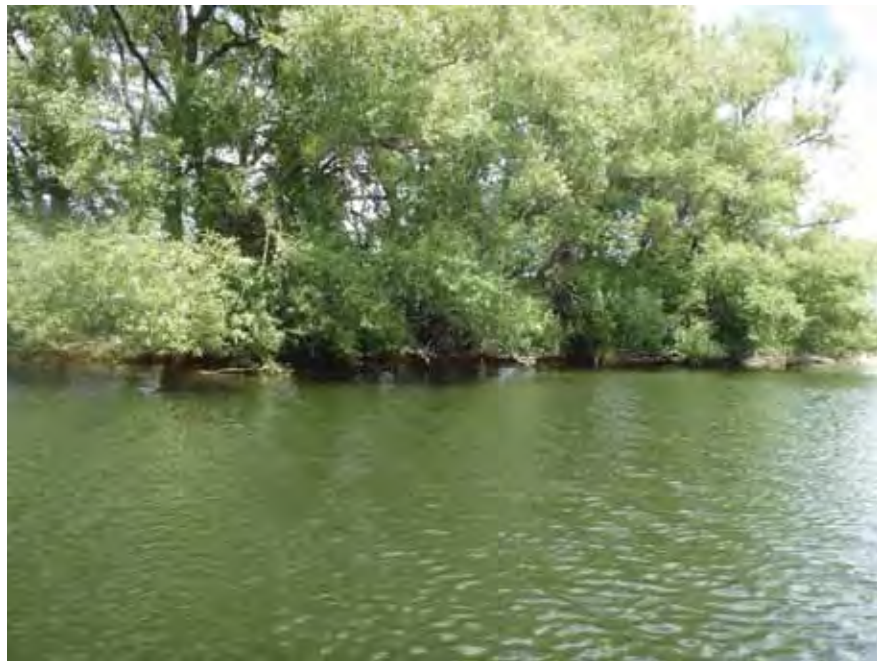
Figure 2.3-17 Littoral Zone Habitat Segment 7 (view toward east end from midpoint)

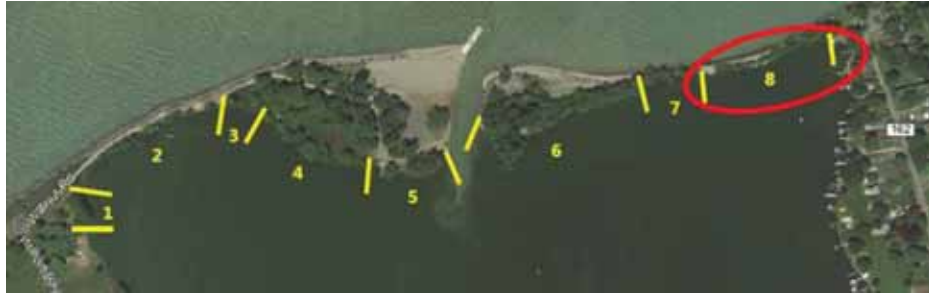
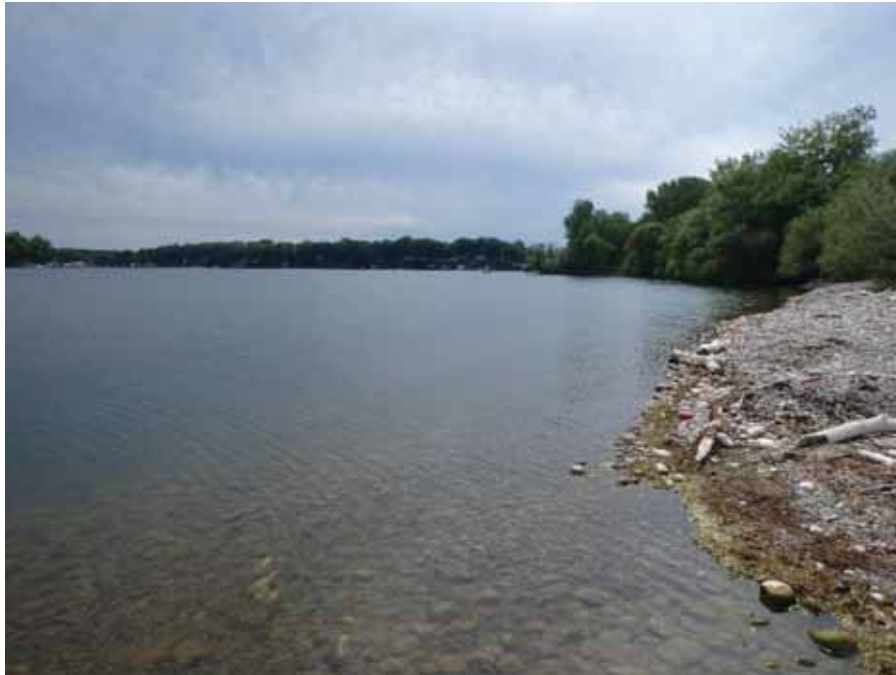
Figure 2.3-18 Littoral Zone Habitat Segment 8 (looking west from near midpoint)

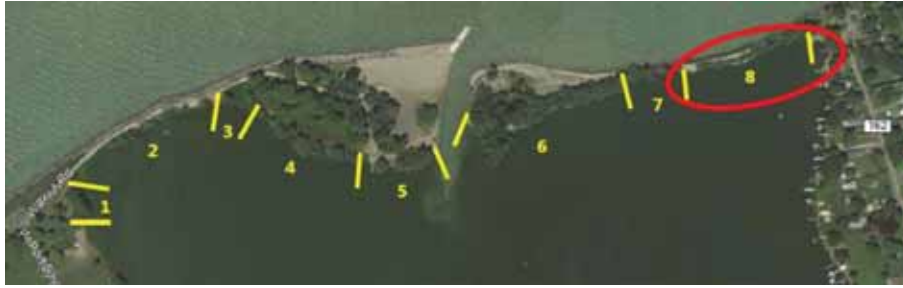
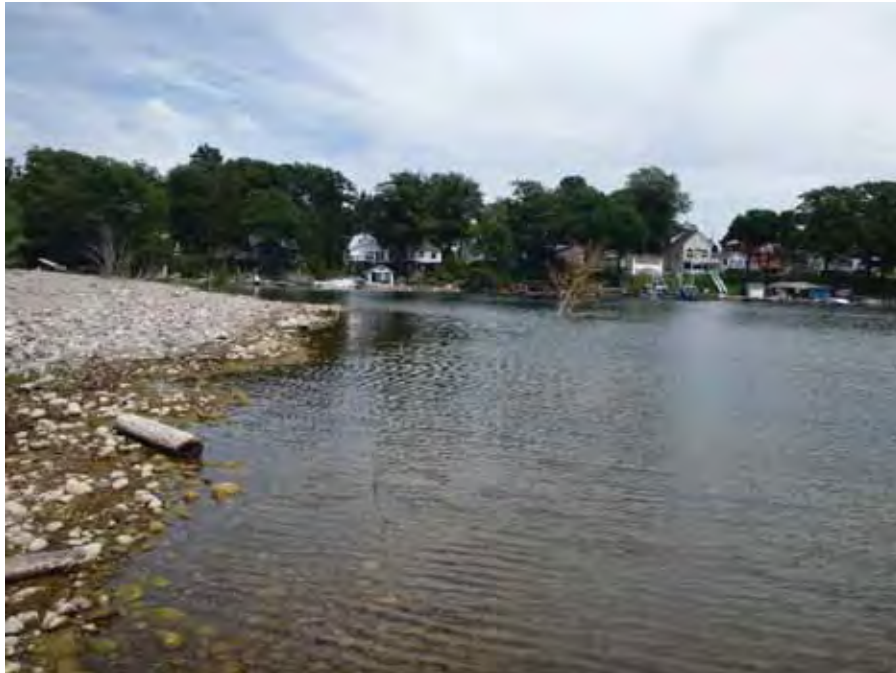
Figure 2.3-19 Littoral Zone Habitat Segment 8 (looking east from near midpoint)

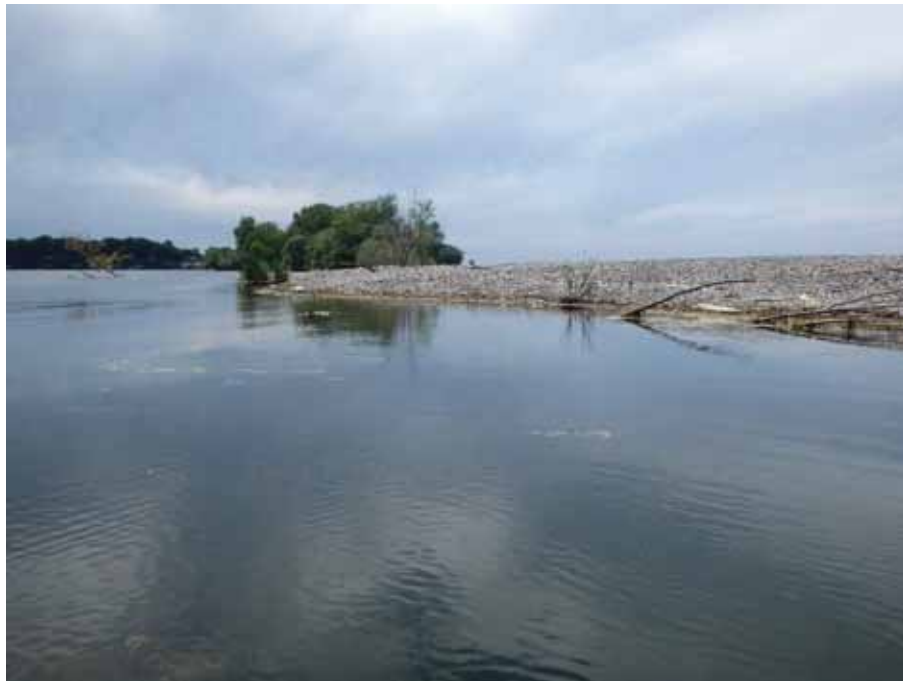
Figure 2.3-20 Littoral Zone Habitat Segment 8 (looking west from east end)
